# **Arboricultural Impact Appraisal & Preliminary Arboricultural Method Statement**

Q0138\34HavntRd\AIA+AMS(P)\PTI\_V12021

**34  
Havant Rd  
Emsworth  
Hampshire  
PO10 7JG**

# **Internal Decay Detection Assessment 34 Havant Road**

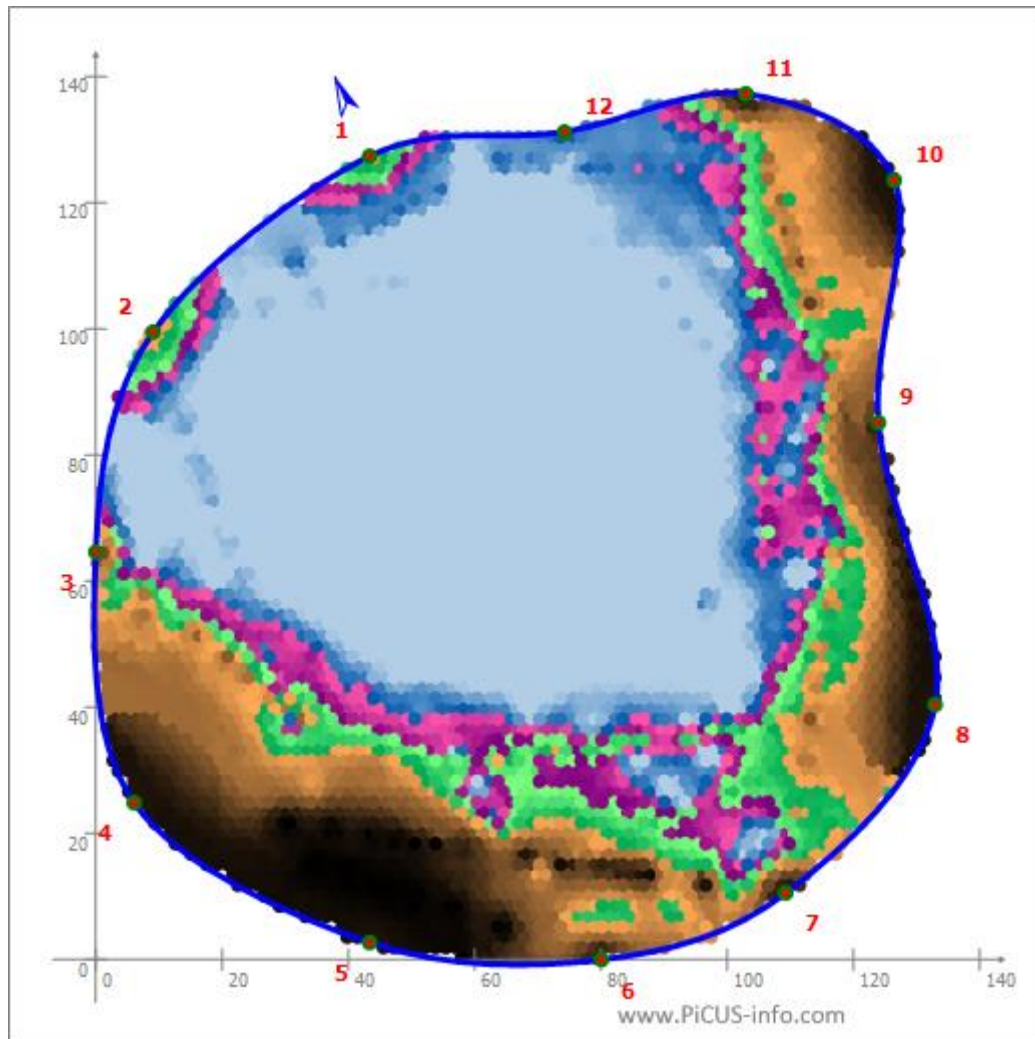
### 4.1. Tree 1

The Results of the Sonic Tomograph conducted upon the tree identified the presence of a large decay cavity orientated toward the northernmost portion of the trees lower stem. Little unaltered/healthy wood is shown throughout the tomogram graph. Where it is present it is located in small amounts close to the tree's root buttress flare. Light brown areas preceded by green, purple and blue indicate insipient decay which has not been effectively compartmentalised by the tree. Consequently, decay is continuing to spread throughout the tree's stem at the height at which it has been assessed. The subject tree has extremely low amounts of residual wood which would be considered as "healthy".

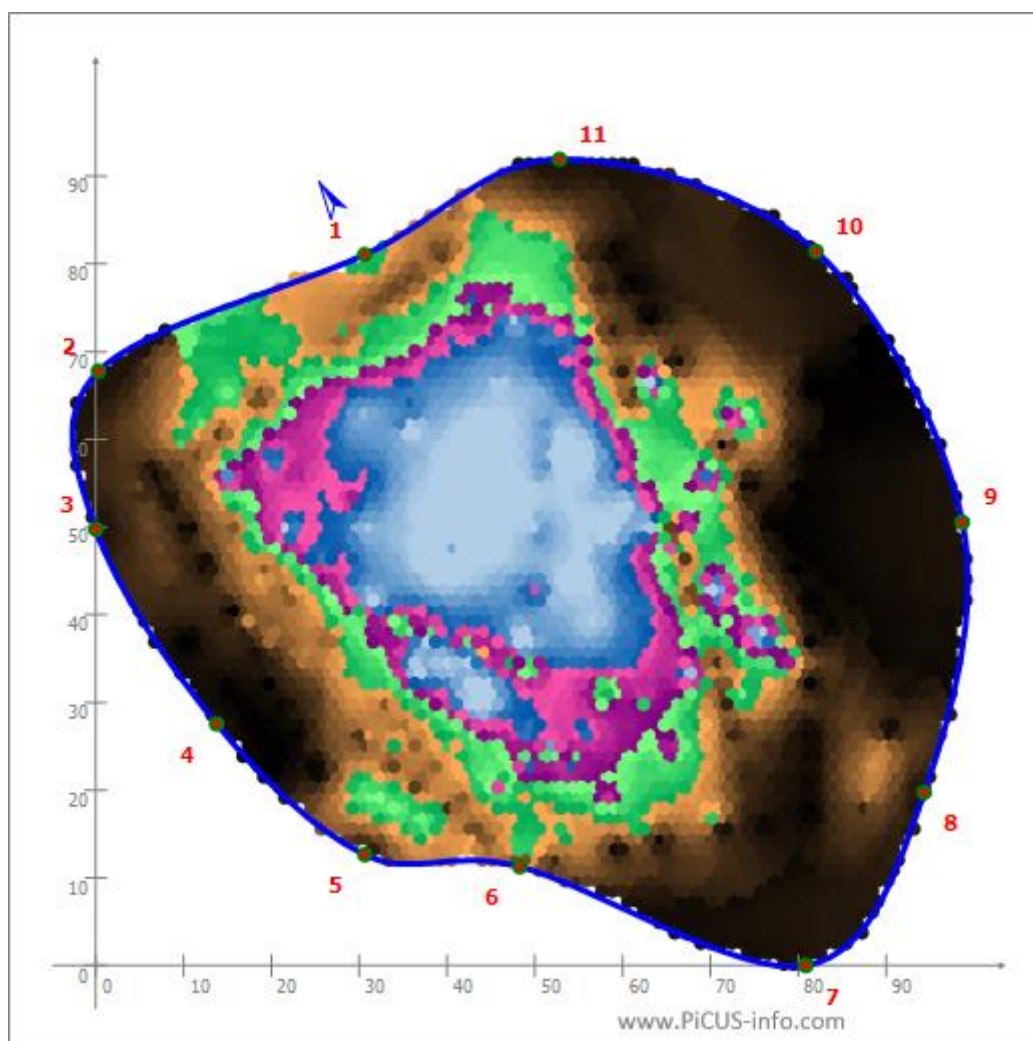
## 4.2. Tree 2

The Results of the Sonic Tomograph conducted upon the tree identified the presence of a large decay cavity located centrally within the tree's lower stem. Large areas of purple and green indicate advanced decay which is spreading into surrounding wood which is undergoing alteration (early decay process). The graph shows that the decay is only covered by a thin layer of Bark at sensor points 1 and 6. Little unaltered/healthy wood is shown throughout the tomogram graph. Where it is present it is located primarily on the eastern side of the tree's stem. Light brown areas preceded by green, purple and blue indicate insipient decay which has not been effectively compartmentalised by the tree. Consequently, decay is continuing to spread throughout the tree's stem at the height at which it has been assessed. The subject tree has very low amounts of residual wood which would be considered as "healthy".

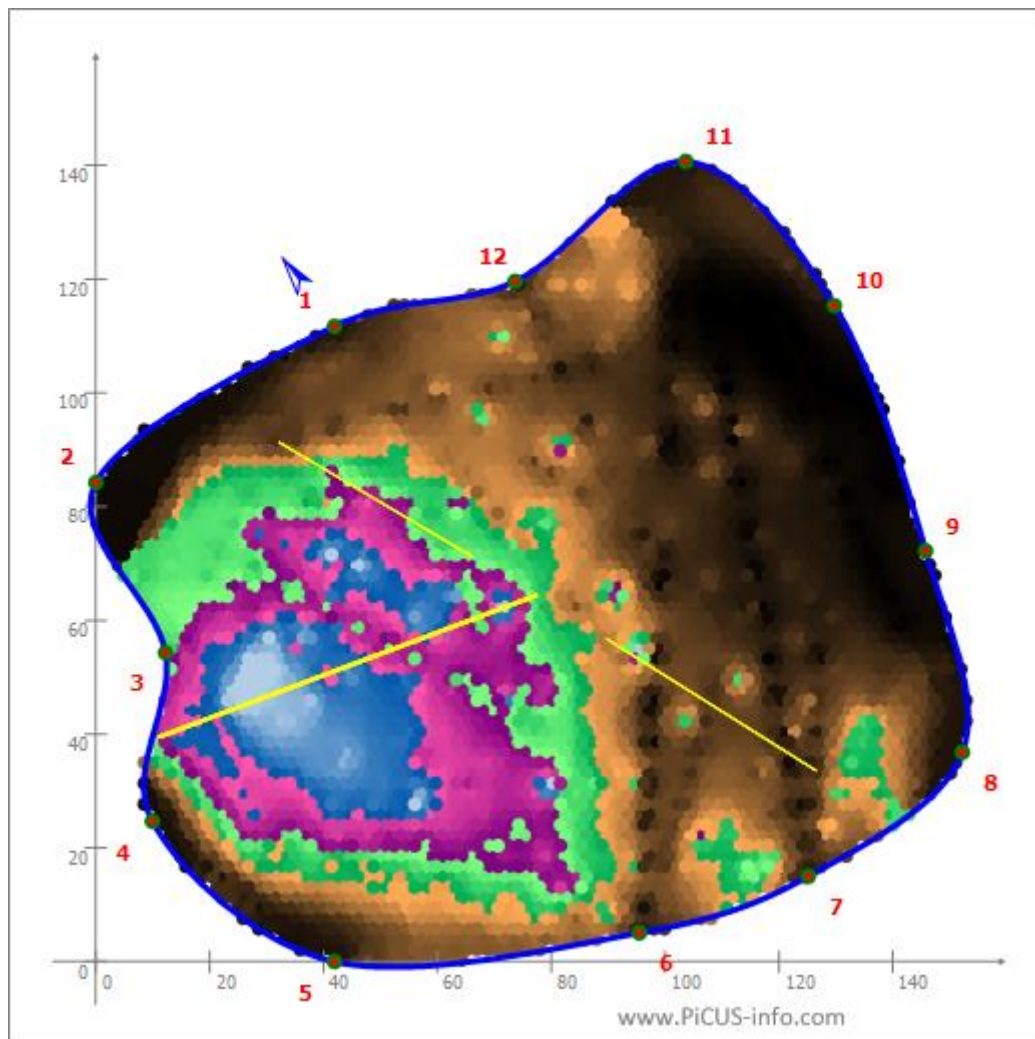
## 4.3. Tree 3

The Results of the Sonic Tomograph conducted upon the tree identified the presence of a large decay cavity (light blue/white) located toward the western portion of the tree's lower stem. Large areas of purple and green indicate advanced decay which is spreading into surrounding wood which is undergoing alteration<sup>5</sup> (light brown). Light brown areas preceded by green, purple and blue indicate insipient decay which has not been effectively compartmentalised by the tree. The presence of several linear yellow lines indicates the presence of radial and longitudinal fractures within the tree's stem.
