**PRE-DEVELOPMENT ARBORICULTURAL SURVEY  
AND  
ARBORICULTURAL ASSESSMENT OF IMPACT**

**MENGHAM PARK,  
NORMAN ROAD, HAYLING ISLAND,  
HAMPSHIRE**

**HAVANT BOROUGH COUNCIL**

**Report Number: MB2120117-01**

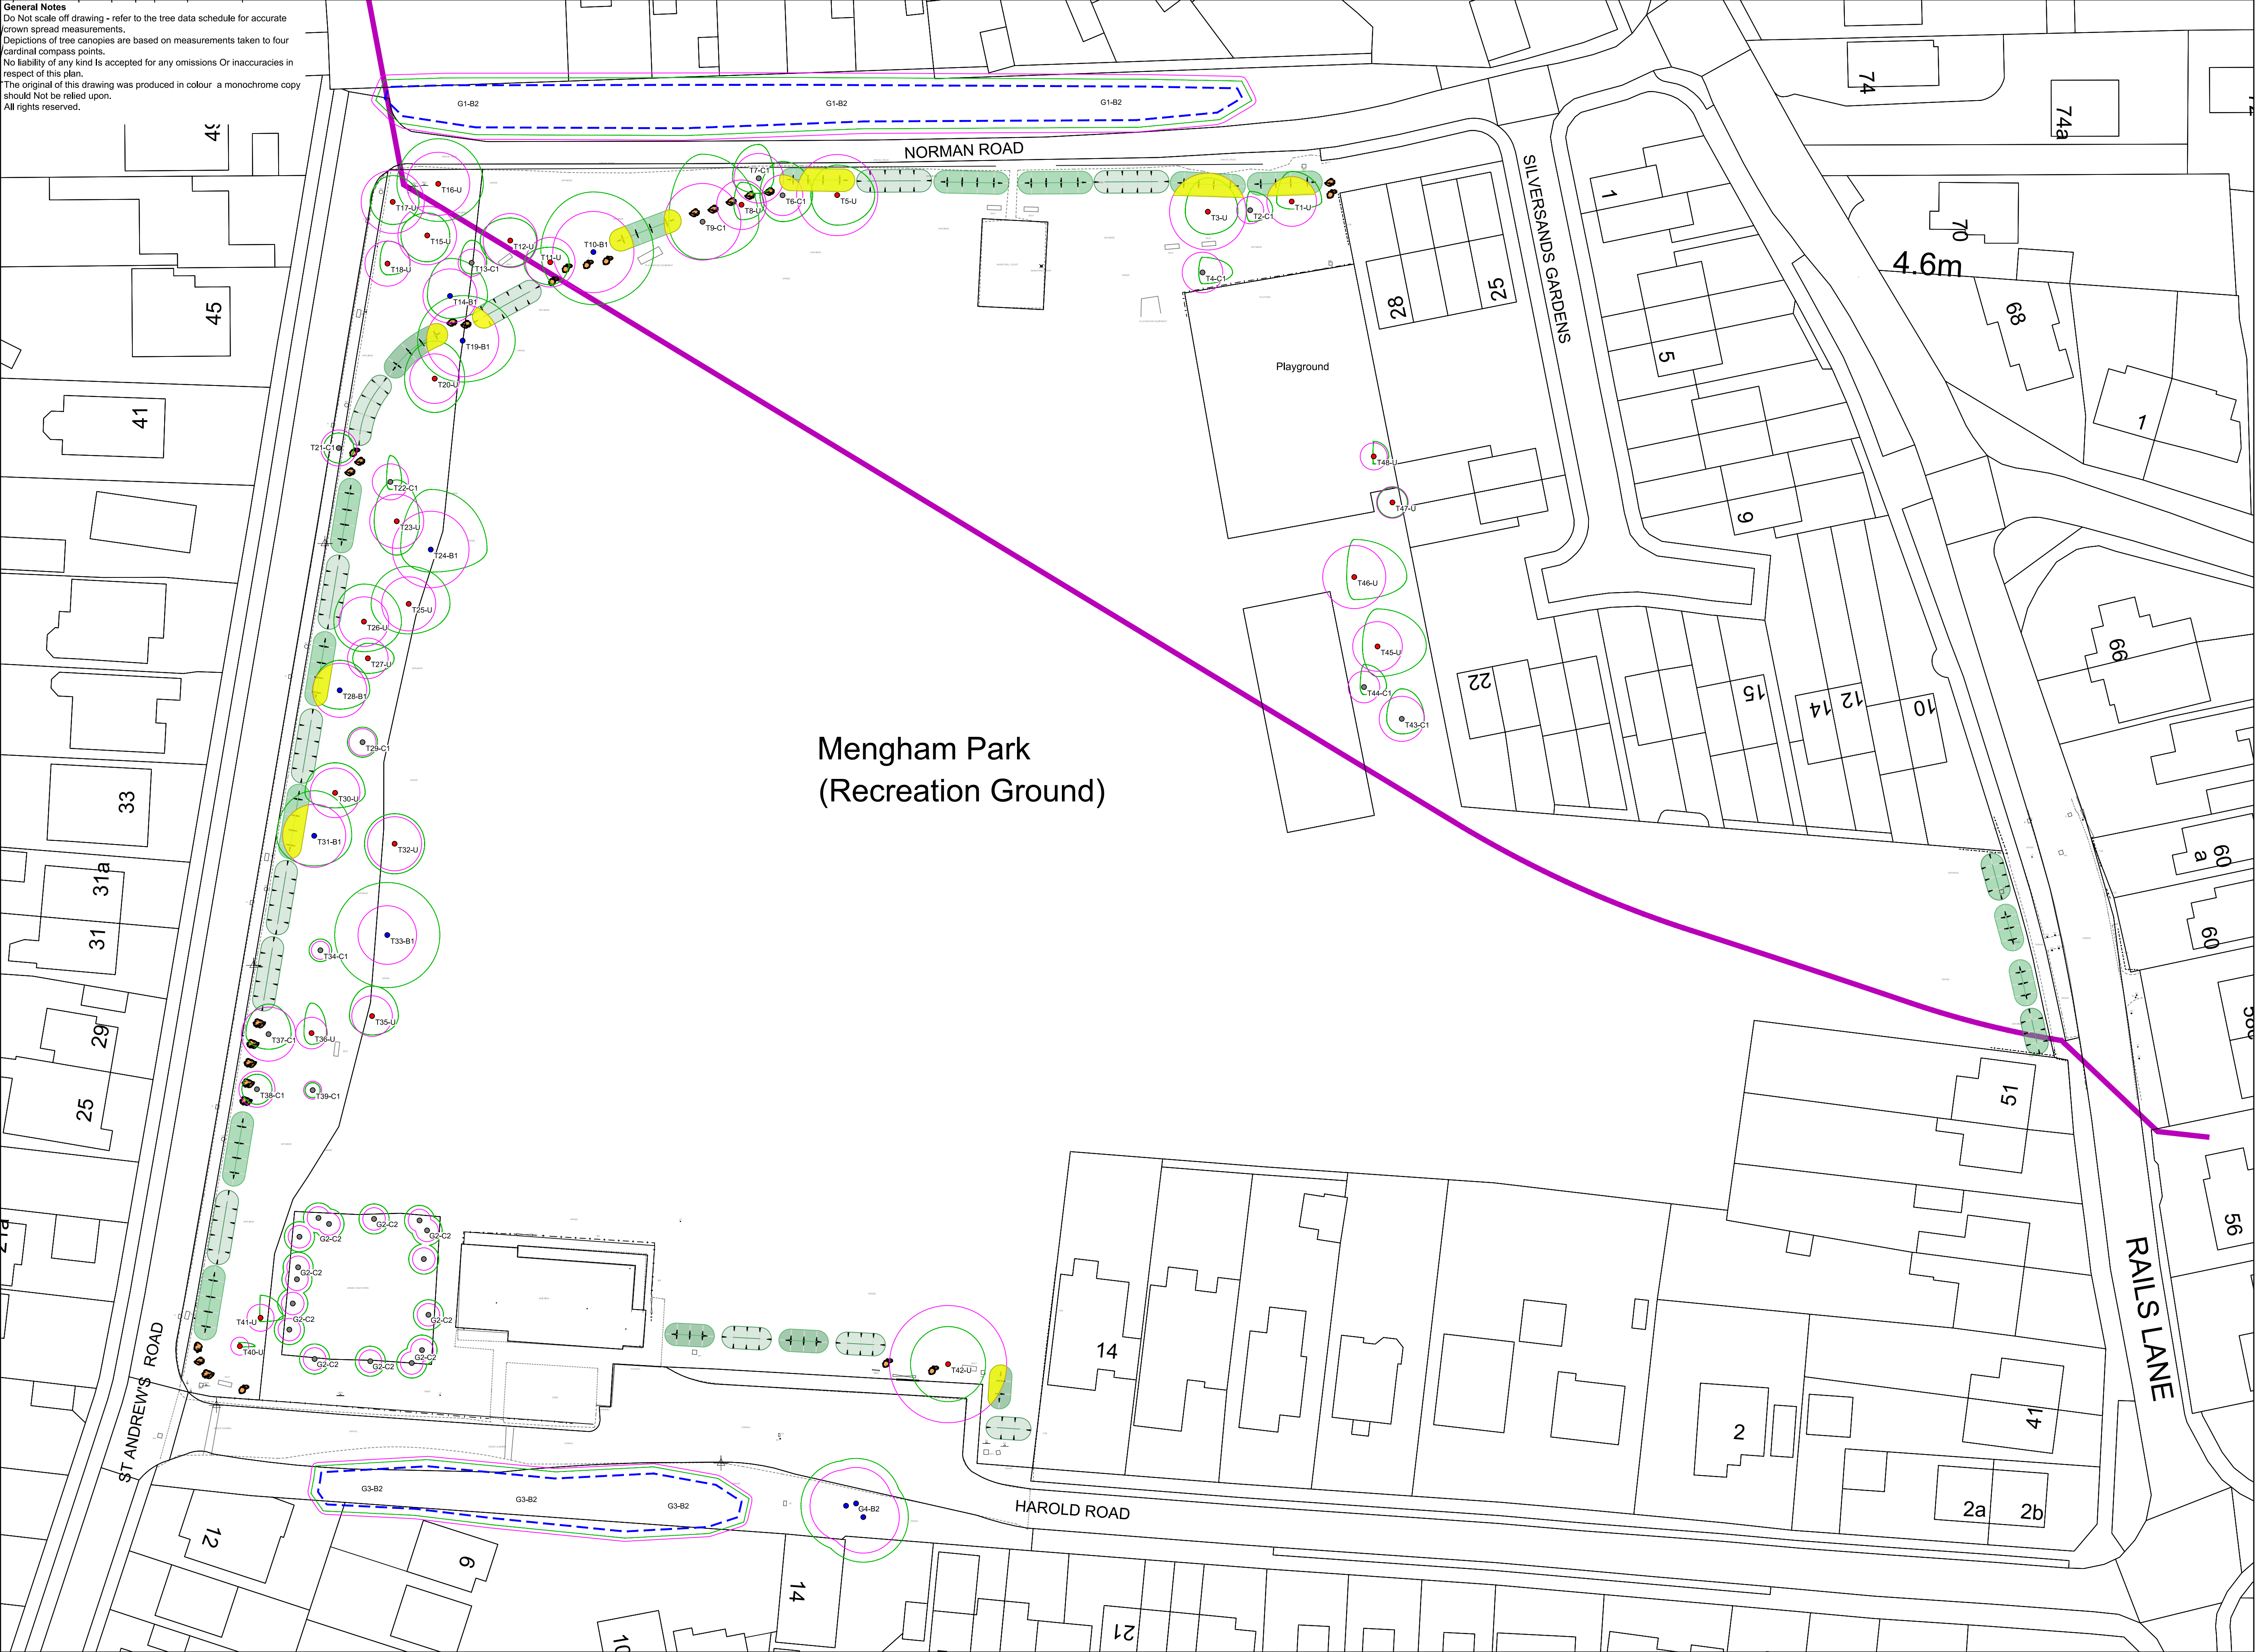
| MB220117-01-01 | | | A | |

The location of the trees surveyed can be found on Arbor-Eco Consultancy, Drawing Number MB220117-01-01 within Section 6 of this report.

All works to be carried out from the highway. No incursion within RPA's is permitted. All works to be carried out under arboricultural supervision.
