**ARBORICULTURAL SURVEY**  
**at**  
**7 Glamis Close**  
**Waterlooville**  
**Hampshire**  
**PO7 8JN**

**Claim Number:**  
DLG-SN-20-001935

**JCA Ref:**  
16315/RH

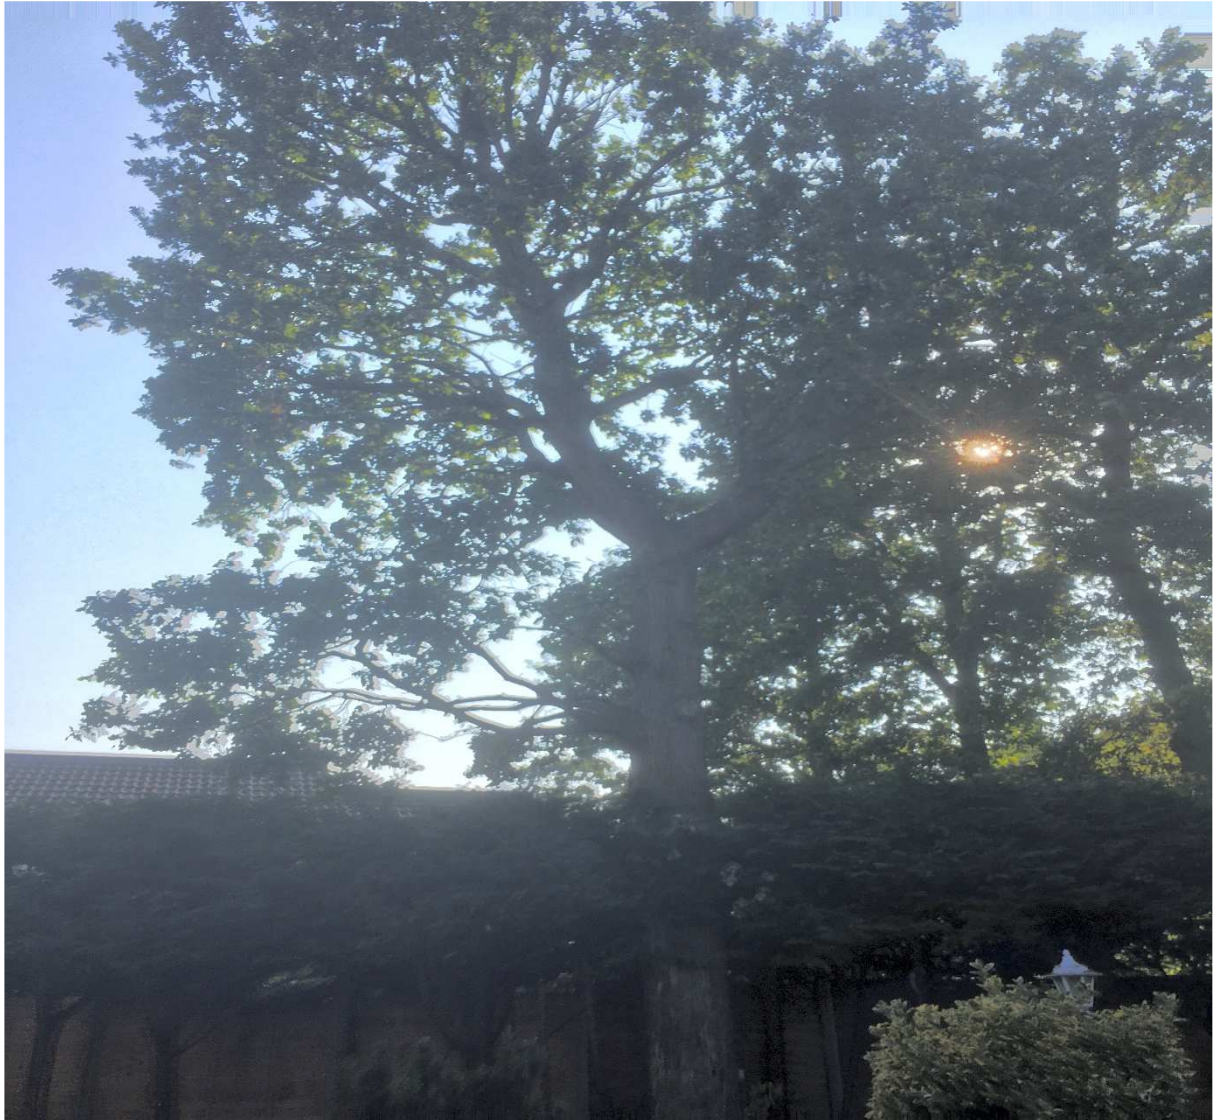
- 6.3 We consider the vegetation identified as **T3** to be contributing to the damage observed at the subject property. We have therefore recommended that **T3** be removed. **T3** comes under to the Area TPO (**1101**).

| Tree Ref. | Age<br>Common Name<br><i>Botanical Name</i> | Height (m) | Diameter (cm) | Spread (m) | Observations | Condition | Vigour | Distance to Property (m) | NHBC Water Demand | Life Expectancy (yrs) | Within Potential Influencing Distance | Root Identification Match | Contributing to Damage | Recommendations |
|---|---|---|---|---|---|---|---|---|---|---|---|---|---|---|
| T 3 | Mature<br>Oak<br><i>Quercus robur</i> | 11 | 70 | 8 | Single stemmed and vertical with a balanced crown. Pruning wounds noted on stem which are occluding well. Comes under Area TPO <b>(1101)</b> . Circa 50-100 years old. | FAIR | MOD | 6 | HIGH | 10+ | Yes | Yes | Yes | Fell to ground level and treat stump to prevent re-growth. |

Photo above shows T3

| Item | Species | Recommended Action | Location | Planning Restriction |
|---|---|---|---|---|
| T3 | Oak | Fell to ground level and treat stump to prevent re-growth. | Subject Property. | TPO. |
