22 January 2015

## **SURVEY REPORT**

**Re:-  
208 London Road  
Waterlooville  
PO7 7AN**

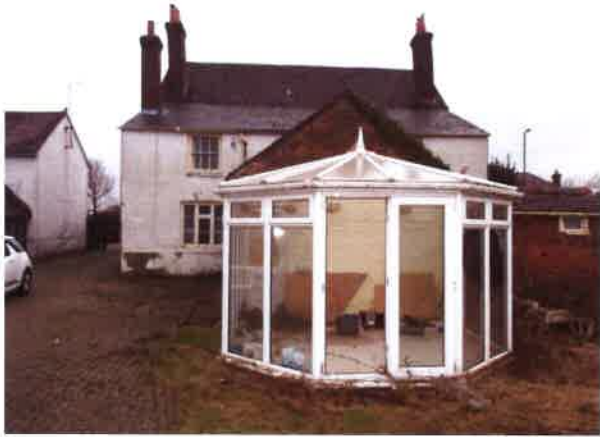
p13 chimneys

There are three chimney stacks with the property; the fourth stack associated with the kitchen has been removed from above roof level. (photo 13)

The main building has stacks at the northern and southern flank, each of which is excessively tall and leaning to the south. These chimneys have inferior mortar flashing.

The south-east chimney stack serving the old kitchen emerges above the slate roof and again is excessively tall.

The condition of these chimneys above roof level is considered unsound, being in excess of the height to girth ratio and leaning badly. It is recommended that they be taken down.

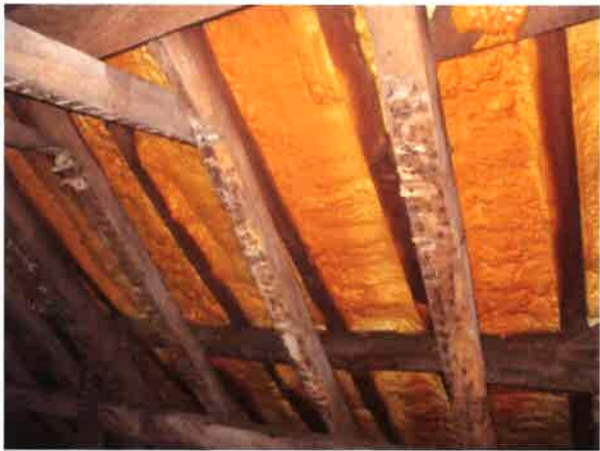
p 29 styrafoam

Inspection within the roof void revealed that these tiles have been fixed to the laths and to the rafters by a styrene foam, which is a discredited and cheap form of roof renovation, whereby the tiles are, in effect, glued to the rafters (photo 29). This is known to cause problems of timber decay due to non-breathability and is difficult to remove from both the timbers and impossible to remove from the tiles without excessive labour.

It is considered that the tile roof covering is ruined by the application of foam glue and rafters will be affected. The tiles will not be suitable for salvage.

The front pitch is not supported by a lower purlin and, consequently, the rafters have sagged excessively (P34). To the rear pitch, a lower level purlin has been inserted behind original rafters and newer rafters fitted (p 29).

The excessive deflection of rafters, failure of adequate support and evident timber decay, when combined with the styrene foam, leads to the conclusion that the roof must be re-strutted and completely rebuilt with new tiles.

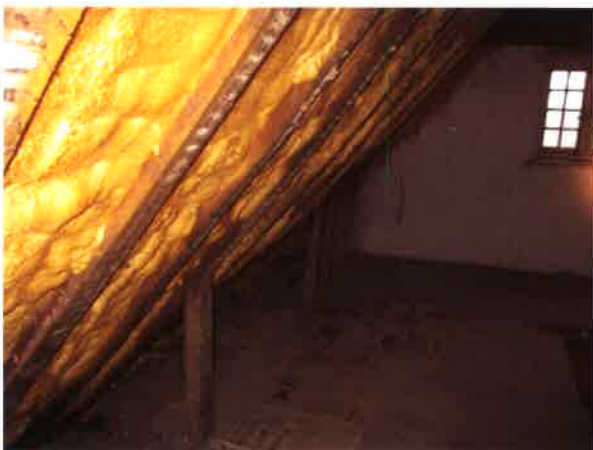
p 34 sagging timbers

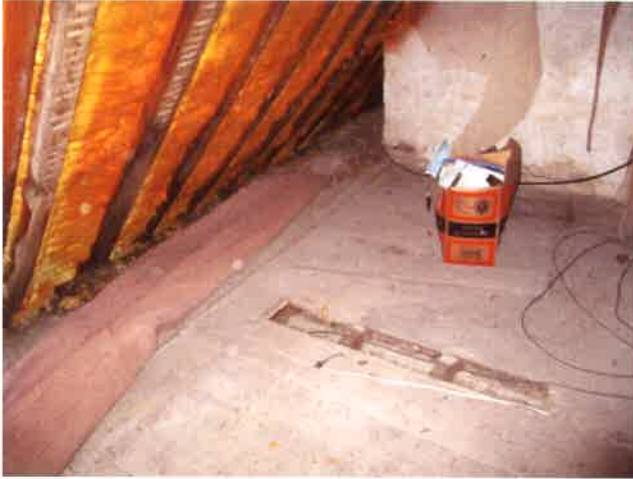
way  
p 30 ceiling/floor joists span wrong

Floor joists span side to side and thus there is no lateral support to front and rear rafters (p 30).

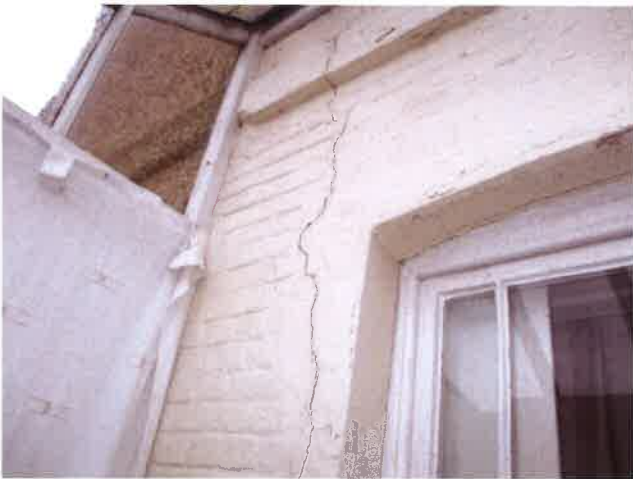
p 37 structural crack

Main rear elevation – structural cracking through south-east ground floor window and compromised brick arch over. Severe saturation to the entirety of the middle section of the wall and to the base of the wall. The wall is emulsion painted but this is peeling off and brickwork is extremely porous and decayed, immediately to the right of the kitchen back addition.

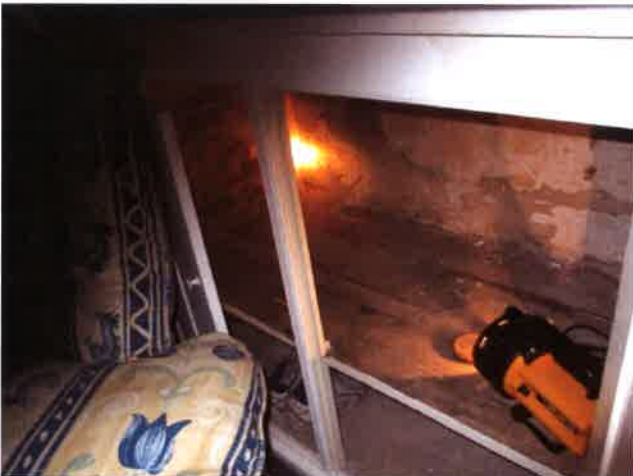
p 21 decayed bricks/ damp

It is difficult to treat old brickwork when rendered, as hacking off the render can cause dislodgement of bricks or defacement. Evidence of brick decay is clearly seen in the south east reception cupboard (p 21). The condition o high moisture level in main walls

The base of internal walls was checked, where fixtures and furnishings permitted, and were found to be suffering from serious rising damp. As most of the walls are dry lined or fitted with cupboards there is little visual evidence of this, apart from surface staining. However, the cupboard in the SE ground floor room, in the rear corner, shows the actual condition of the plaster and

brickwork which comprises extreme damp saturation and decay to the bricks and mortar, whilst the plaster has fallen off (p 21).

Ground level is high in relation to floor level and it is doubted whether there is a damp-proof course. Significant damp remedial treatment is required but, due to the soft saturated condition of the bricks, this may not be effective.

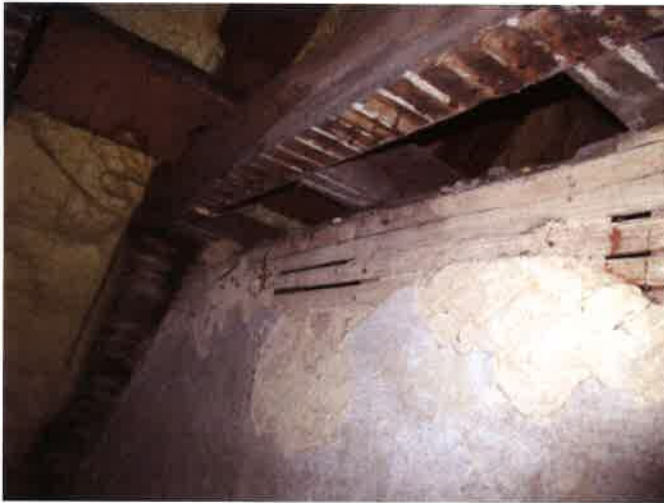
p 36 lath and plaster

The lath and plaster dates from the Victorian period, being a simple lime daub over the lathes (p 36). This effectively dates the building to early or mid-Victorian period.

It is a recommendation that all interior walls be replastered, including dry lining to all external walls.

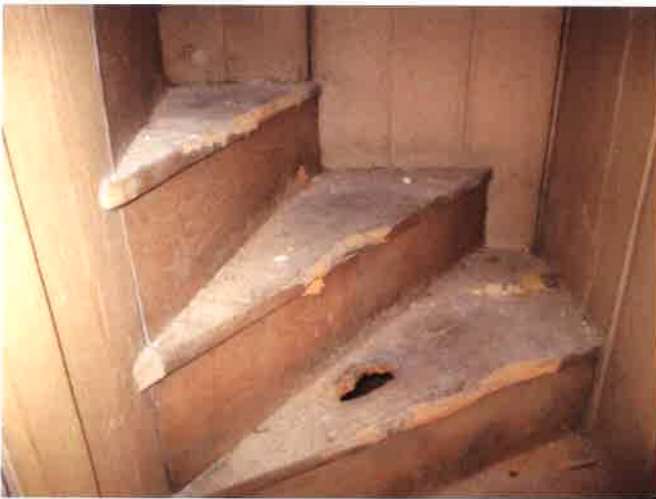
p26 timber decay

The timber staircase shows serious decay due to worm (P 26).

There is excessive decay of timber, as illustrated by photos P26, 32 and 35). In addition, there is very high humidity level within the roof and the integrity of the timbers is compromised.

The staircase to the attic floor is in dangerous decayed condition due to excessive worm (p 26).

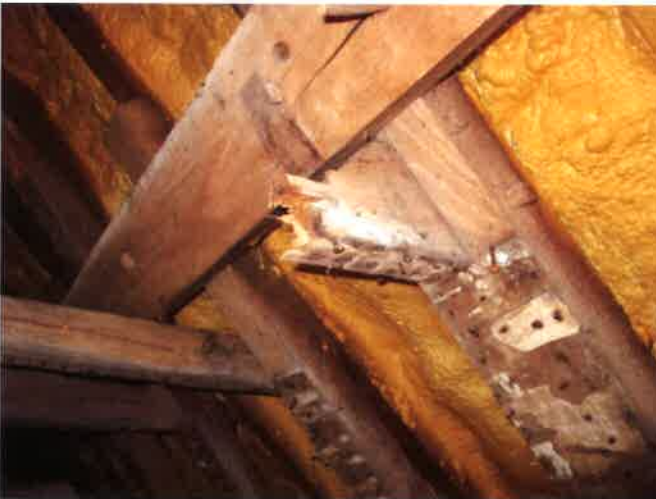
p32 timber decay

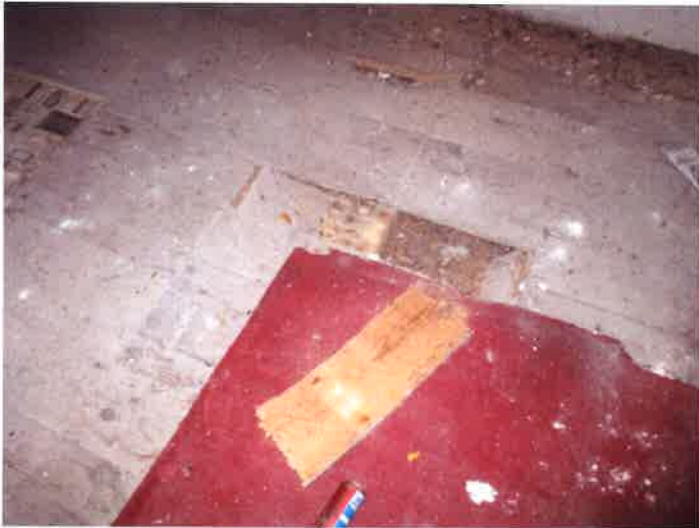
p35 timber decay

Floors throughout the attic are extremely decayed, as are the boards, which are brittle and unsafe to walk upon (p 35). An entire new floor on new beams may be a requirement for attic floors, upon exposure for further assessment.

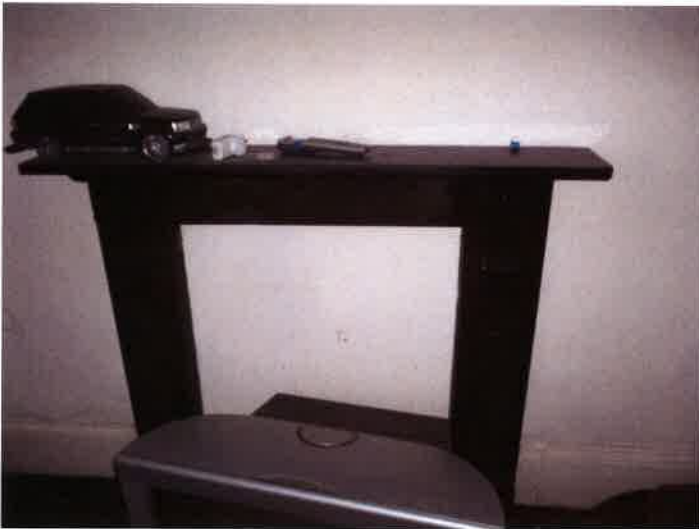
p21 Victorian fireplace

Fireplaces within the building are all blocked off and each shows damp penetration. The style of fire surrounds is consistent with mid-Victorian fittings. (photo 21)

Fireplaces comprise either very plain timber (presently boarded over) or mid-Victorian marble fireplaces (p 21) and a 1930s fireplace to the SE reception.

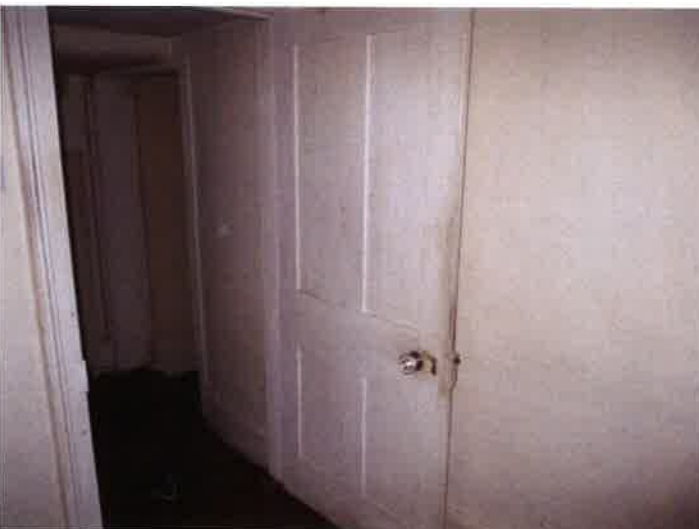
p 16 plain door

Otherwise, doors throughout comprise a mixture of styles, mostly plain boarded doors without raised fields, i.e. basic quality, and there is a brace and ledge door to the north-east reception. Several doors comprise 20<sup>th</sup> Century replacements.
