# Arboricultural Appraisal Report

## Subsidence Damage Investigation at:

20 Pinetree Gardens  
Waterlooville  
PO8 8AE

| REPORT DATE: | 23/12/2021 |

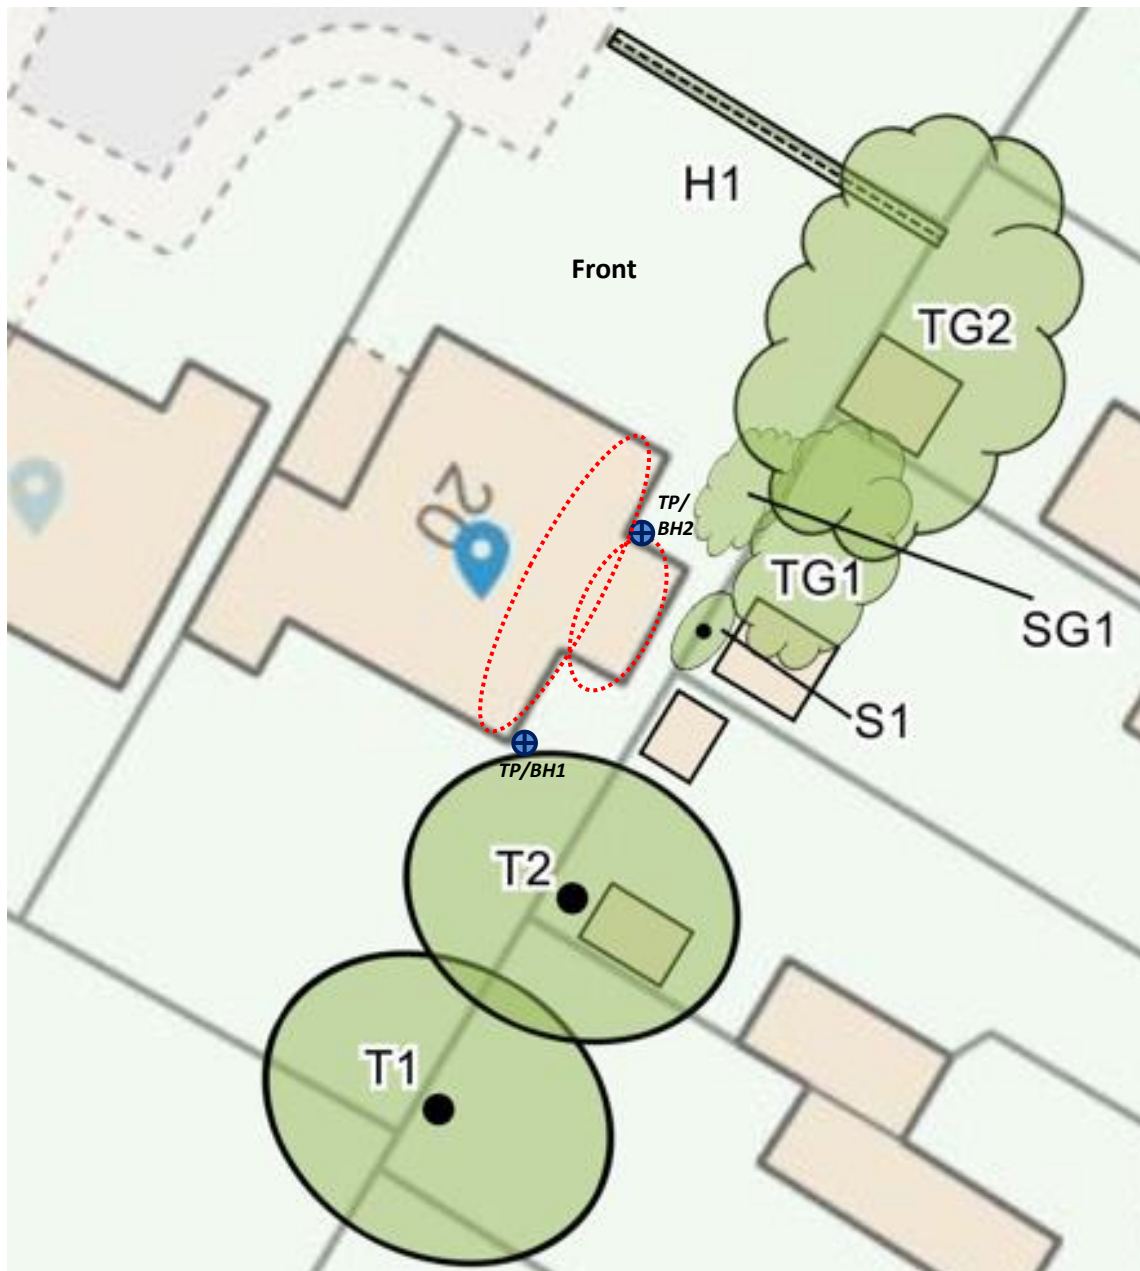
Approximate areas of damage

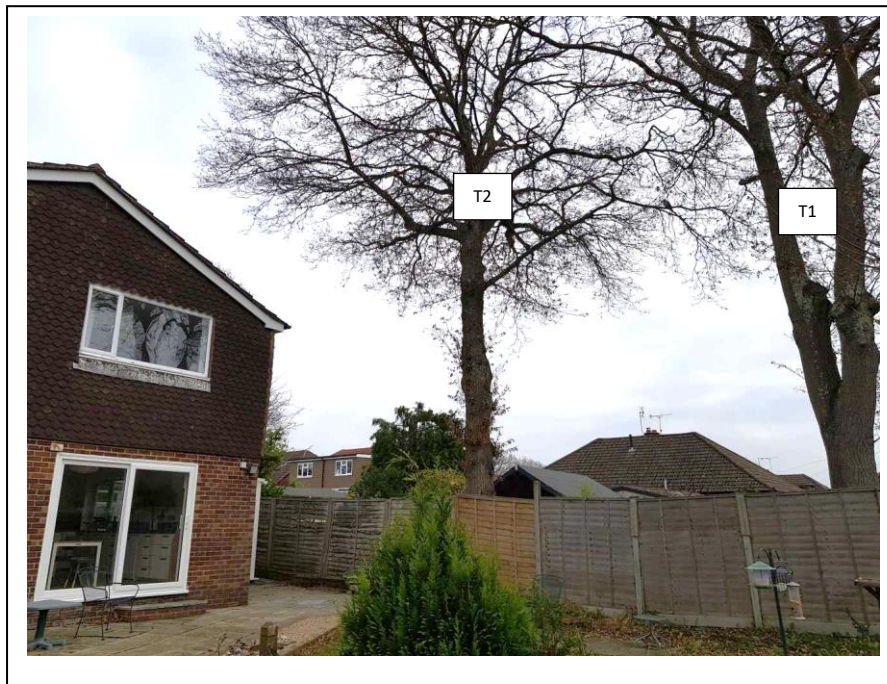
View of rear left corner of dwelling

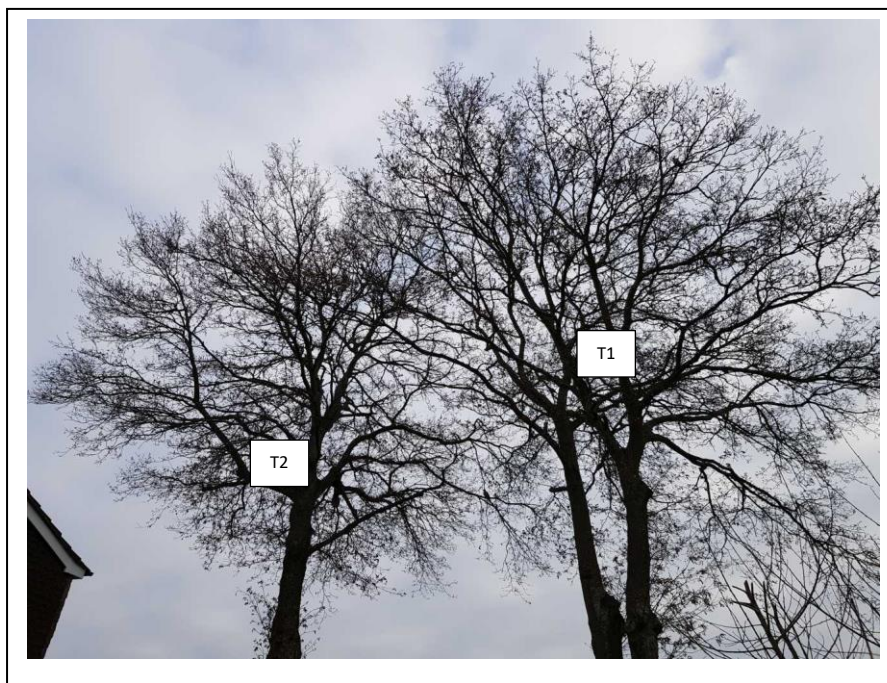
Roots were observed to a depth of 1150mm bgl in TP/BH1 and recovered samples have been positively identified (using anatomical analysis) as *Quercus spp.*, the origin of which will be T2 or T1, confirming their influence on the soils below the foundations.

T1 and T2 are already subject to regular pruning including a high crown lift. Given the combination of slight desiccation and relatively low but significant movement in the monitoring data we conclude that these trees could be retained subject to crown reduction.

View of crowns of T2 and T1

| Tree No. | Species | Ht. (m) | Dia. (mm) | Crown Spread (m) | Dist. to building (m) | Age Classification | Ownership |
|---|---|---|---|---|---|---|---|
| Recommendation | | Reduce height to 18m and crown spread to 9m leaving balanced crown. Prune on a triennial cycle to maintain at broadly reduced dimensions. | | | | | |

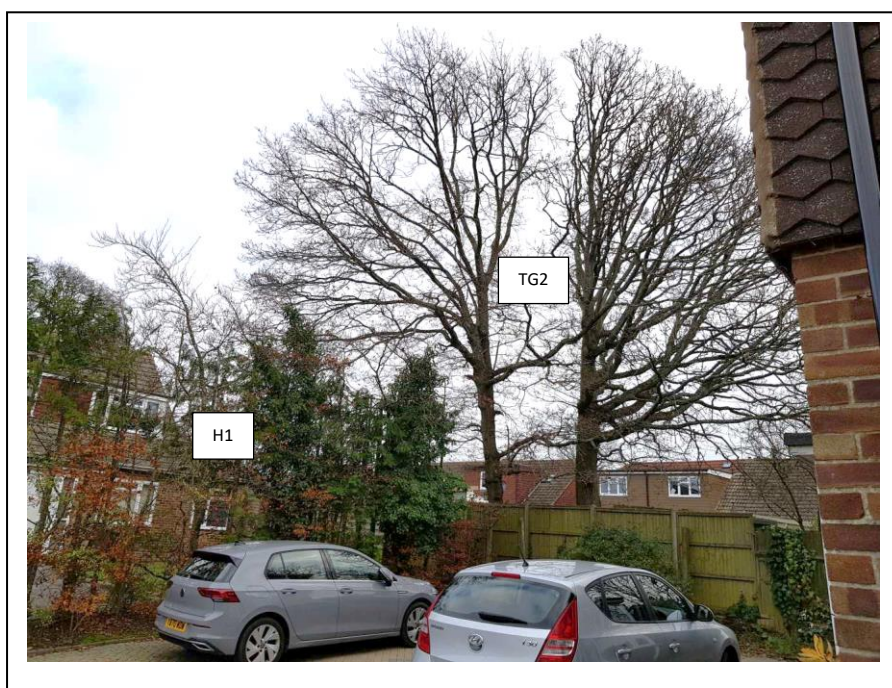
Roots were observed to a depth of 1500mm bgl in TP/BH2 and recovered samples have been positively identified (using anatomical analysis) as *Quercus spp.* or *Castanea spp.*, the origin of which will be TG2, confirming its influence on the soils below the foundations.

Based on the technical reports currently available, engineering opinion and our own site assessment we conclude the damage is consistent with shrinkage of the clay subsoil related to moisture abstraction by vegetation. Having considered the information currently available, it is our opinion that TG2 and TG1 are the principal cause of or are materially contributing to the current subsidence damage. T2 and T1 are also likely to be affecting the rear of the dwelling but do so to a much lesser degree.

View of TG2

If an arboricultural solution is to be implemented to mitigate the influence of the implicated trees/vegetation we recommend that TG2 is removed and TG1 reduced.

| Tree No. | Species | Ht. (m) | Dia. (mm) | Crown Spread (m) | Dist. to building (m) | Age Classification | Ownership |
|---|---|---|---|---|---|---|---|
| Recommendation | | Remove (fell) to near ground level. Owner to physically remove any regrowth (no chemical treatment due to translocation risk). | | | | | |
