# Camera Survey Report

## **PFIZER**

New Lane Havant

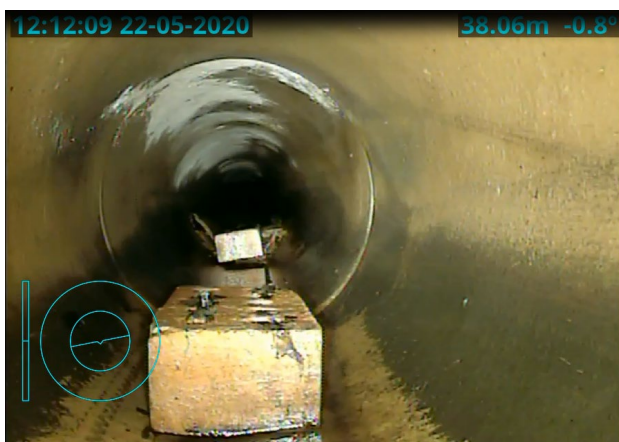
### Surface water lids 7 – 6 (Survey0000041/90145761) (Survey0000041/90146334)

| Lid ID (start) | Lid ID (finish) | Video | Issues Identified location | Material | Length (m) | Size (mm) | Map (sheet) |
|---|---|---|---|---|---|---|---|
| 6 | 7 | Survey0000041/90145761 | Bricks in pipe | F/G | 54 | 12" | 6 |

Bricks found in the pipework

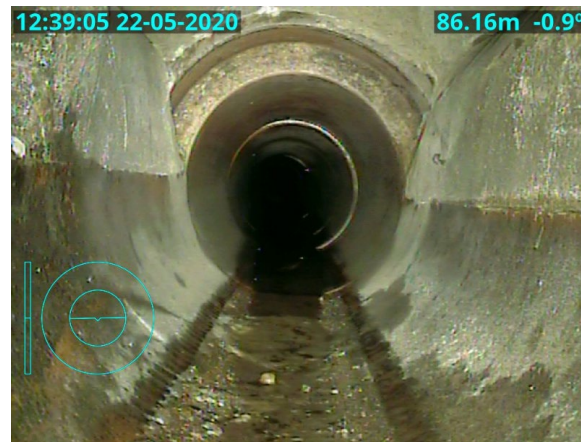
### Surface water lids 8 – 12

| Lid ID (start) | Lid ID (finish) | Video | Issues Identified location | Material | Length (m) | Size (mm) | Map (sheet) |
|---|---|---|---|---|---|---|---|
| 8 | 12 | Survey0000041/90146334 | Broken / cracked pipe | F/G | 91 | 12" | 6 |

Cracked pipework – still from video

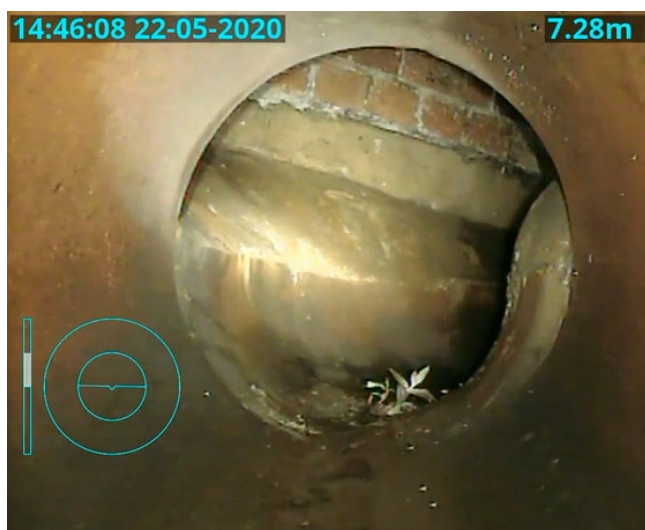
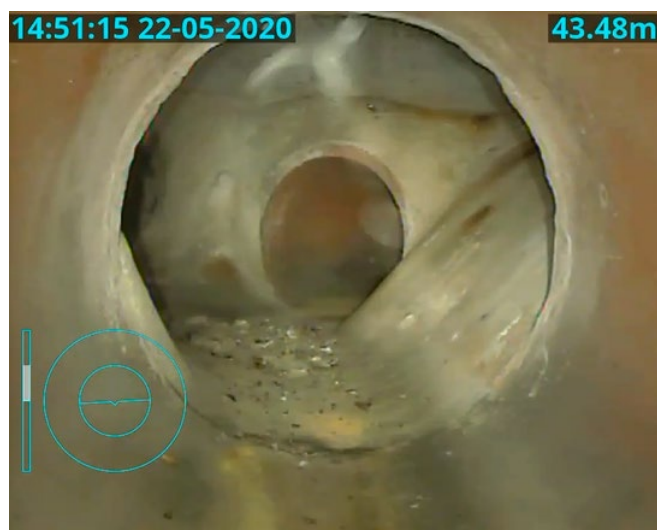
Surface Water Lids 46 – 309118 Survey0000044/90155114

Pipework CLEAR

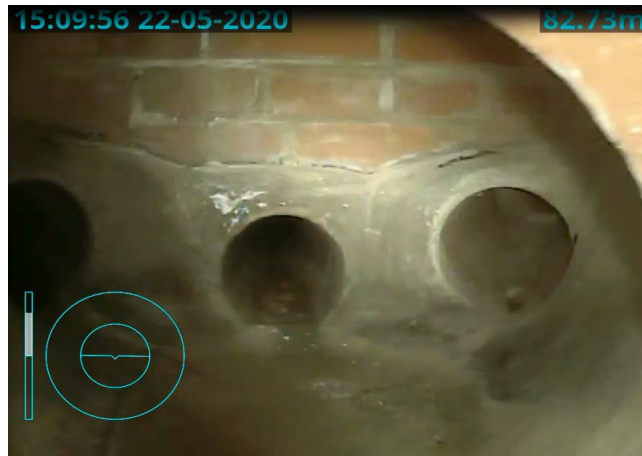
Surface Water Lids 309118 – Under Building Survey0000045/90156178

Pipework CLEAR

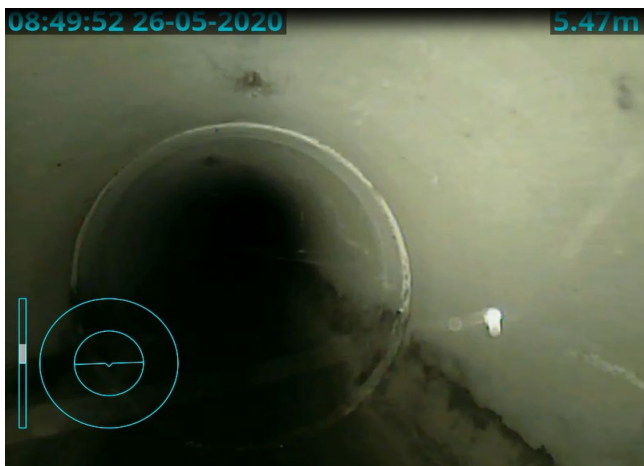
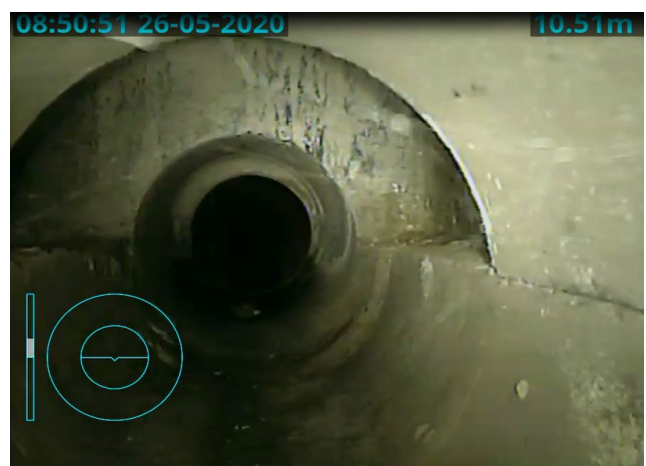
Surface Water Lids 40 – 41 – 42 Survey0000047/90479332

Pipework CLEAR

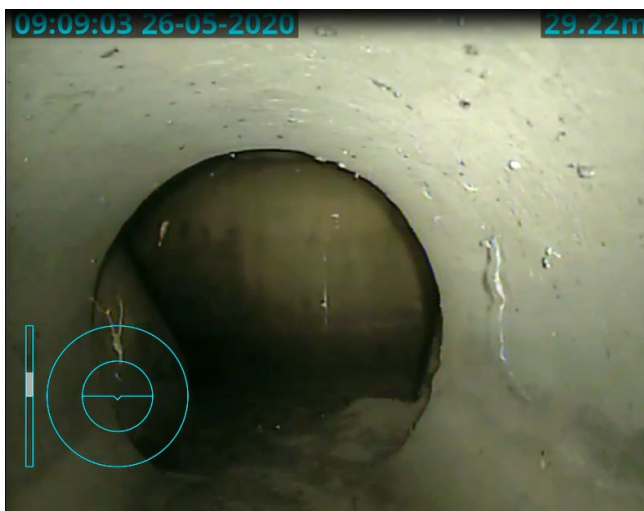
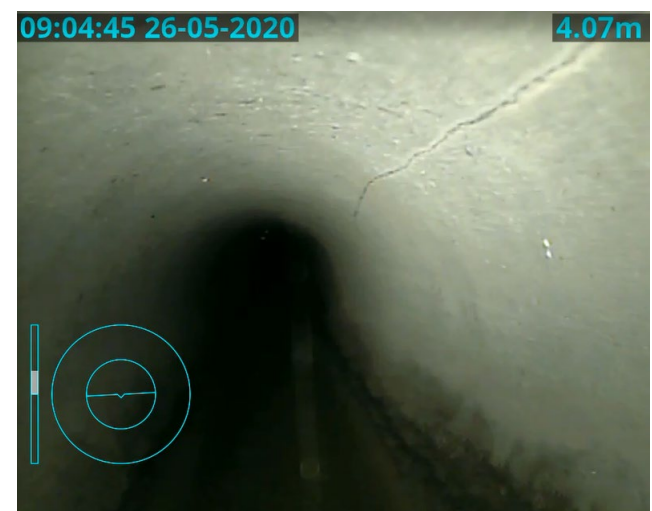
Surface Water Lids 45 – 44 – 43 Survey0000048/90480232

Pipework CLEAR, has cracking laterally but no displacement

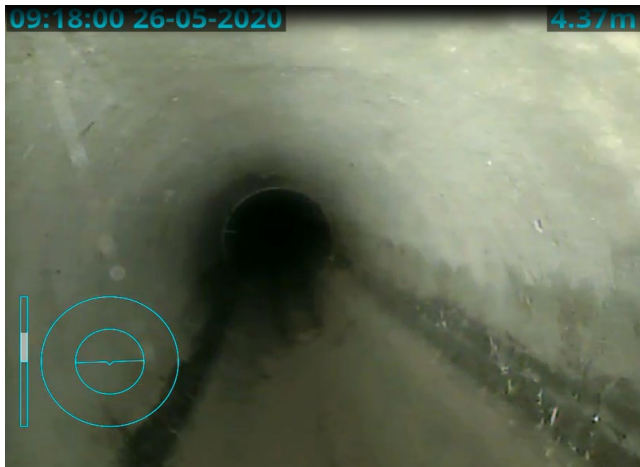
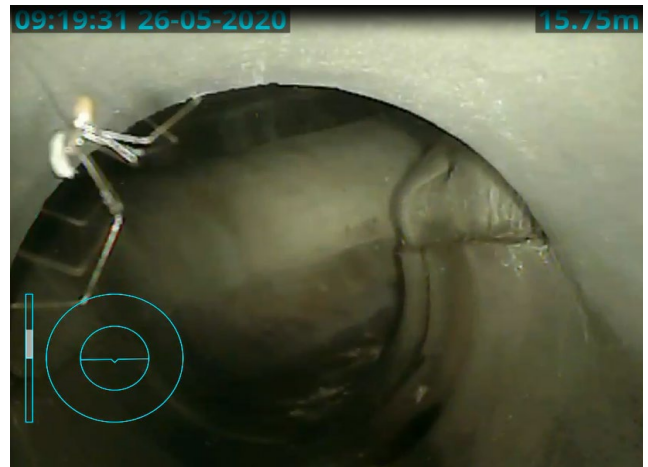
Survey0000049/90481030

Pipework CLEAR

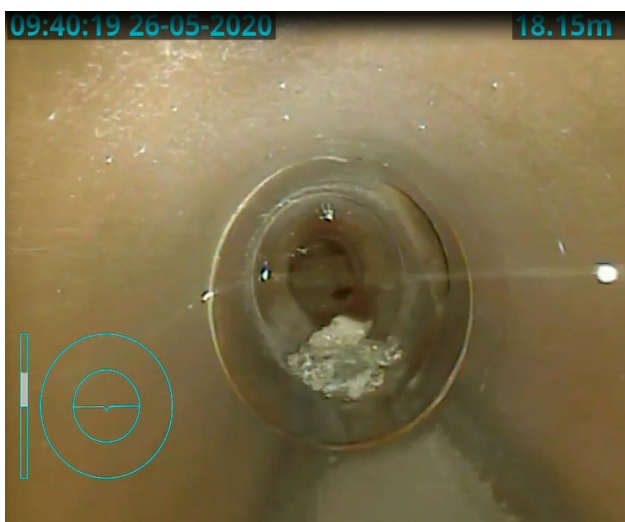
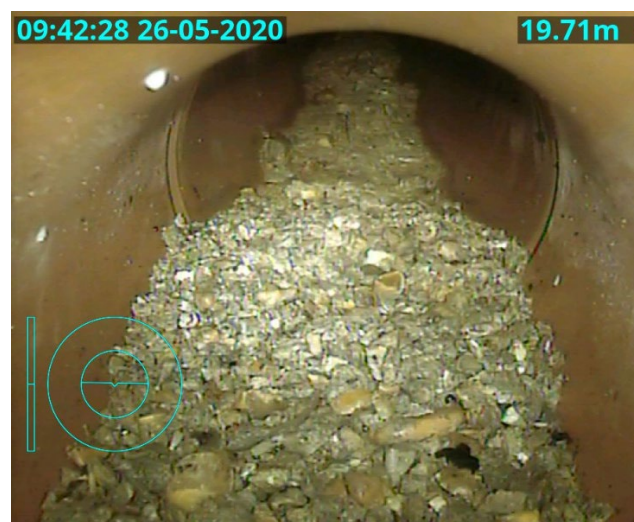
Surface Water Lids 318119 – 361119 - Under building Survey0000050/90482231

Pipework shows HEAVY DEBRIS

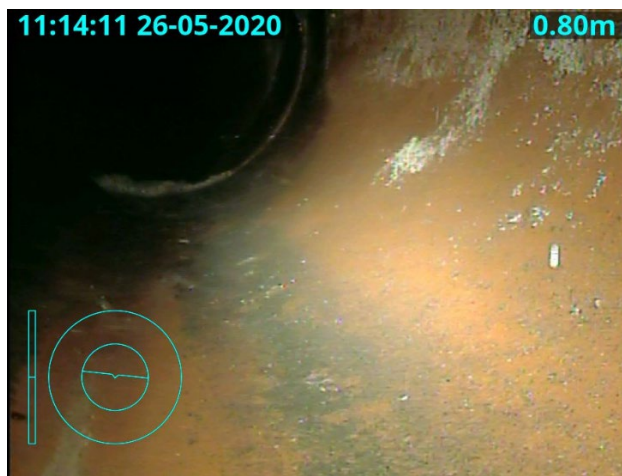
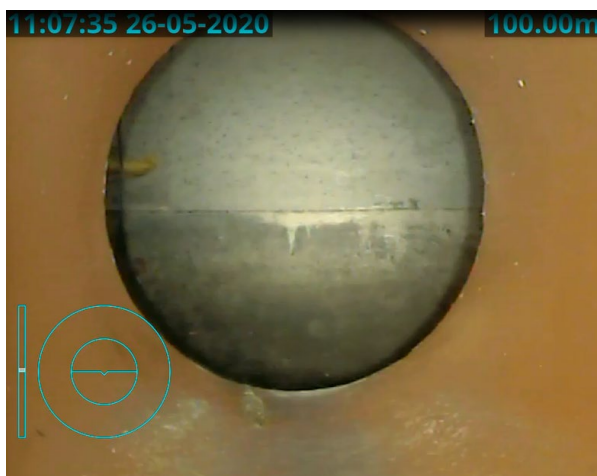
Surface Water Lids 361006 – Catch Pit Survey0000052/90487000

Pipework CLEAR

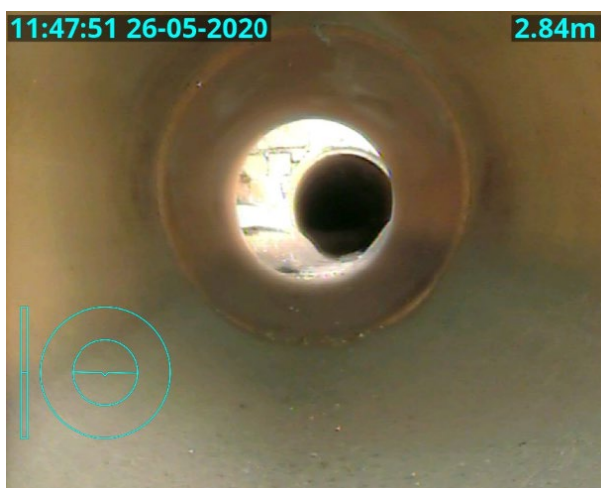
Surface Water Lids 30294006 – 397006 - 394013 Survey0000054/90490159

Pipework CLEAR

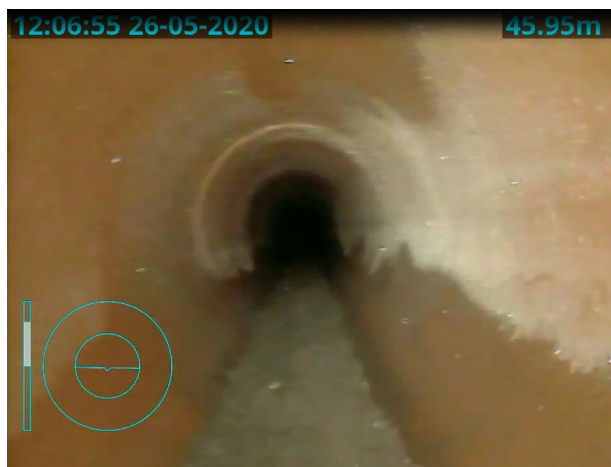
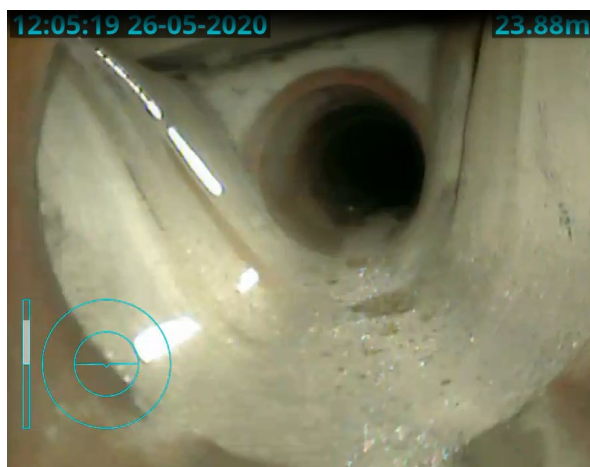
Surface Water Lids 394018 –391104 Survey0000057/90491017

Pipework shows LIGHT SILTING

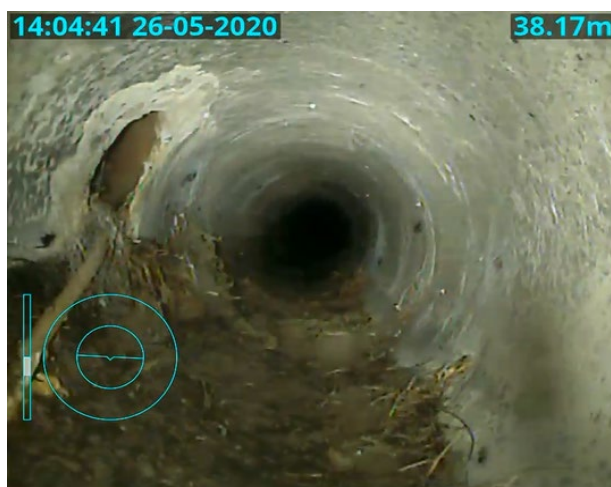
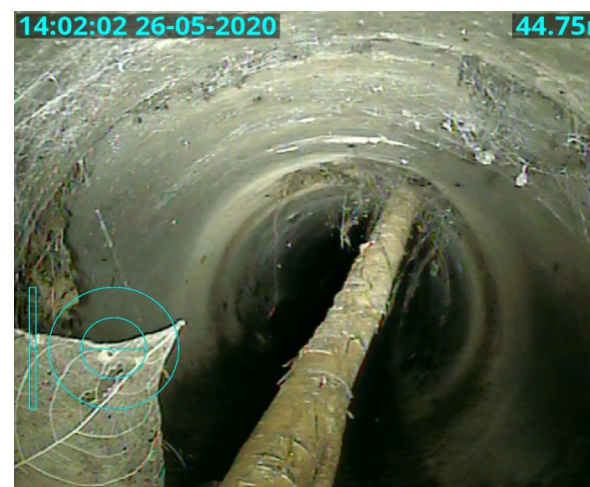
Surface Water Lids S49 – East Side Road Survey0000059/90497875

Pipework shows INGRESS of ROOTS and HEAVY SILTING

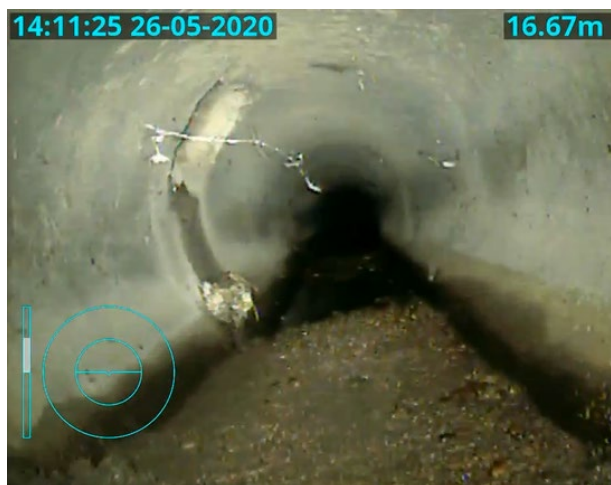
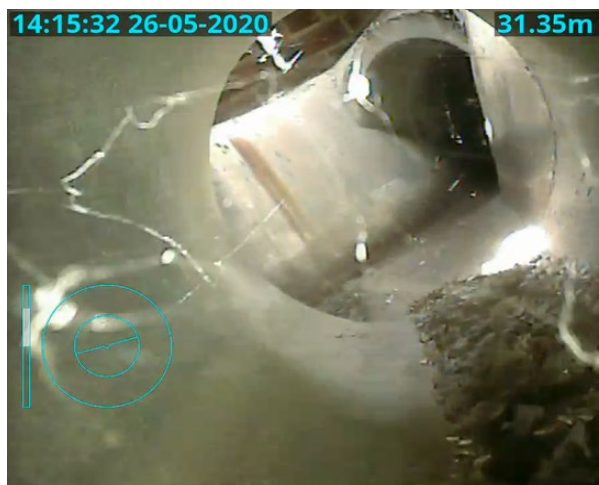
Surface Water Lids S49 –S70 Survey0000060/90498593

Pipework shows SILTING

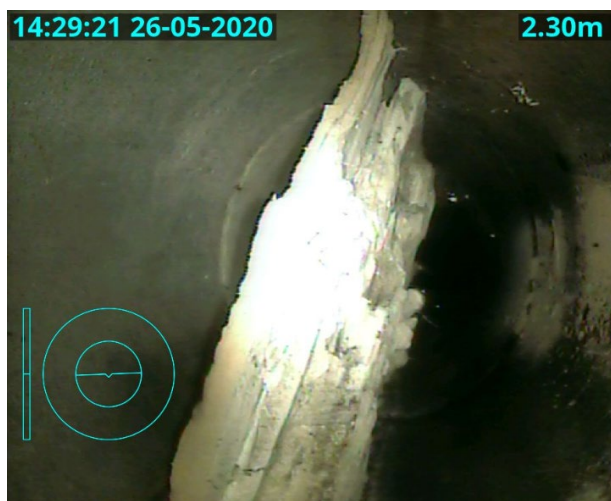
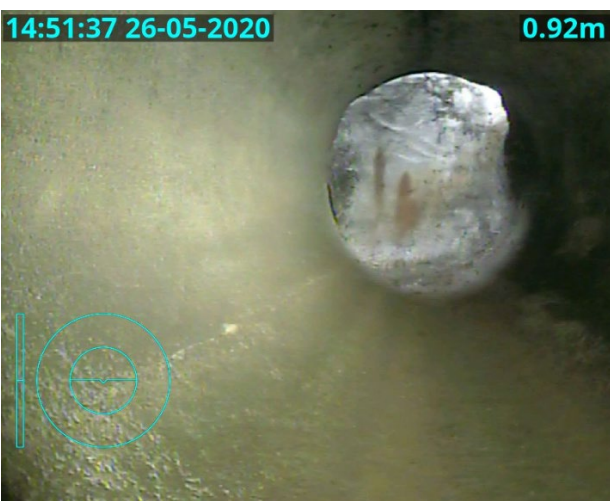
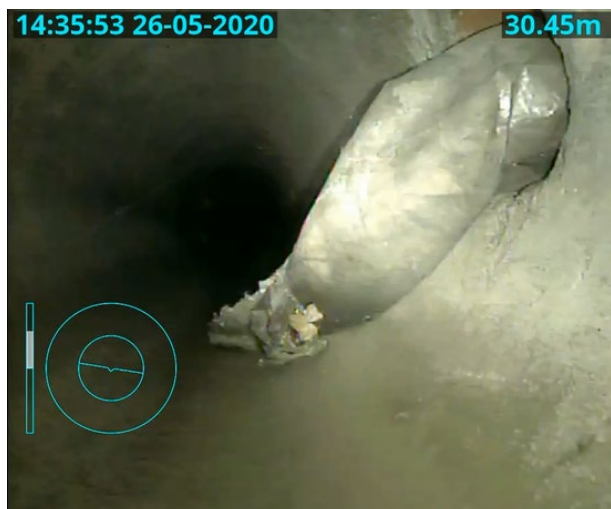
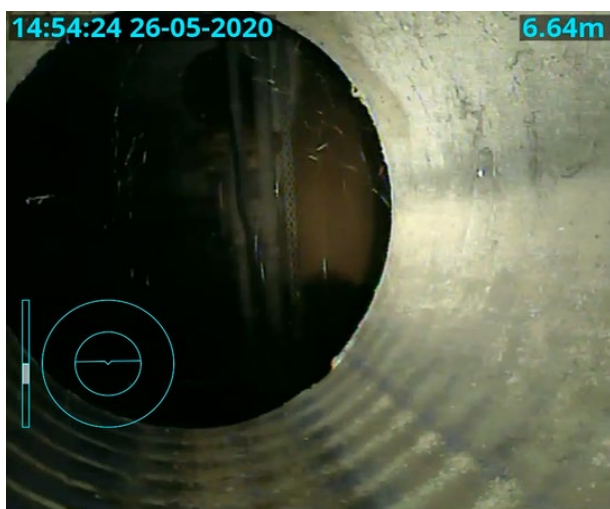
Surface Water Lids S71 –S70, S71-S73 Survey0000061/90499679 – 90499912 - 90500889

Pipework shows areas of POTENTIAL BLOCKAGE otherwise clear (or light silt)

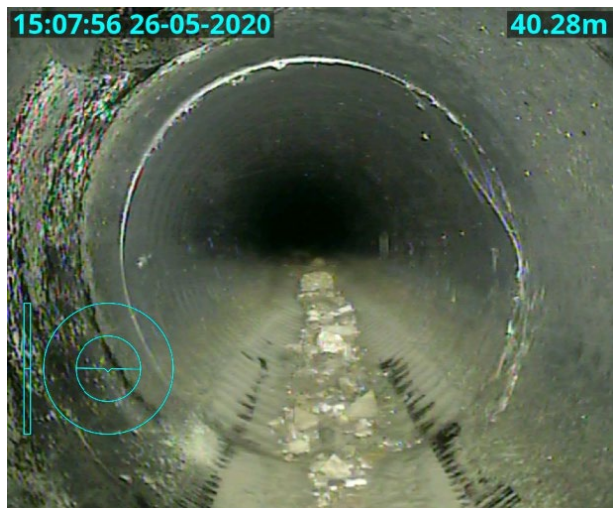
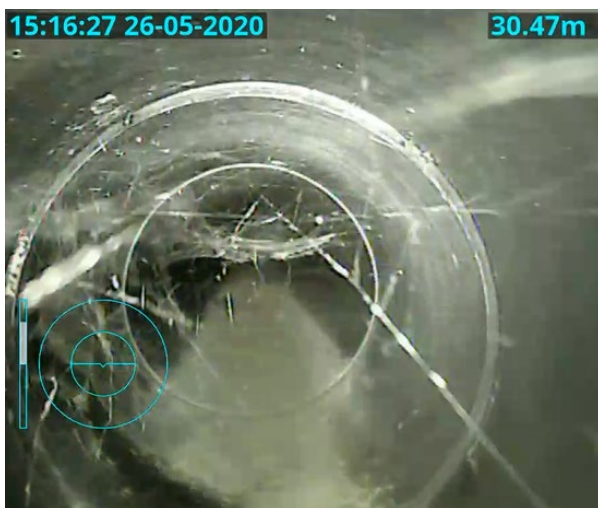
Surface Water Lids 397177 – 363176 – Rod Eye Survey0000062/90501764

Pipework shows LIGHT DEBRIS

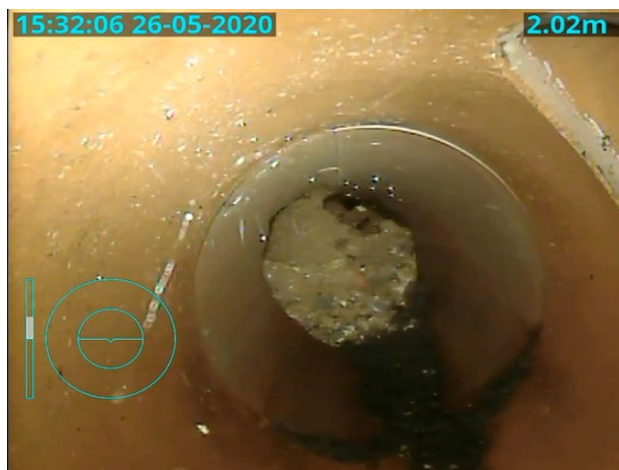
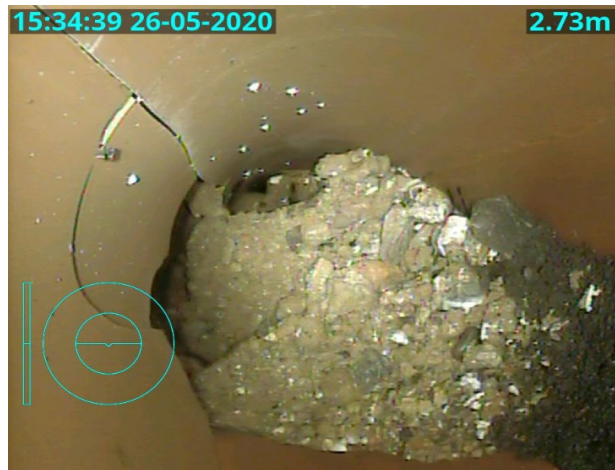
Surface Water Lids 397177 – 397177A Survey0000063/90502869

Pipework shows rear access BLOCKED

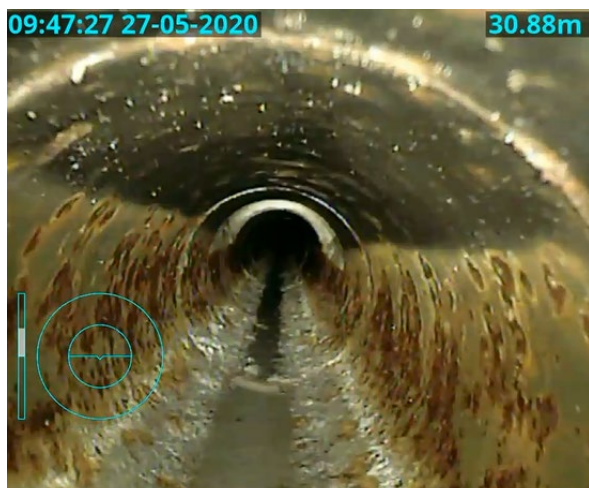
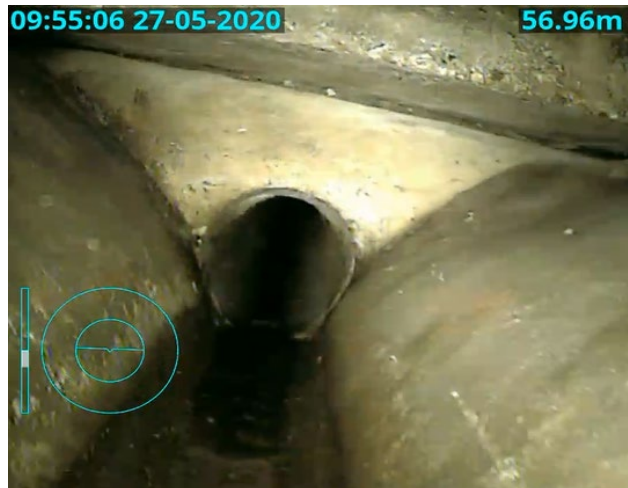
Foul Water Lids F16 – F27 Survey0000065/90568965

RUNNING CLEAR

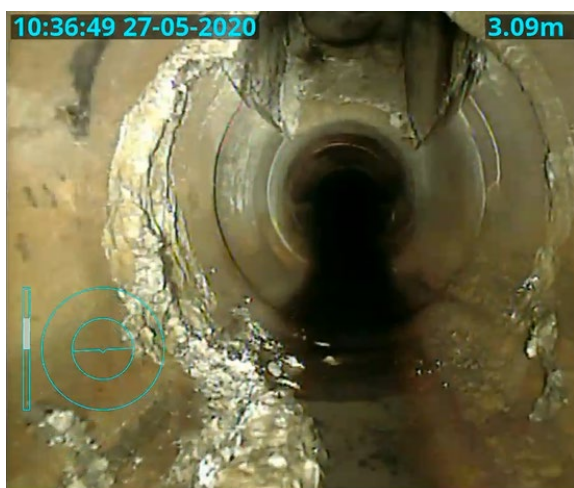
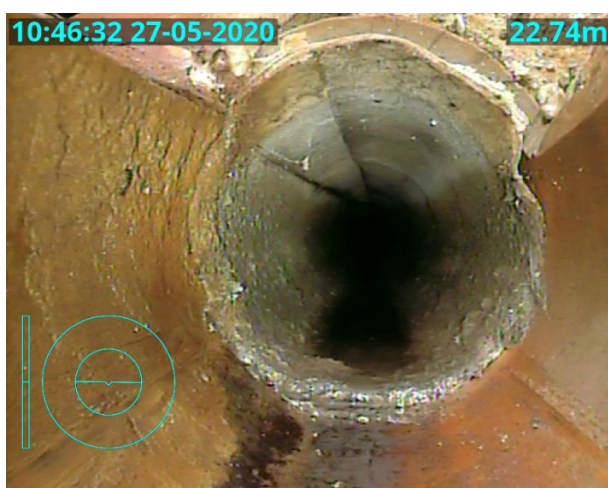
Foul Water Lids F36 – F26 Survey0000066/90572191

JOINT CRACKING – PIPE RUNS CLEAR

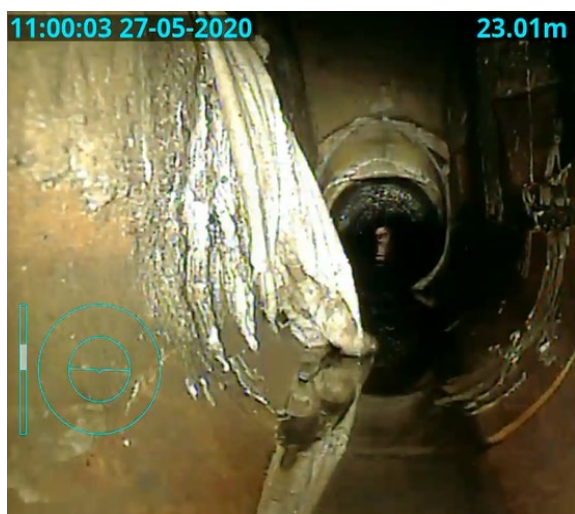
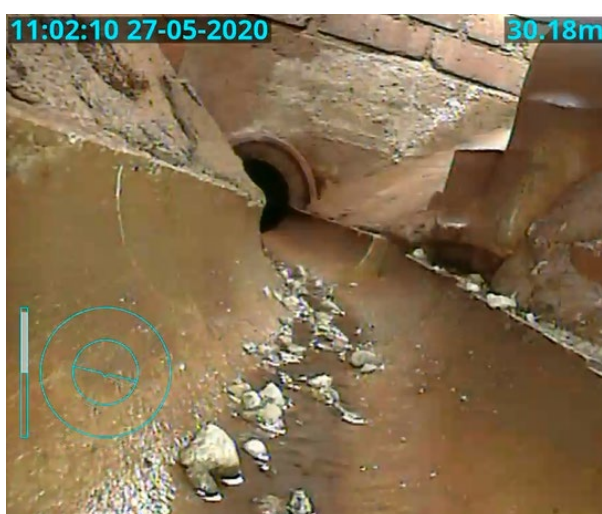
Foul Water Lids F36 – F45 Survey0000067/90573311

DEBRIS – HANGING DEBRIS SLIGHT DEBRIS but RUNS CLEAR

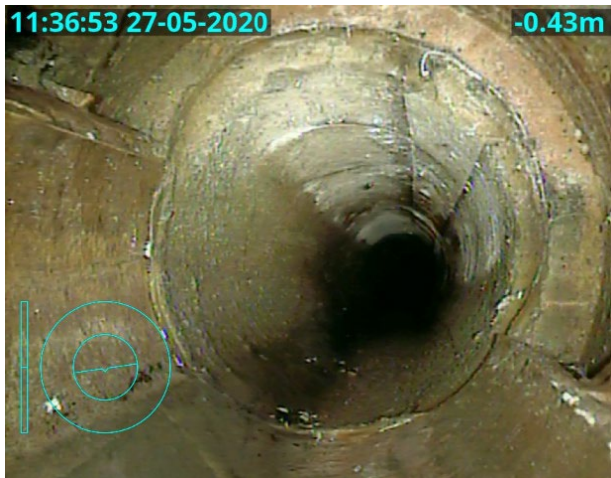
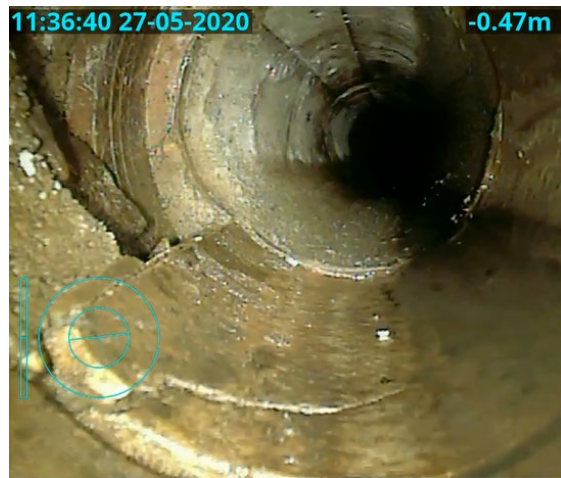
Foul Water Lids F45 – F54 Survey0000068/90575695

BROKEN JOINT – PIPE RUNS CLEAR

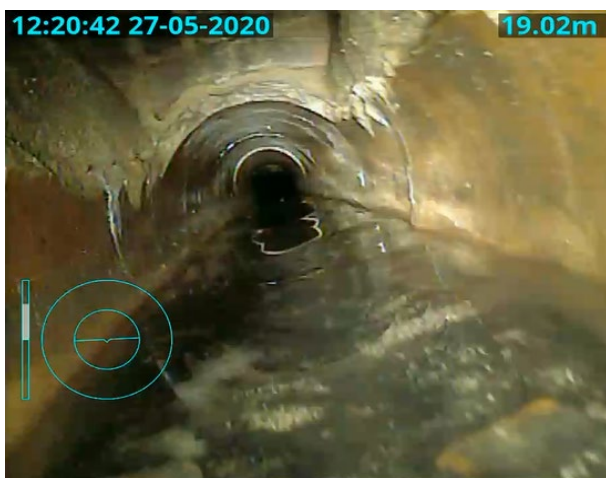
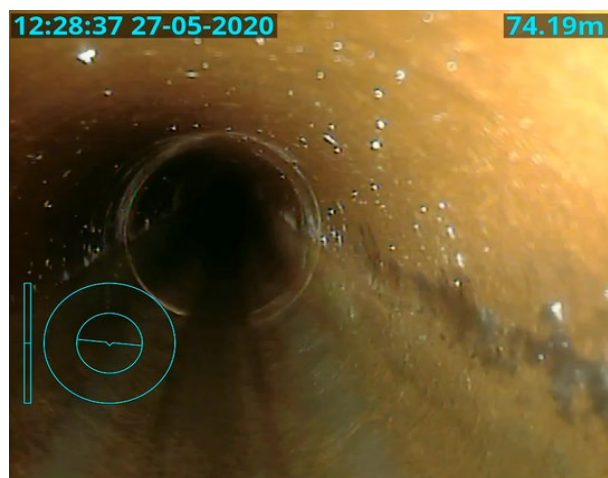
Foul Water Lids F45 – F54 Survey0000070/90578347

PARTIAL FLOOD (STATIC WATER)

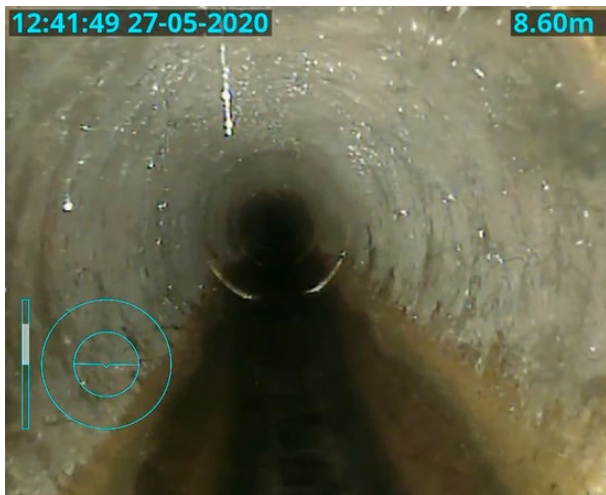
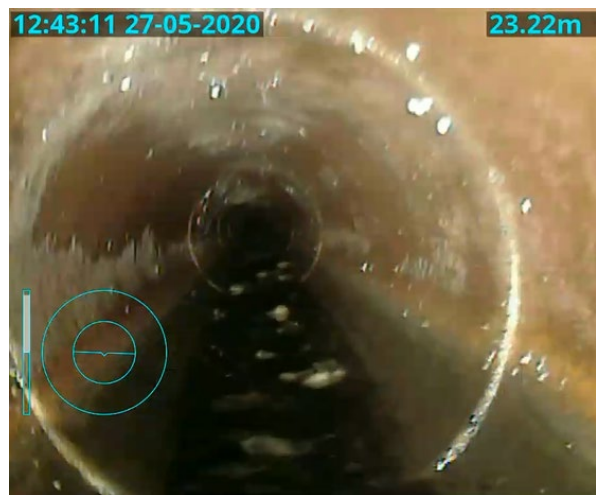
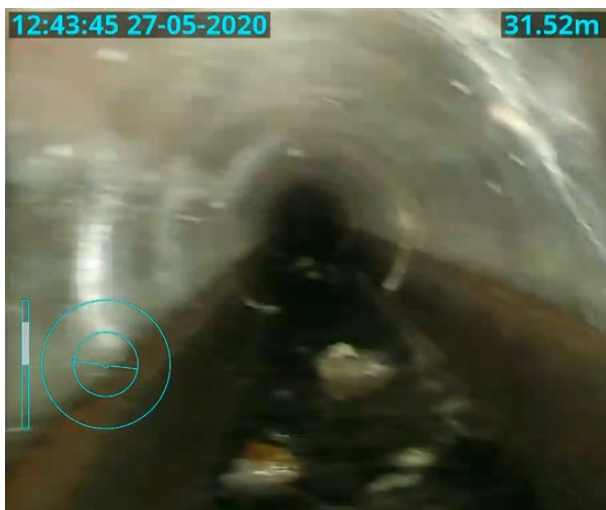
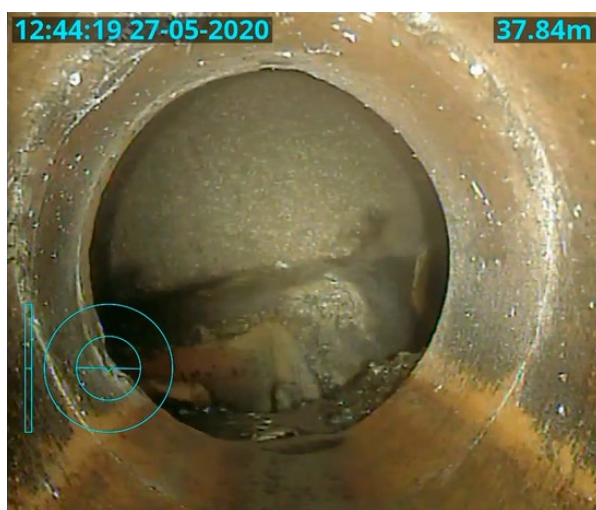
Foul Water Lids F54 – F54C – Boundary Survey0000071/90579586

PARTIAL FLOOD (STATIC WATER)

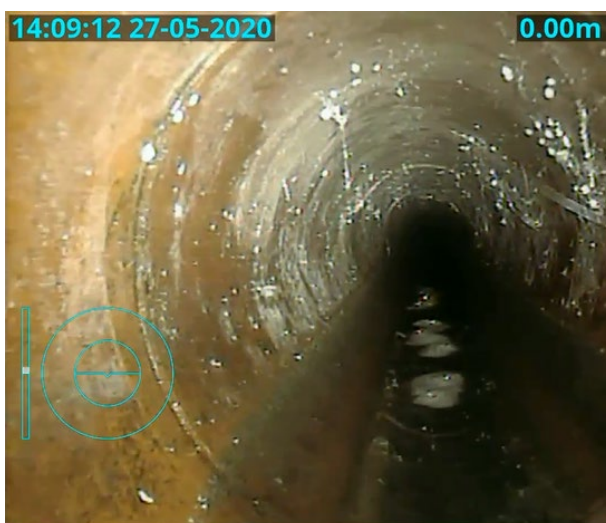
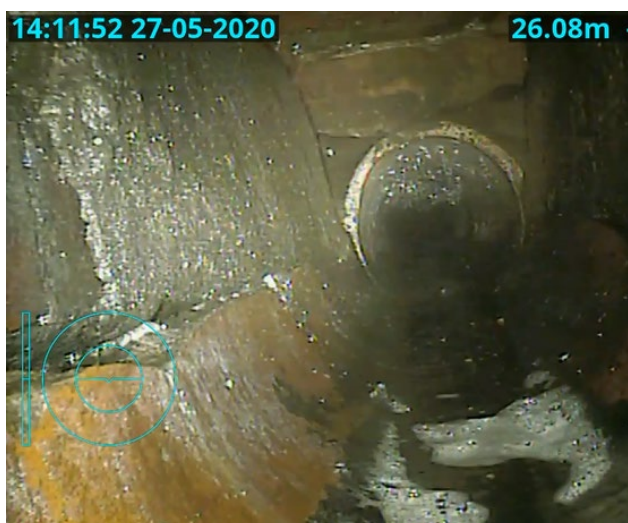
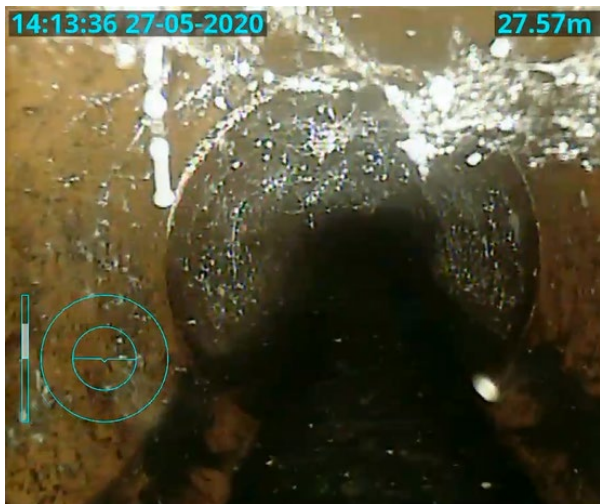
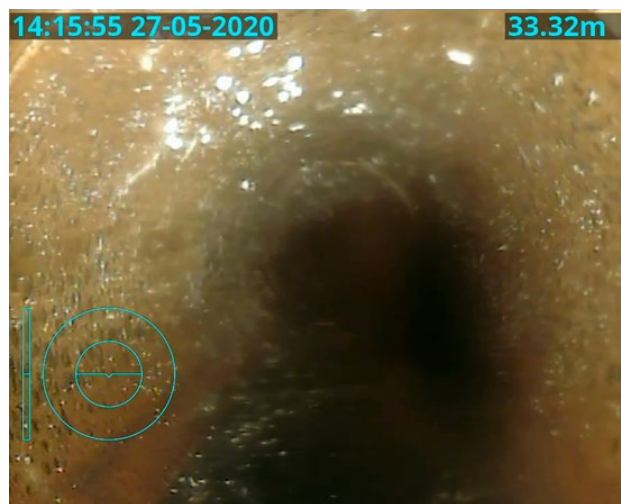
Foul Water Lids F54 – F54A Survey0000072/90584936

STATIC WATER - RUNNING CLEAR

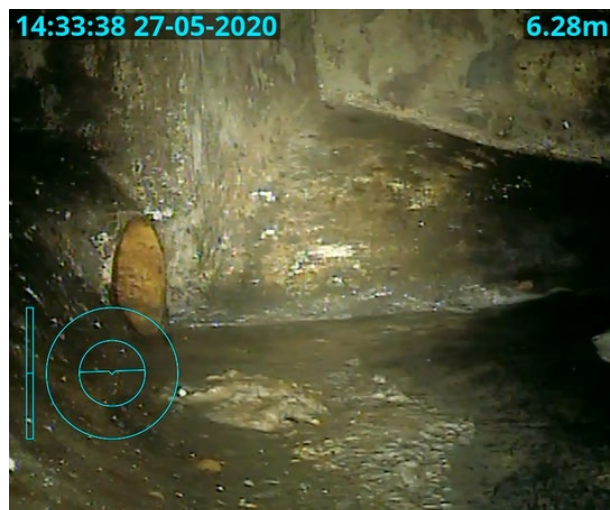
Foul Water Lids F54 – F54B Survey0000074/90586354

RUNNING CLEAR – VIDEO REVERSED

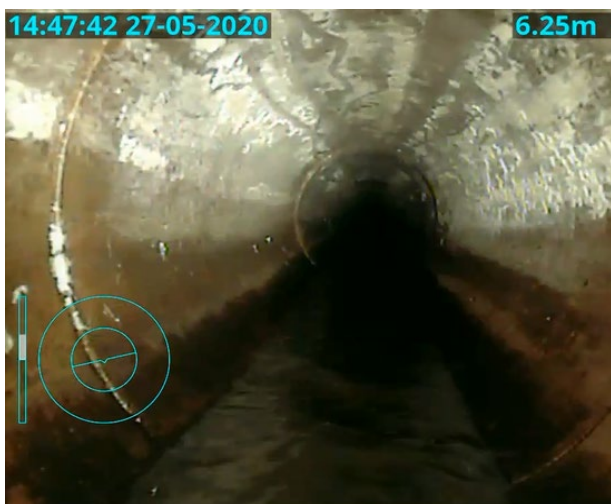
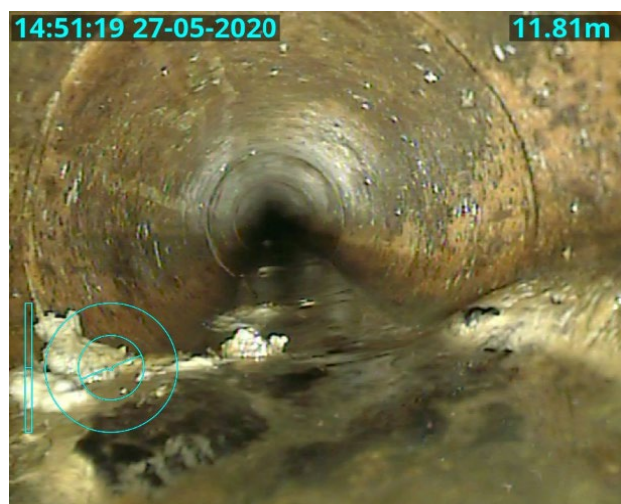
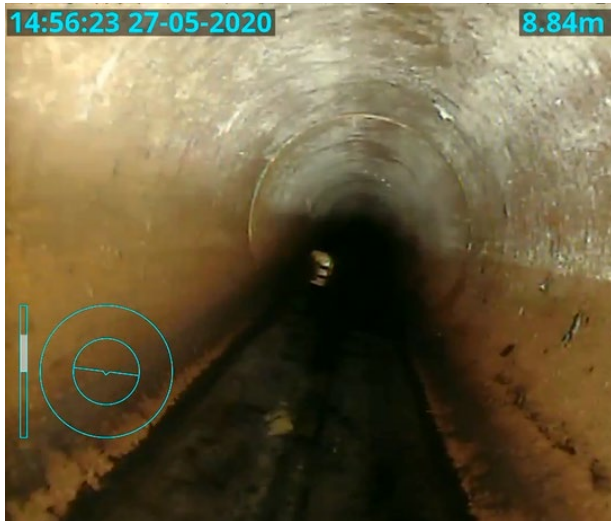
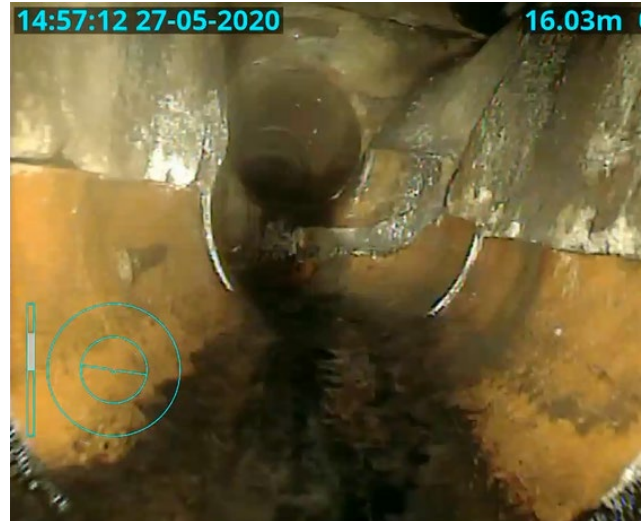
Foul Water Lids F57 – F56 / F57 – F58 Survey0000075/90587195 - 90587698

RUNNING CLEAR

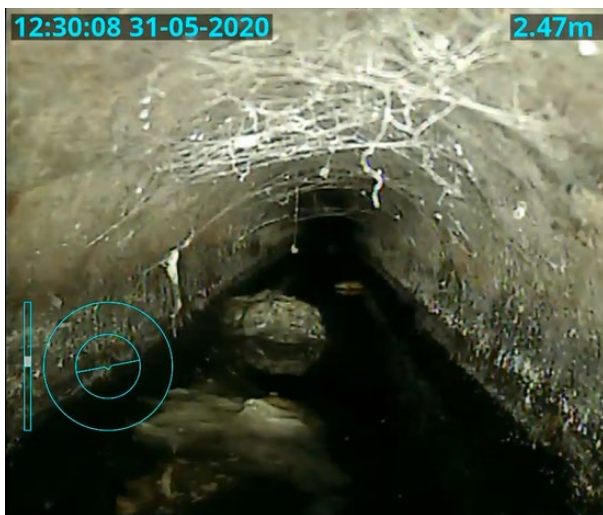
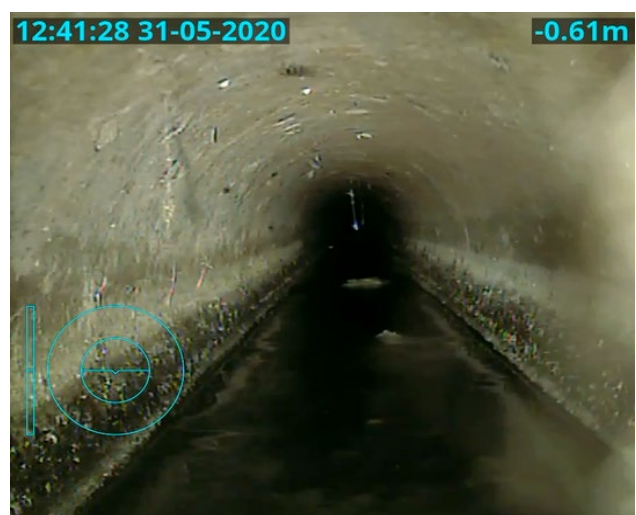
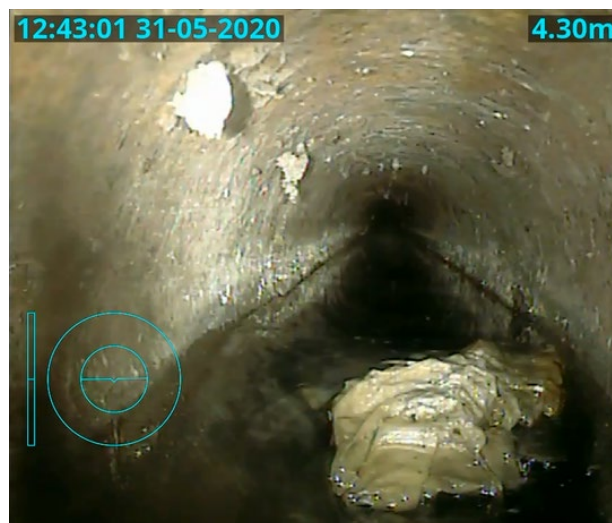
Foul Water Lids F70 – F61 Survey0000076/90924602

FLOWING WATER – STATIC OBSTRUCTIONS

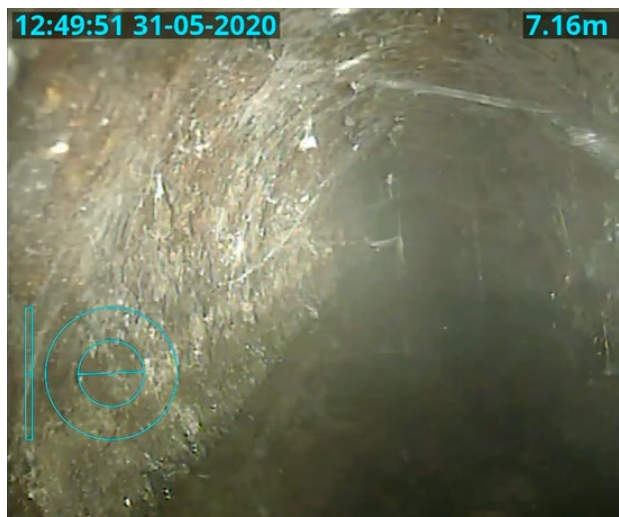
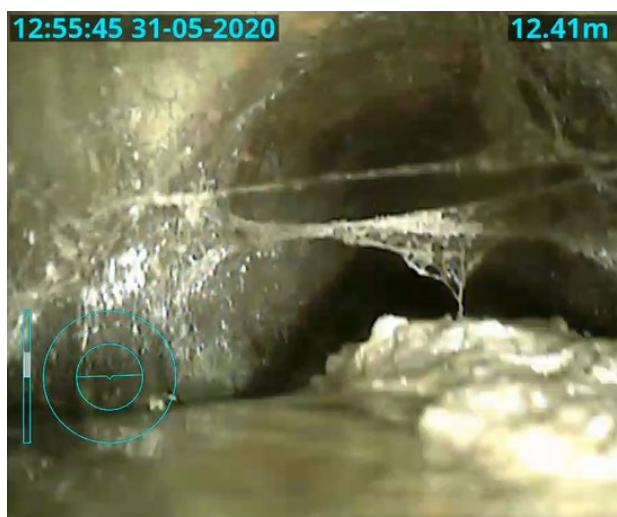
Foul Water Lids F70 – F73 Survey0000077/90925638 – 90926314(return video)

FLOWING WATER – STATIC OBSTRUCTIONS

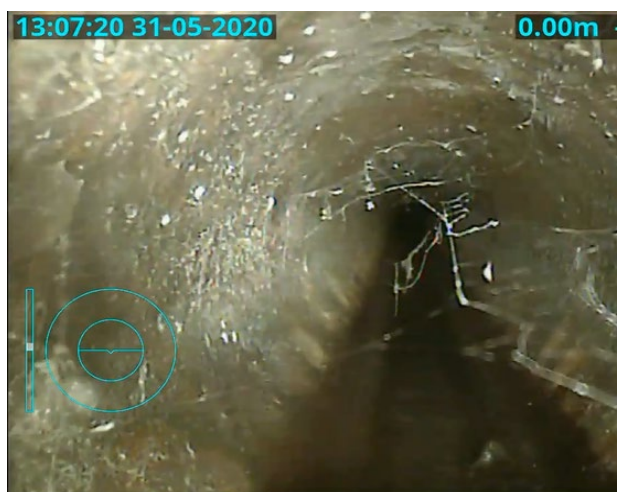
Foul Water Lids F73 – F70 Survey0000078/90926816

FLOWING WATER

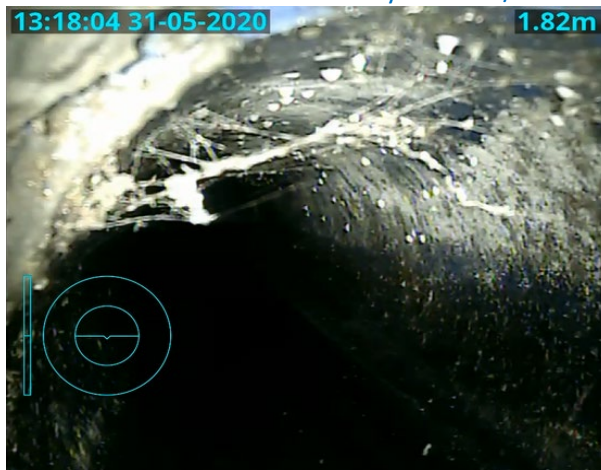
Foul Water Lids F74A – F76 Survey0000079/90927455

FLOWING WATER

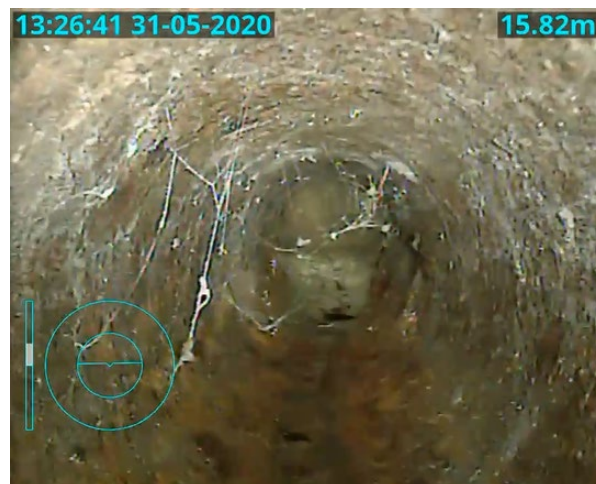
Foul Water Lids F76 – F74A Survey0000080/90927861

FLOWING WATER

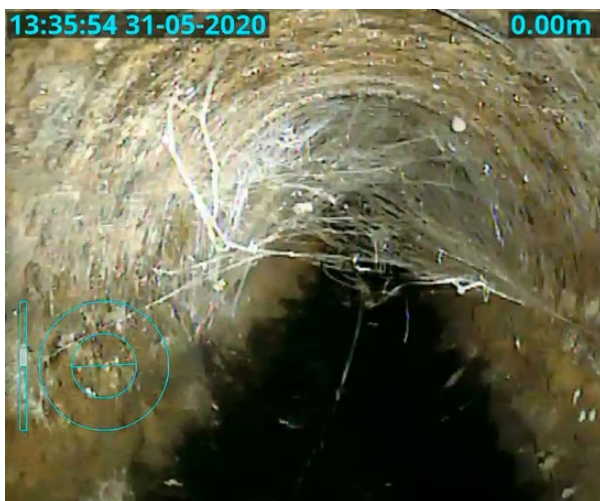
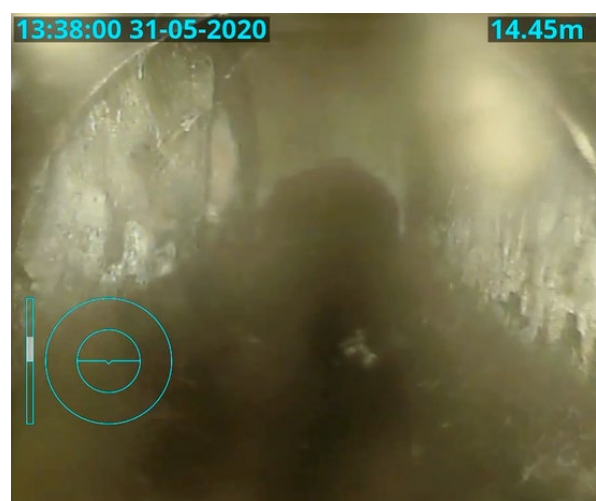
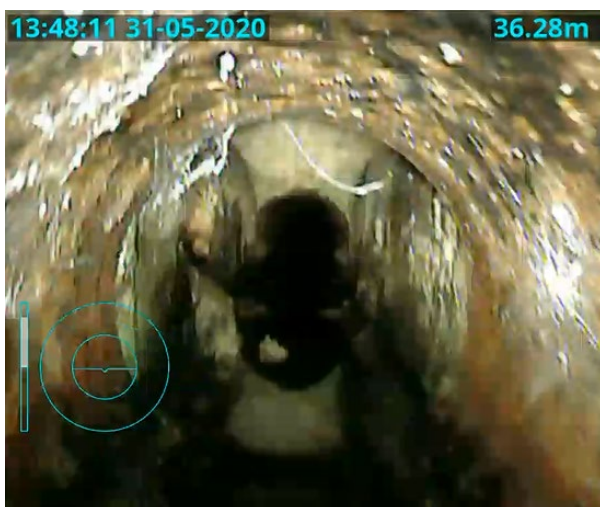
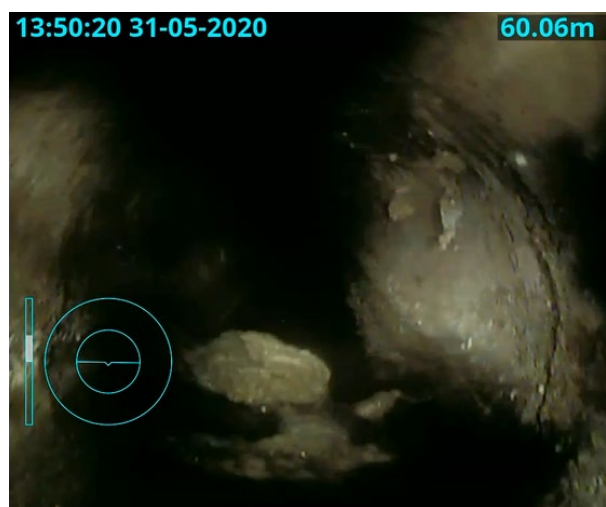
Foul Water Lids F74A – F70 Survey0000081/90928542

FLOWING WATER
