# Engineers Report

**Risk Address** 7 Glamis Close  
Waterlooville  
Hampshire  
PO7 8JN

**360 Reference** DLG-SN-20-001935  
**Insurer Reference** 074274952  
**Policy Holder** Mr. T. Evans

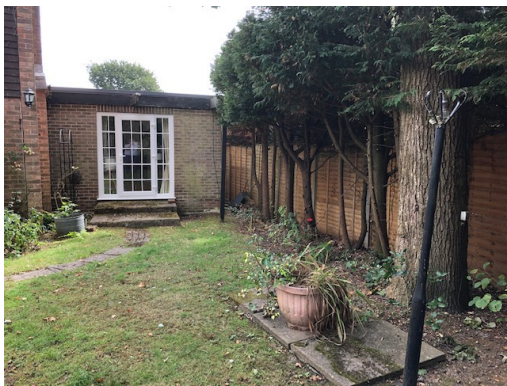
On the rear elevation, the brickwork has dropped and displaced along the damp course line. The steps have also rotated away. Cracking is also evident above the door opening, which has distorted significantly.

Rear View on Extension

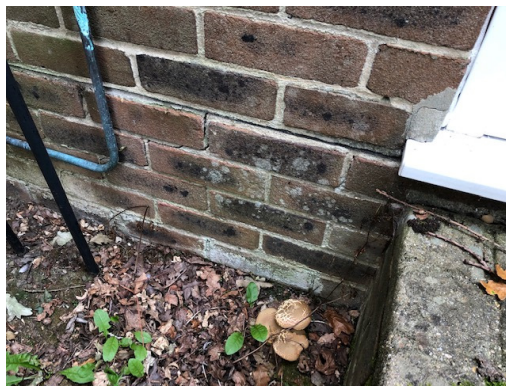
Displaced Brickwork at Low Level

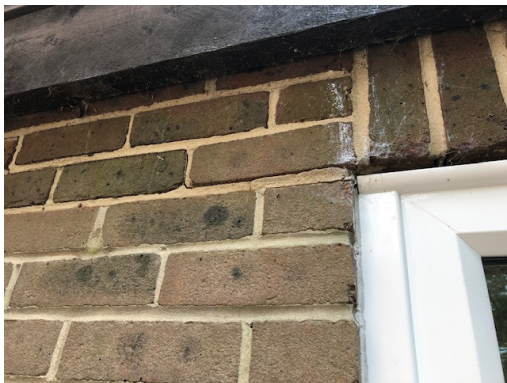
Cracking Adjacent Door

The superstructure damage can be repaired relatively easily once the extension has stabilised. The floor will need to be re-levelled and a new door may be required. A schedule of repairs will be agreed once a contractor has undertaken a detailed inspection.

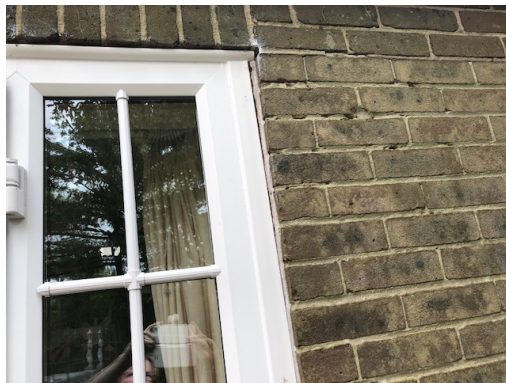
Cracking Adjacent Door

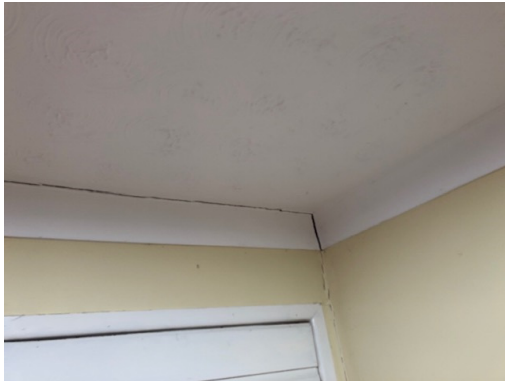
There is significant cracking and displacement of the coving and ceiling at the junction with the main house and the cracking, with cracking to the wall junctions as well. The floor has also dropped significantly.

Cracking and Displacement to Ceiling

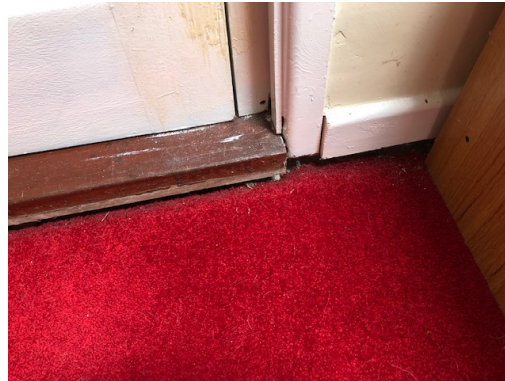
Movement of Floor
