**Tree Report**

**2<sup>nd</sup> May 2017**

**Proposals for New Access Road Tournerbury Farm to Tournerbury  
Woods Hayling Island  
PO11 9DL**

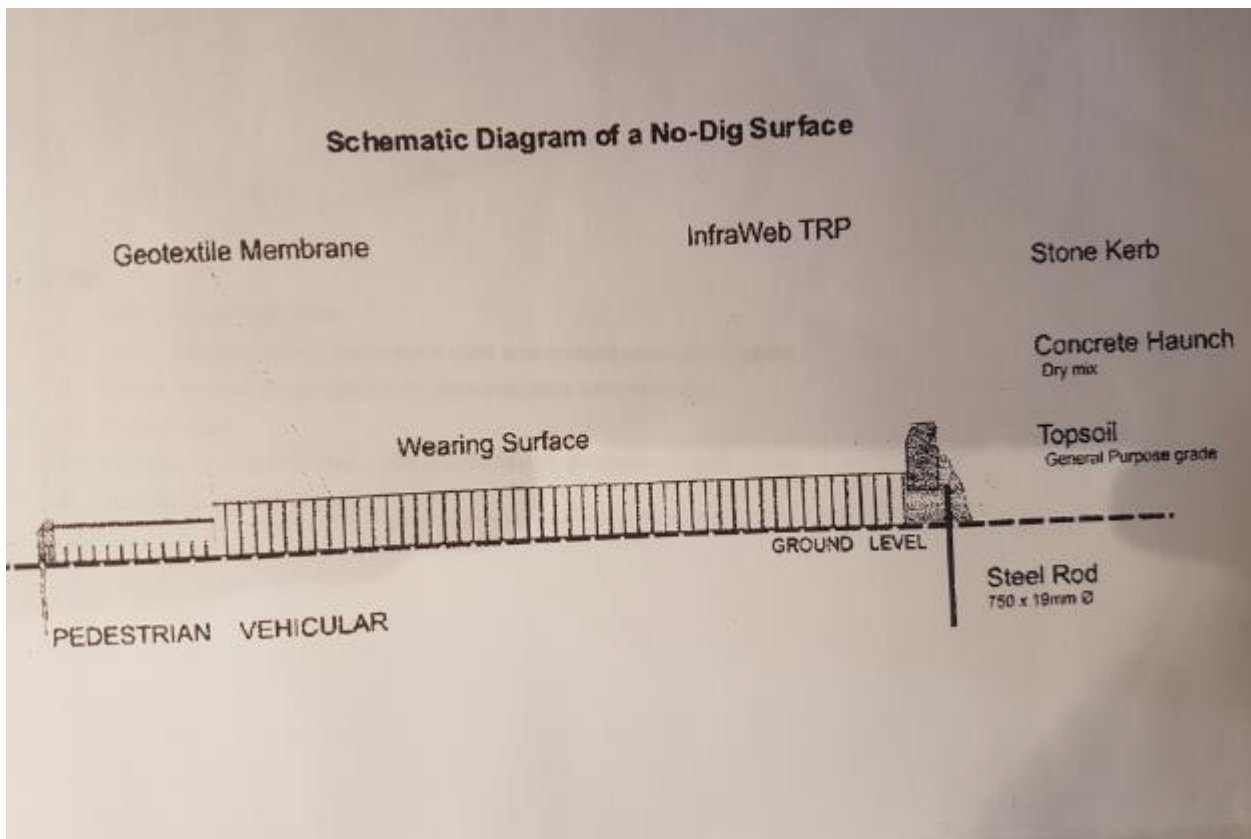
The proposal is to construct a new track from the Tournurbury Farm entrance alongside of the existing paddock field to Tournurbury Woods. The root protection areas adjacent to trees T1, T3 and T15 will be bridged by installing a 'No dig' cellular confinement system across the new track area. These areas will set on a geotextile and geo-grid type underlay to stop leaching of material into surrounding areas within the root protection areas of trees identified in the tree survey. The positioning of the track will be **3.75m** from the existing boundary line to allow a sufficient distance from the trees root protection areas. The construction method by use of a small 3ton digger to be used for spreading delivered materials and work backwards only within the 4m track area and will not travel within the 3.75m RPA. Markers and fencing should be used to indicate and exclude construction traffic within the RPAs of retained specimens.

- Edging as detailed by engineer.
- Lay the tree dimensional cellular confinement system (TDCCS) as specified by the engineer.
- Cover the TDCCS with a no fines aggregate infill. This is to be filled progressively so that machinery only move on the laid sub-base. The aggregate will not be tipped straight on to the TDCCS.
- Compact the sub-base to ensure binding with the TDCCS and minimize future rutting of the surface.
- Lay geotextile membrane directly onto the sub-base over the whole of the drive.
- This sub-base should be surfaced with brick paviours to allow permeability on a dry bed and grouted with kiln-dried sand or porous asphalt or concrete.
