# GEOSHIELD Verification Report

005

New Warehouse Building

Land adjacent Fulflood Road

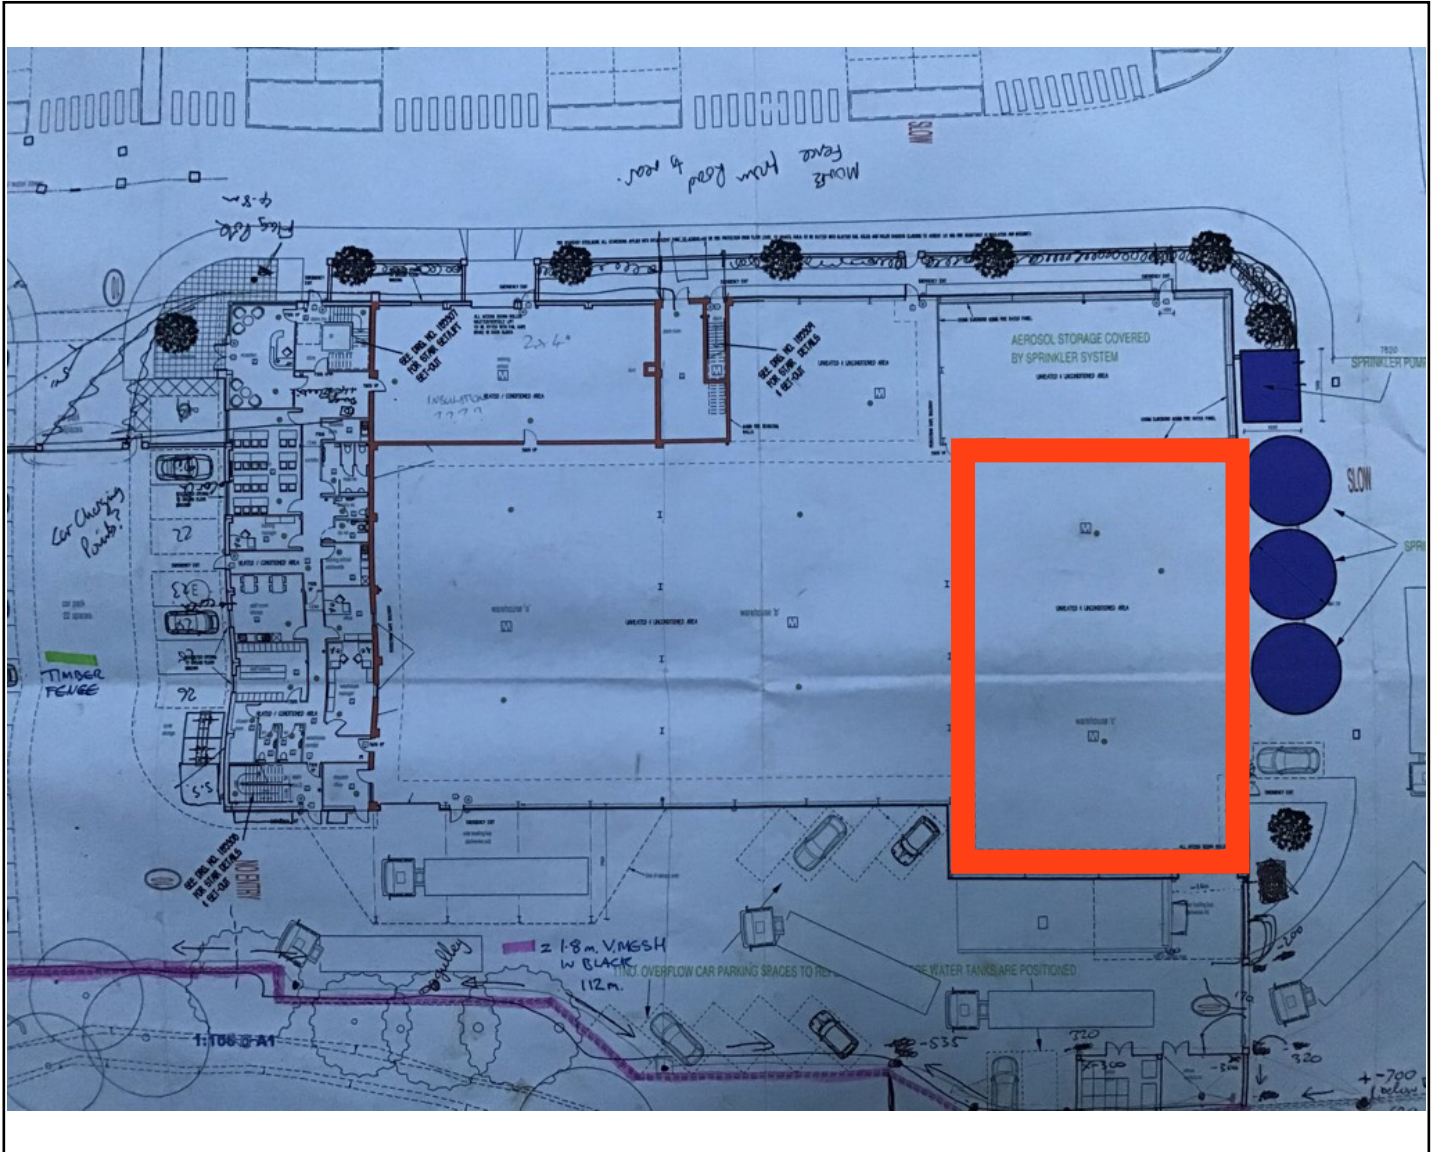
The area highlighted in red above shows where verification of the installation of the

Visqueen gas barrier was carried out during this visit.

Installation to Pour 4 of building.

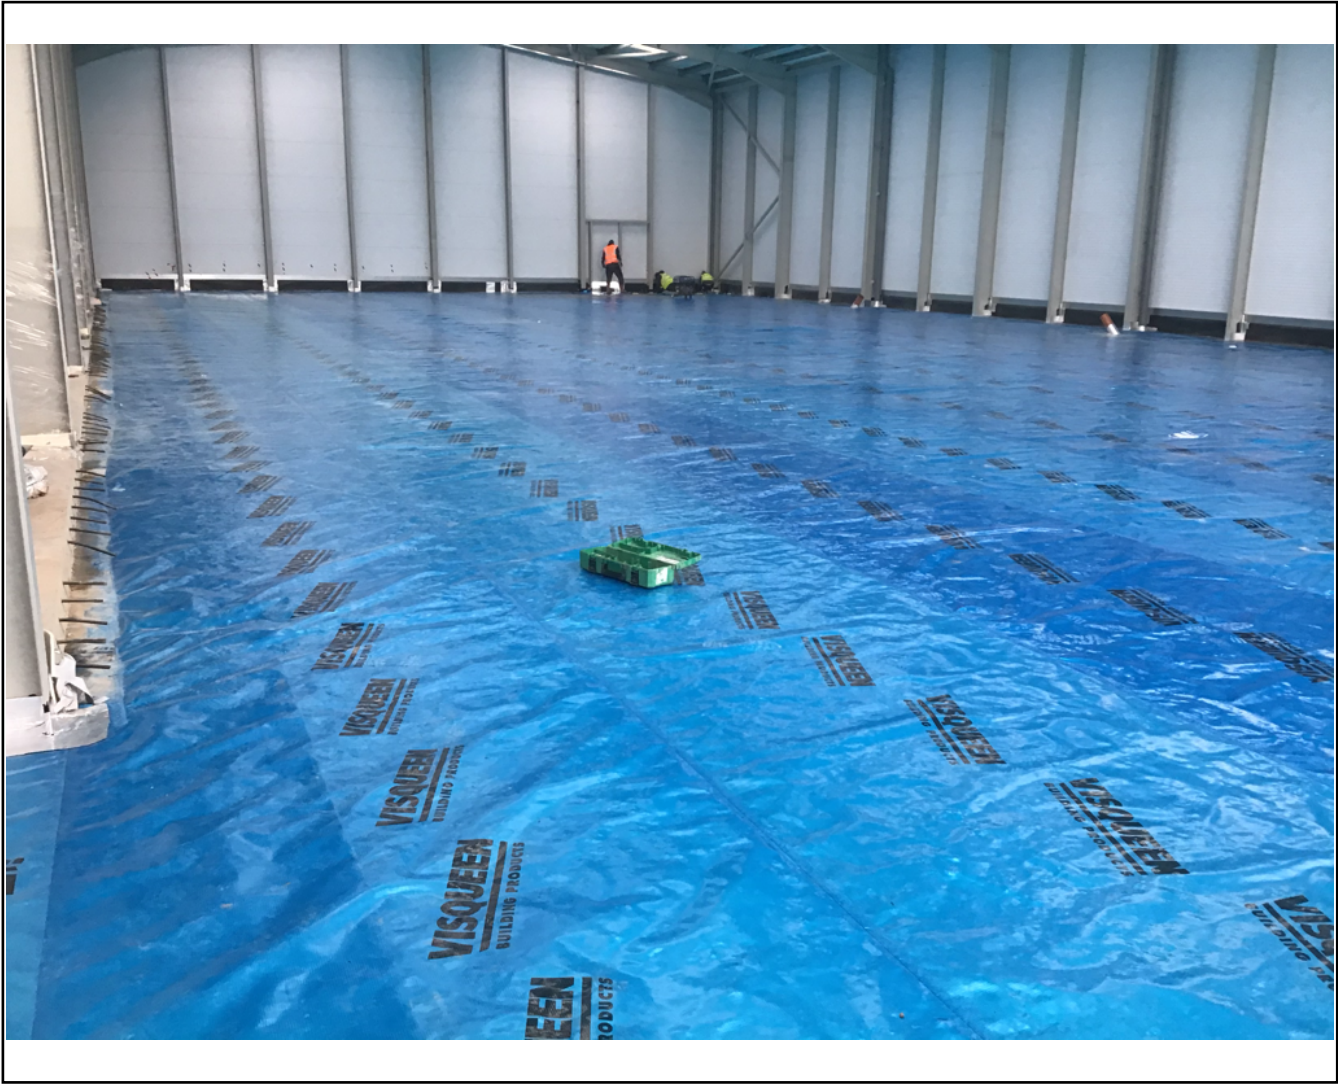
The photograph above shows an overview of the area verified during this

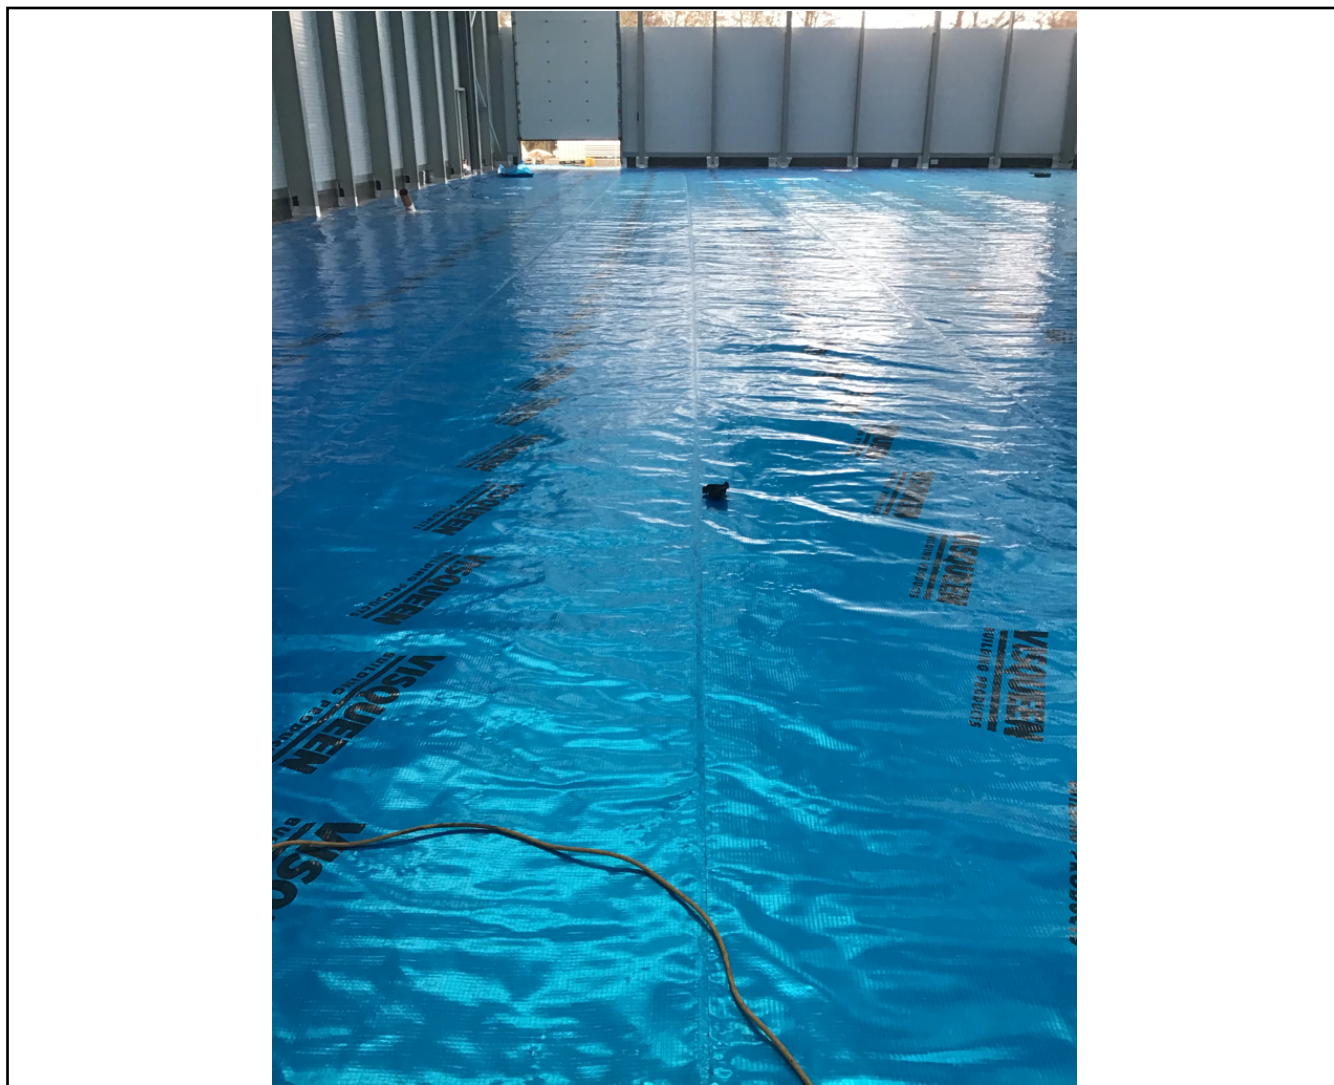
The photograph above shows an alternative overview of the area verified.

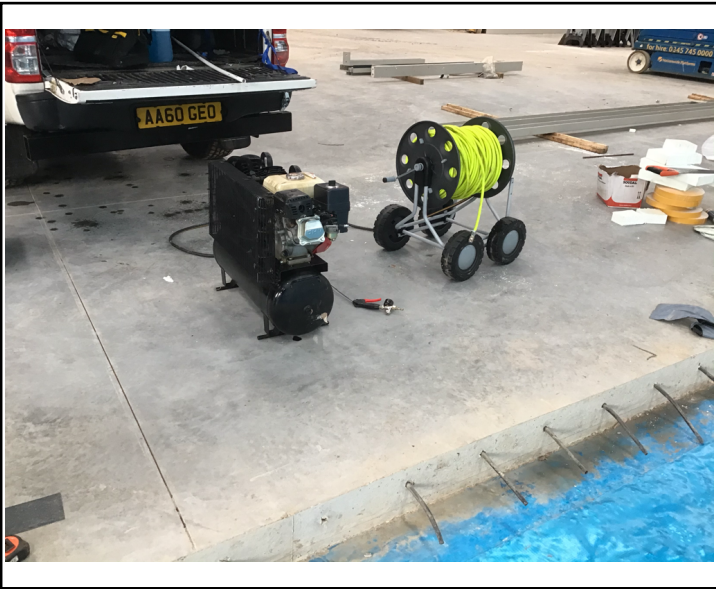
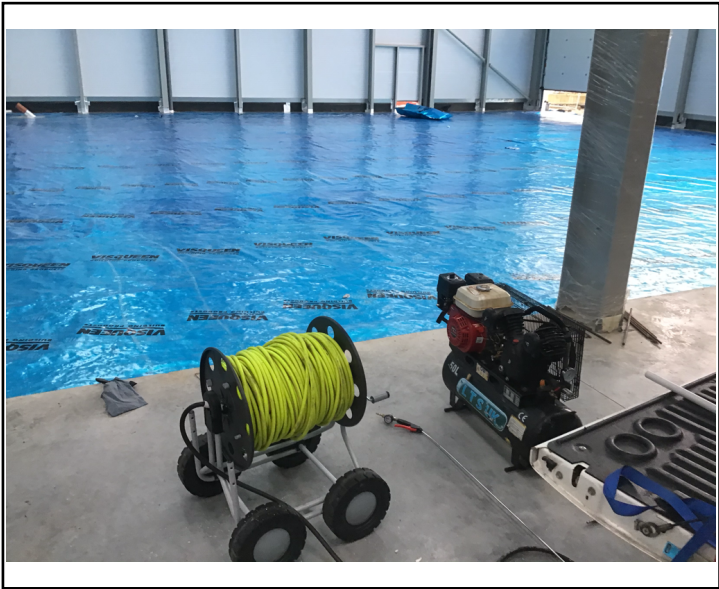
The two photographs below show the air compressor and hose which was removed the vehicle to carry out air lance testing on the area verified during this visit.

Unfortunately the air compressor would not start due to mechanical issues. This meant

that an air lance test could not be carried out during this visit.

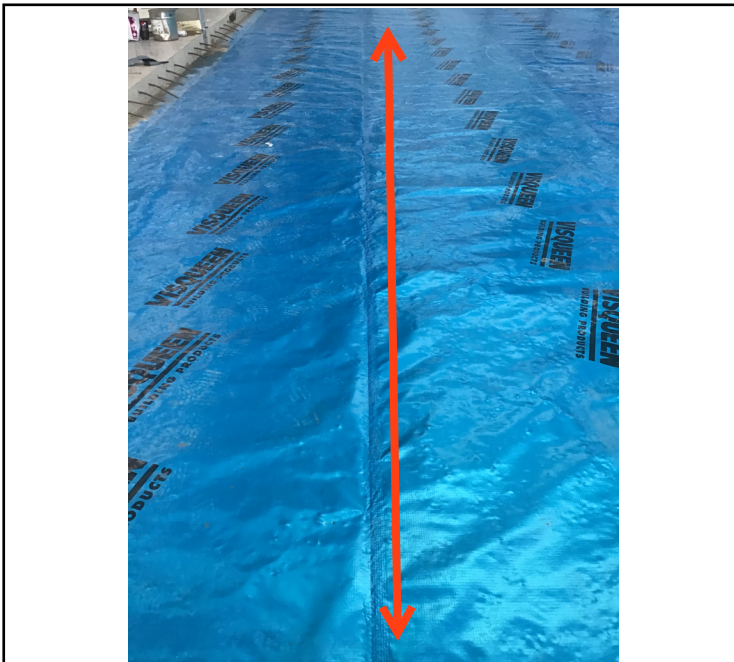
The first photograph below shows an overview of a sealed lap of the Visqueen membrane.

The installers have welded each lap of the membrane using a hot air leister and roller.

A consistent 40mm weld has been achieved.

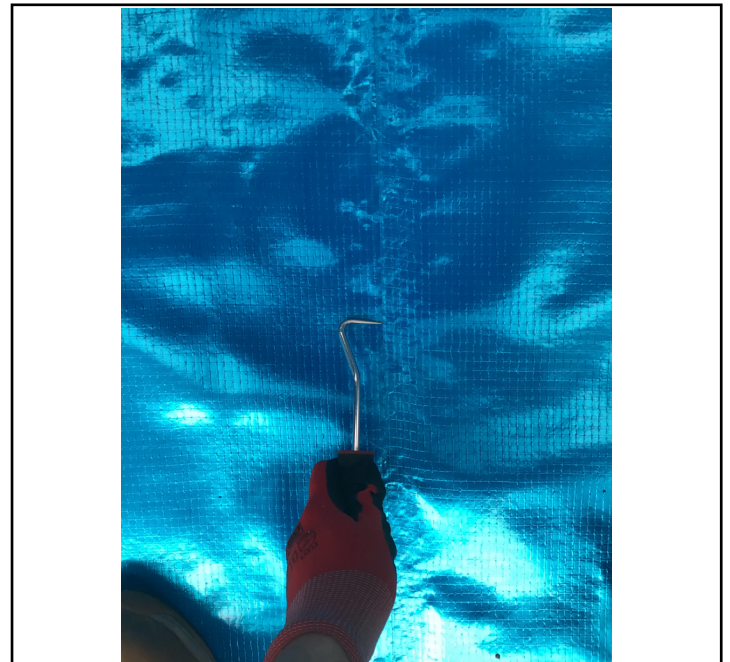
The second photo above shows a pick and probe test carried out to a welded lap.

No faults or defects identified. Verified in accordance with CIRIA 735.

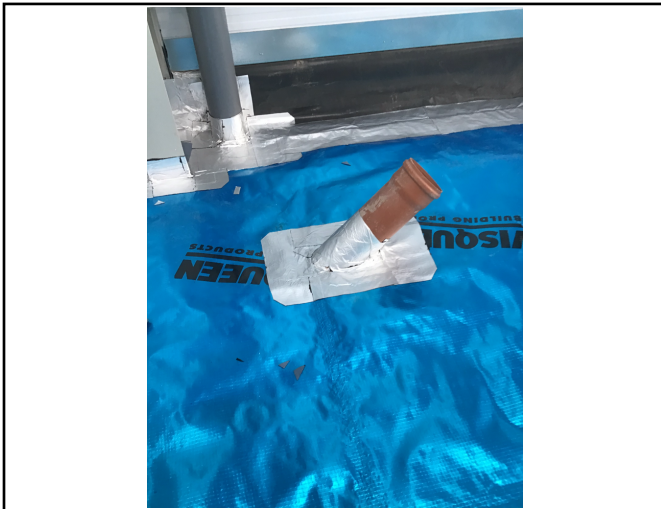
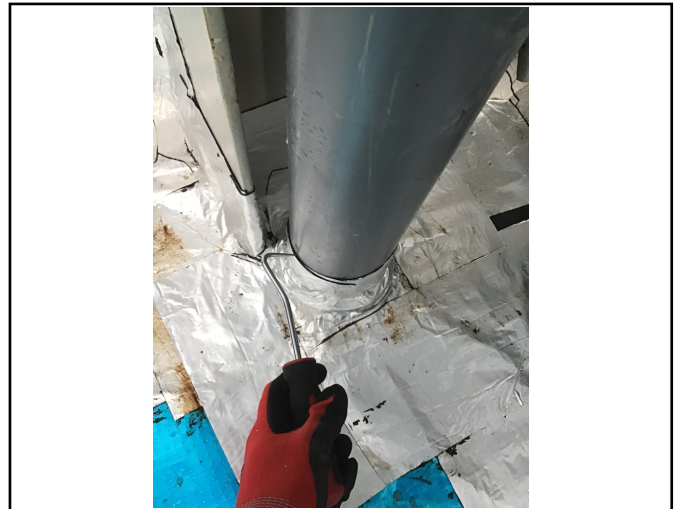
The first photograph below shows a pipe penetration which has been sealed using Visqueen GR SAM. The installers have used patches of the GR SAM to seal each pipe penetration.

The installers have used a hot air leister to achieve a strong seal around each pipe penetration verified during this visit.

Installed in accordance with BS 8485:2019.

A pick and probe test carried out to a sealed pipe penetration revealed no faults or defects. Verified in accordance with CIRIA 735.

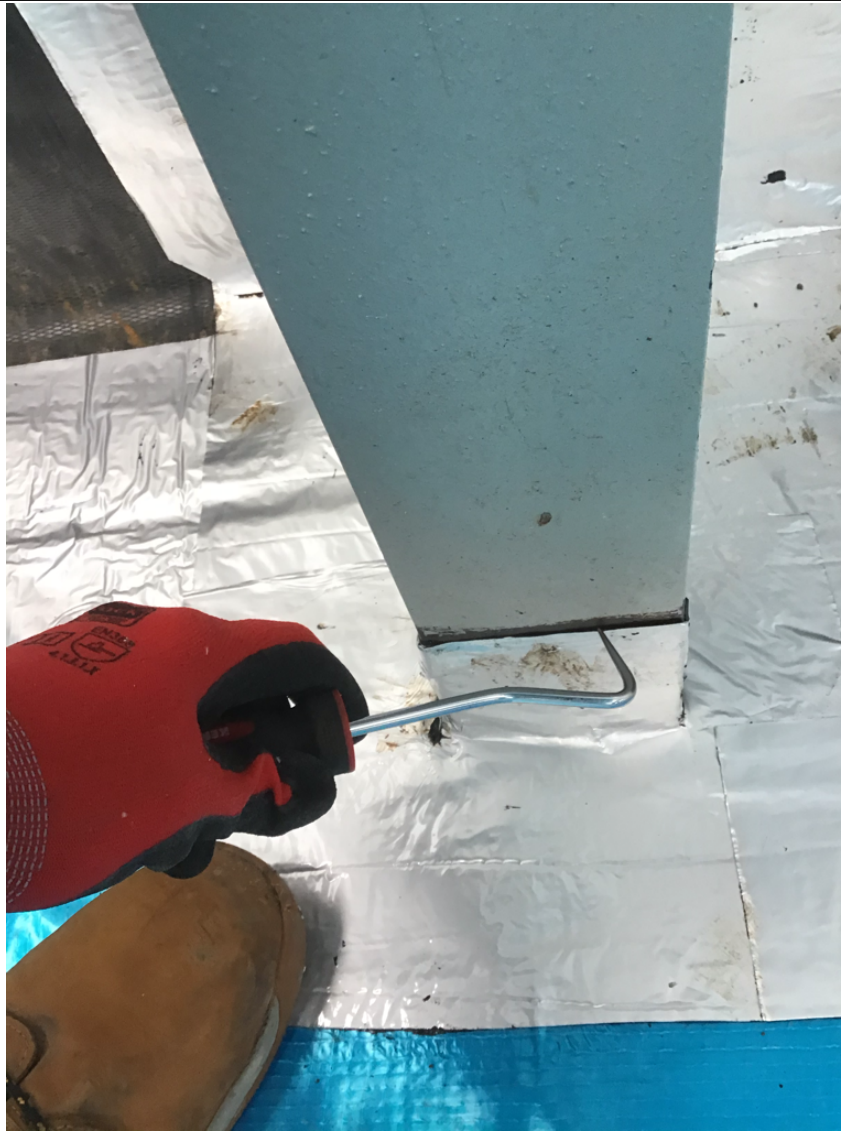
The photograph above shows a pick and probe test carried out to a steel column.

The installers have first applied a coat of Visqueen HP Primer to all areas of steel

where Visqueen GR SAM has been applied to. No faults or defects identified.

Verified in accordance with CIRIA 735.

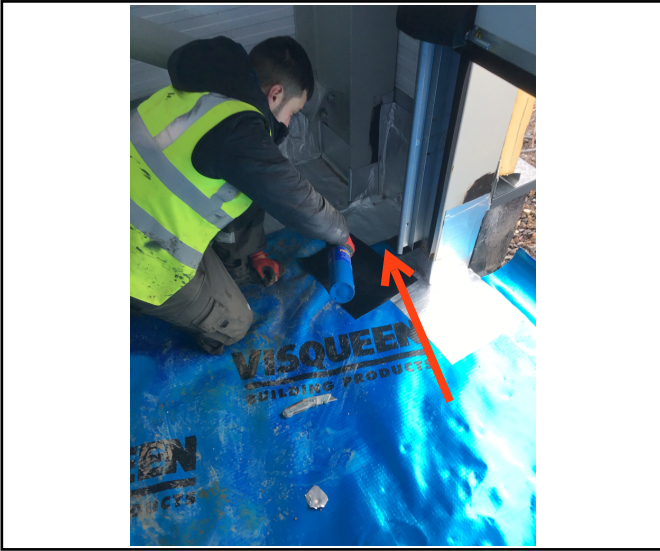
Area with no Visqueen GR SAM

was installed.

| Date | Nr | Remediation Description | Y/N |
|---|---|---|---|
| 06/01/2021 | 005. | 1. One welded lap had on the perimeter had no Visqueen GR SAM | |

| Date | Nr | Remediation Description | Y/N |
|---|---|---|---|
| | | although the weld was strong the installers have applied a strip | |
| | | of the GR SAM to fit with the rest of the area. (See additional | |

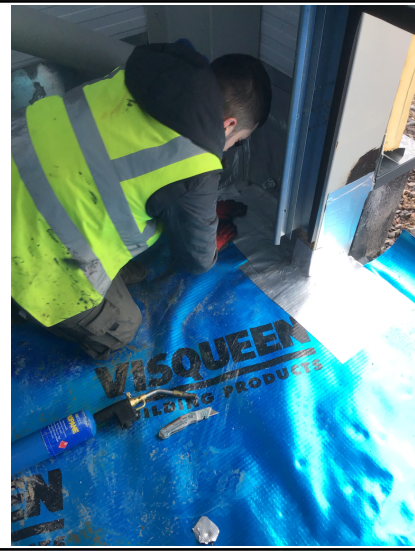
Installers have patched

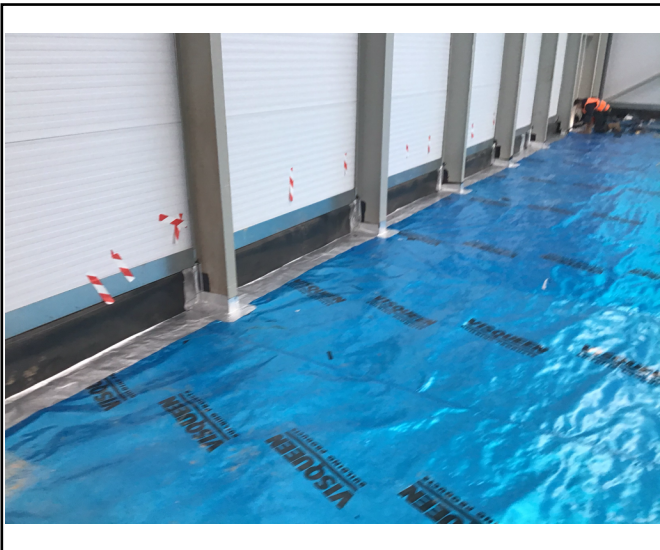
Perimeters sealed to infills and

steel columns sealed.

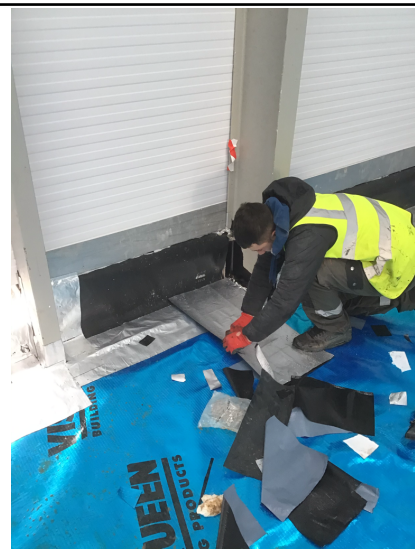
Installers sealing steel columns.
