RE: Application for Removal of TPO Ref- pp-04078368

# Arboricultural Consultancy for HBOS

| <b>Insured</b> | Mrs C Watson | <b>Address</b> | 31 Hollybank Road, Emsworth, West Sussex, PO10 7UE | | |

Client: Lloyds Banking Group  
Client Contact: David Elliot  
Claim Number: 101431391  
Policy Holder: Mrs C Watson  
Report Date: 3 December 2013  
Our Ref: C2811S9805

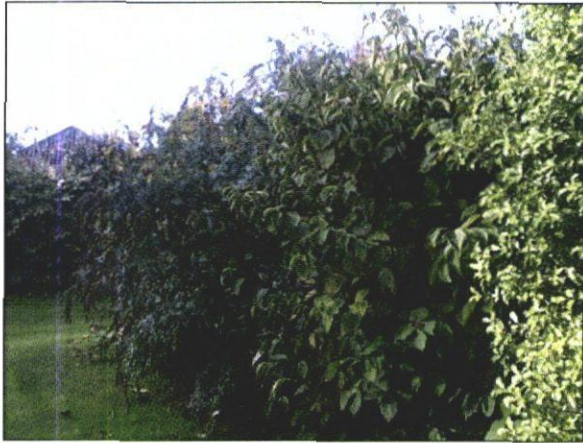
SG1 Mixed

Whilst there is currently no positive root identification to implicate SG1 (Mixed Species Group), T2 (Oak) and TG1 (Oak) in the current damage, our assessment on site considers that the footings of the subject property fall within the anticipated rooting zone of this vegetation.

| Tree No. | Species | Age Cat | Approx. Height (m) | Distance to Building (m) | Ownership | Action | Requirement |
|---|---|---|---|---|---|---|---|
| SG1 | Mixed species shrubs<br>Including;<br>Dogwood, Acer | 1 | 2.6 | 3.4 | C - Insured | Maintain as detailed | Remove to ensure 4m clearance to the rear conservatory. Do not allow remainder to exceed current dimensions. |

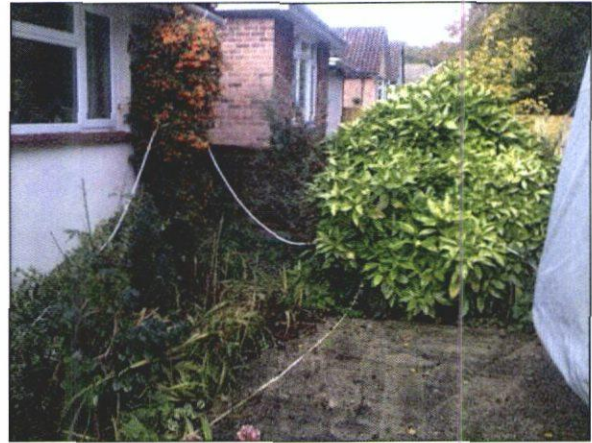
SG2 Mixed

| Tree No. | Species | Age Cat | Approx. Height (m) | Distance to Building (m) | Ownership | Action | Requirement |
|---|---|---|---|---|---|---|---|
| SG2 | Mixed species shrubs Group including; Laurel and Pyracantha. | 1 | 2.3 | 3.4 | C - Insured | Action to avoid future risk | Do not allow to exceed current dimensions. |

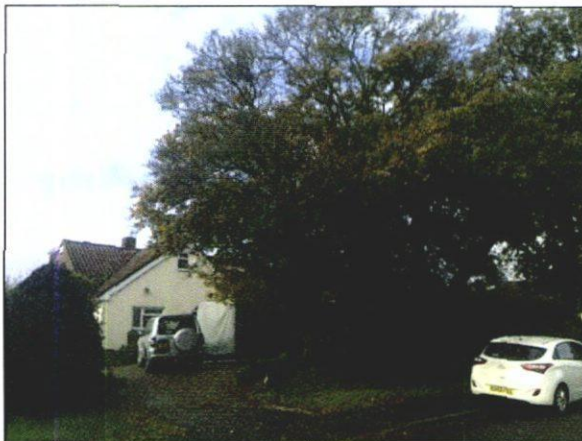
T1 Field Maple

| Tree No. | Species | Age Cat | Approx. Height (m) | Distance to Building (m) | Ownership | Action | Requirement |
|---|---|---|---|---|---|---|---|
| T1 | Maple (Field) | 3 | 10.5 | 16.5 | E - Boundary Veg (ownership to be confirmed) | Action to avoid future risk | Remove and treat stump to inhibit regrowth subject to heave assessment. |

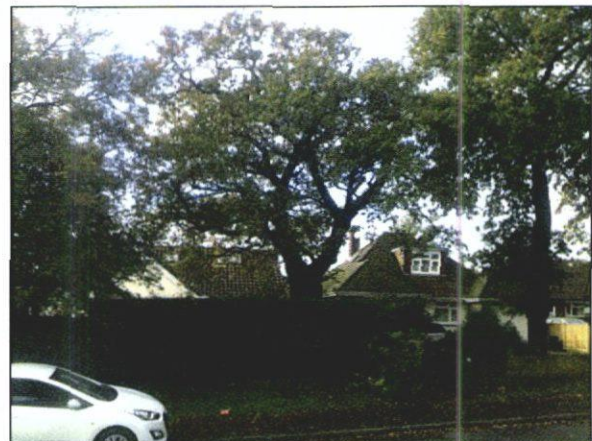
T2 Oak

| Tree No. | Species | Age Cat | Approx. Height (m) | Distance to Building (m) | Ownership | Action | Requirement |
|---|---|---|---|---|---|---|---|
| T2 | Oak | 3 | 10 | 13.8 | C - Insured | Remove | Remove subject to heave assessment. |

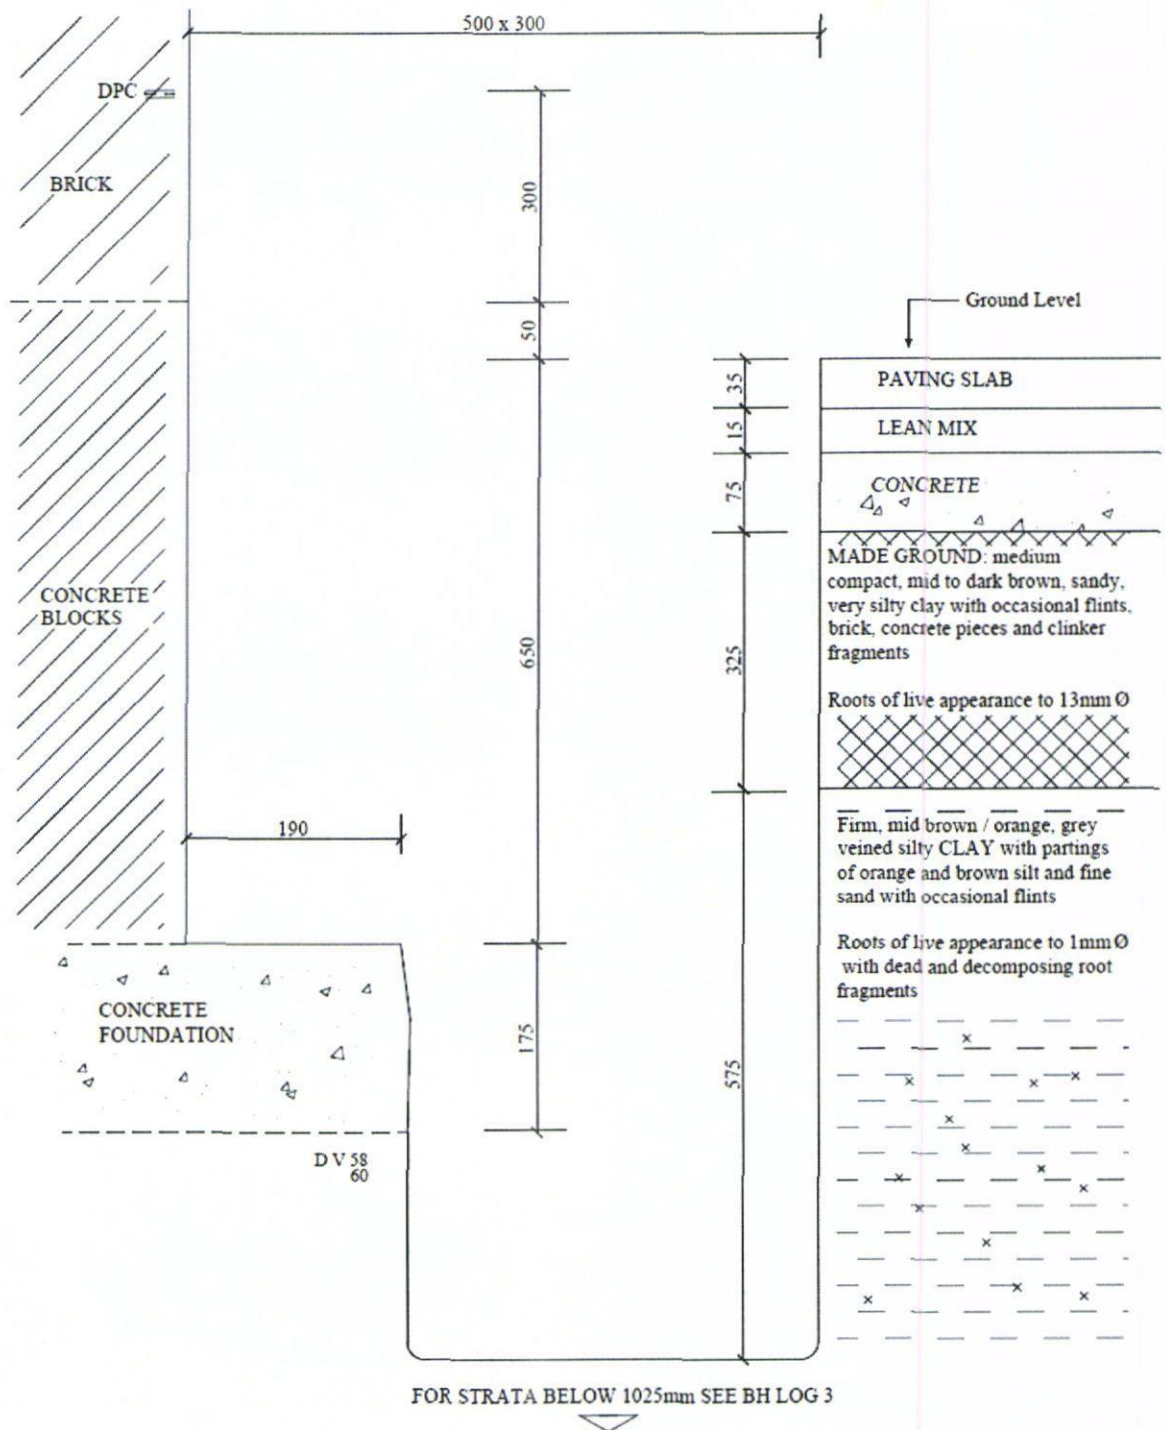
TP/BH3 Foundation Detail

Remarks: Limited working space

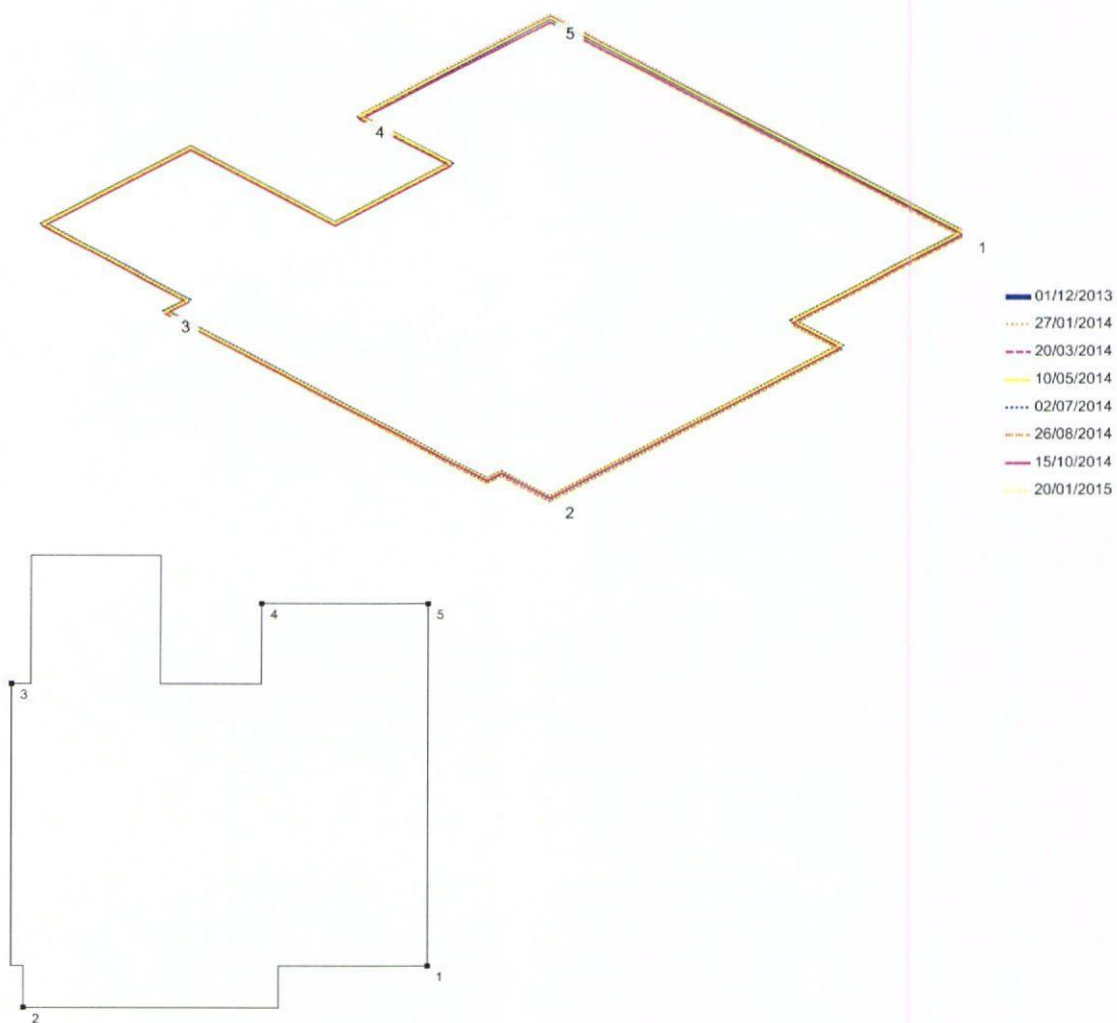
## Level Monitoring Displacement Map

The following image shows an isometric representation of the movement of the property, based on the Level Monitoring Stations that were installed.
