# GEOSHIELD Verification Report

003

New Warehouse Building

Land adjacent Fulflood Road

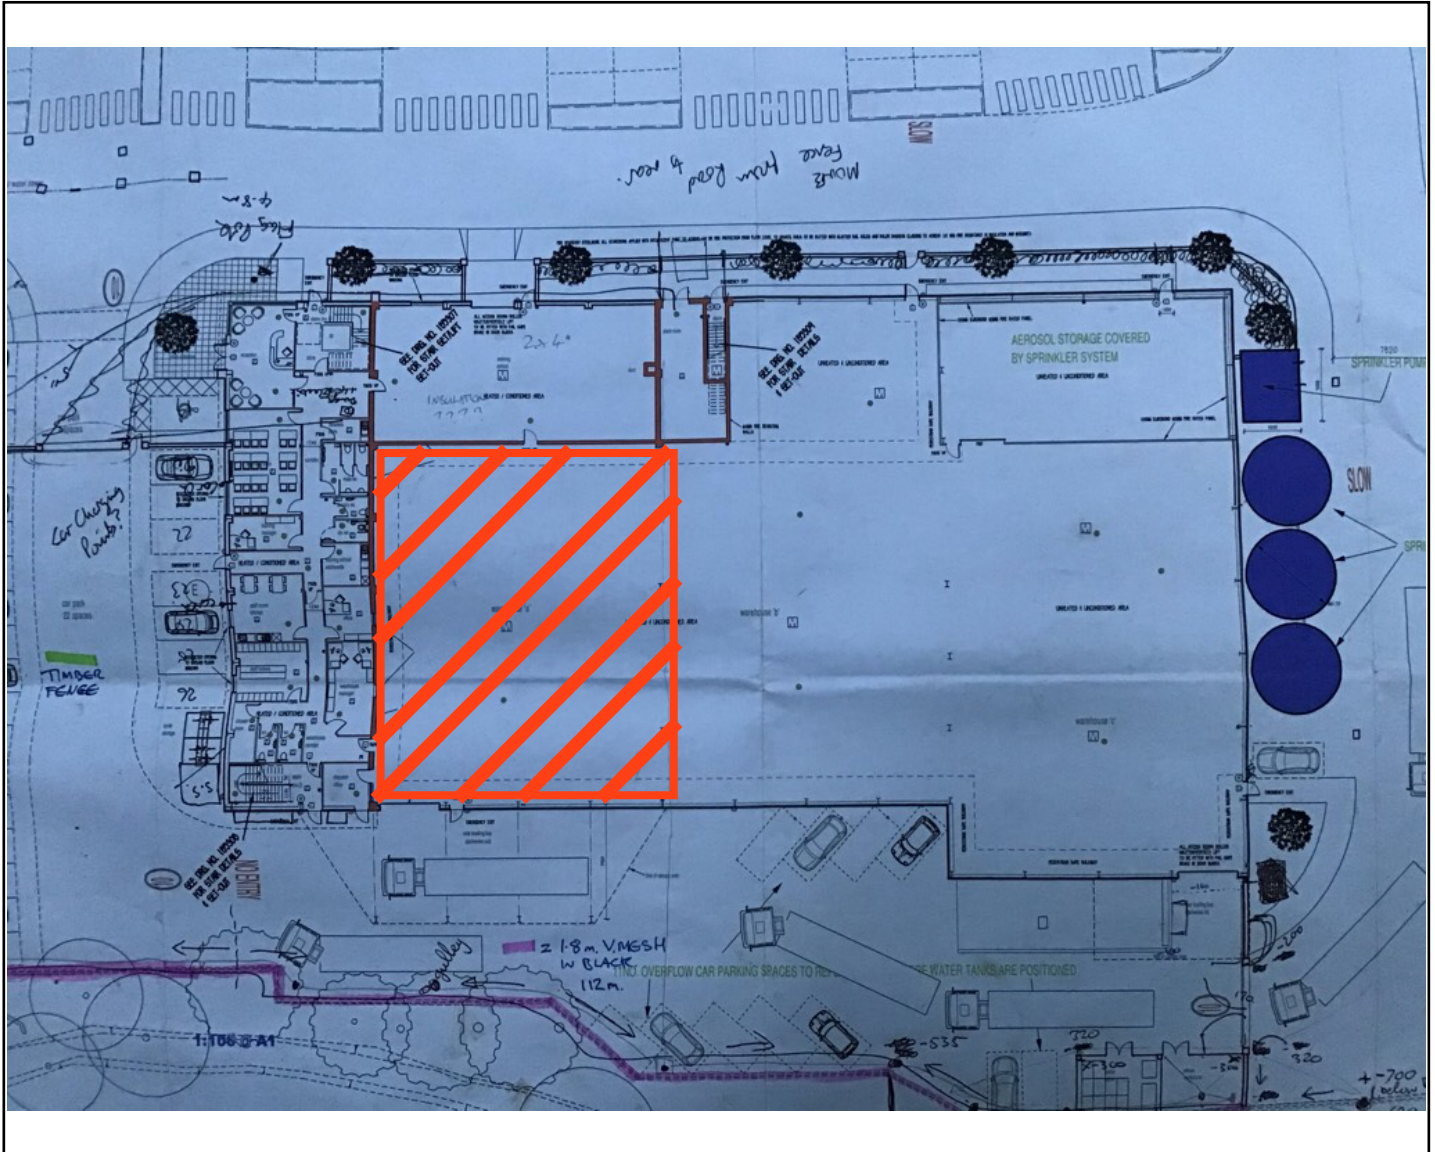
The above photo shows the highlighted area to Block A & D where

verification took place.

Installation to Pour 2 of building.

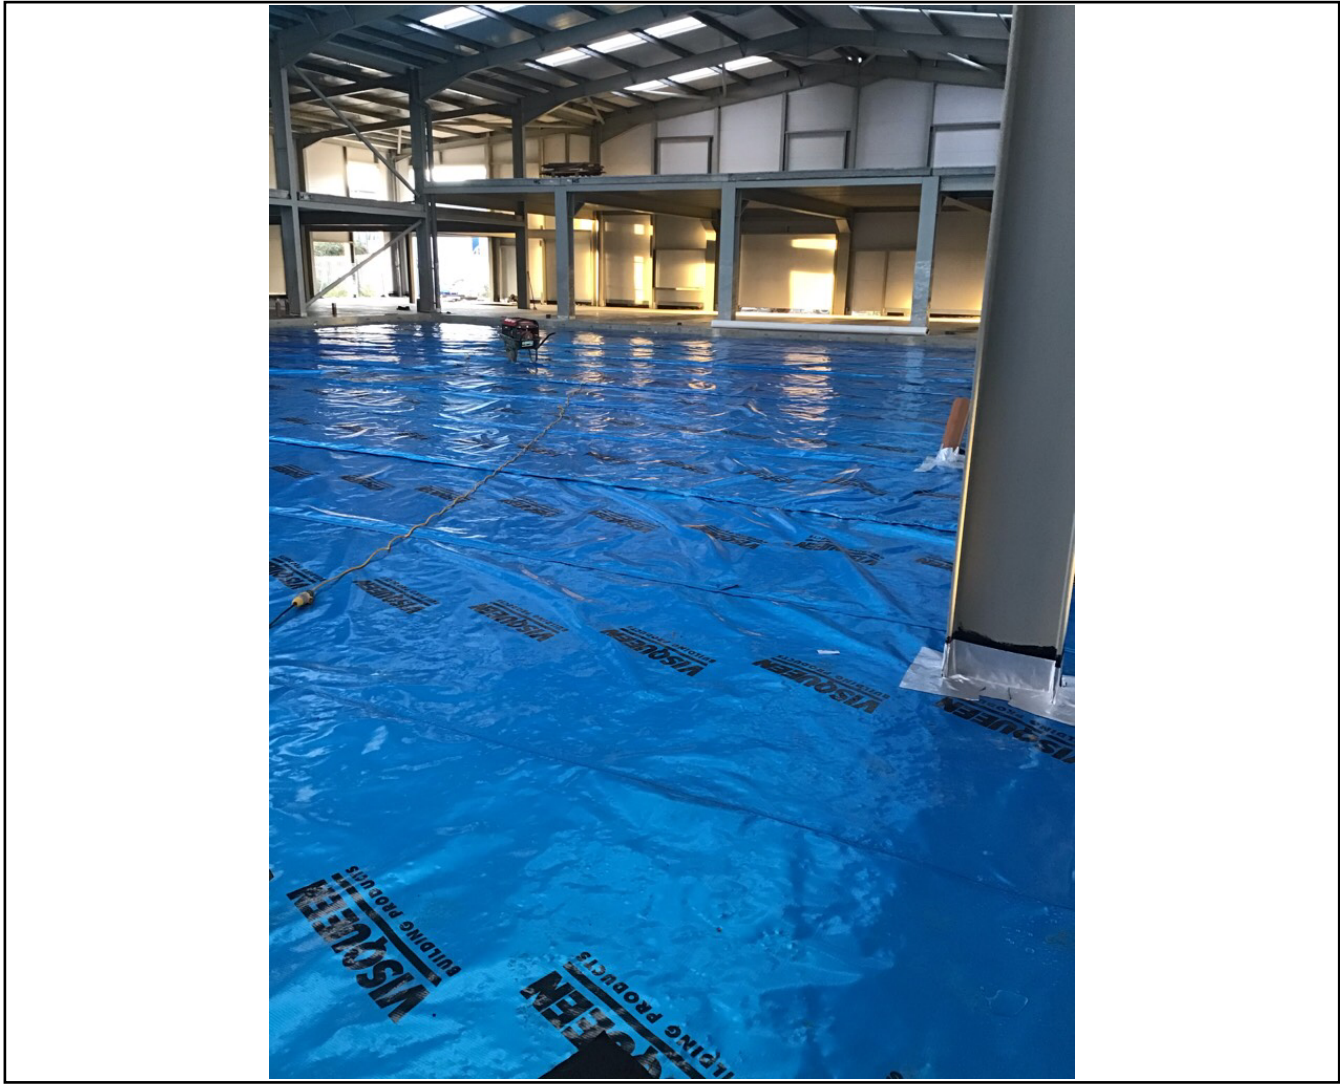
Overview photograph showing installation completed to Pour 2.

Visqueen standard gas barrier installed.

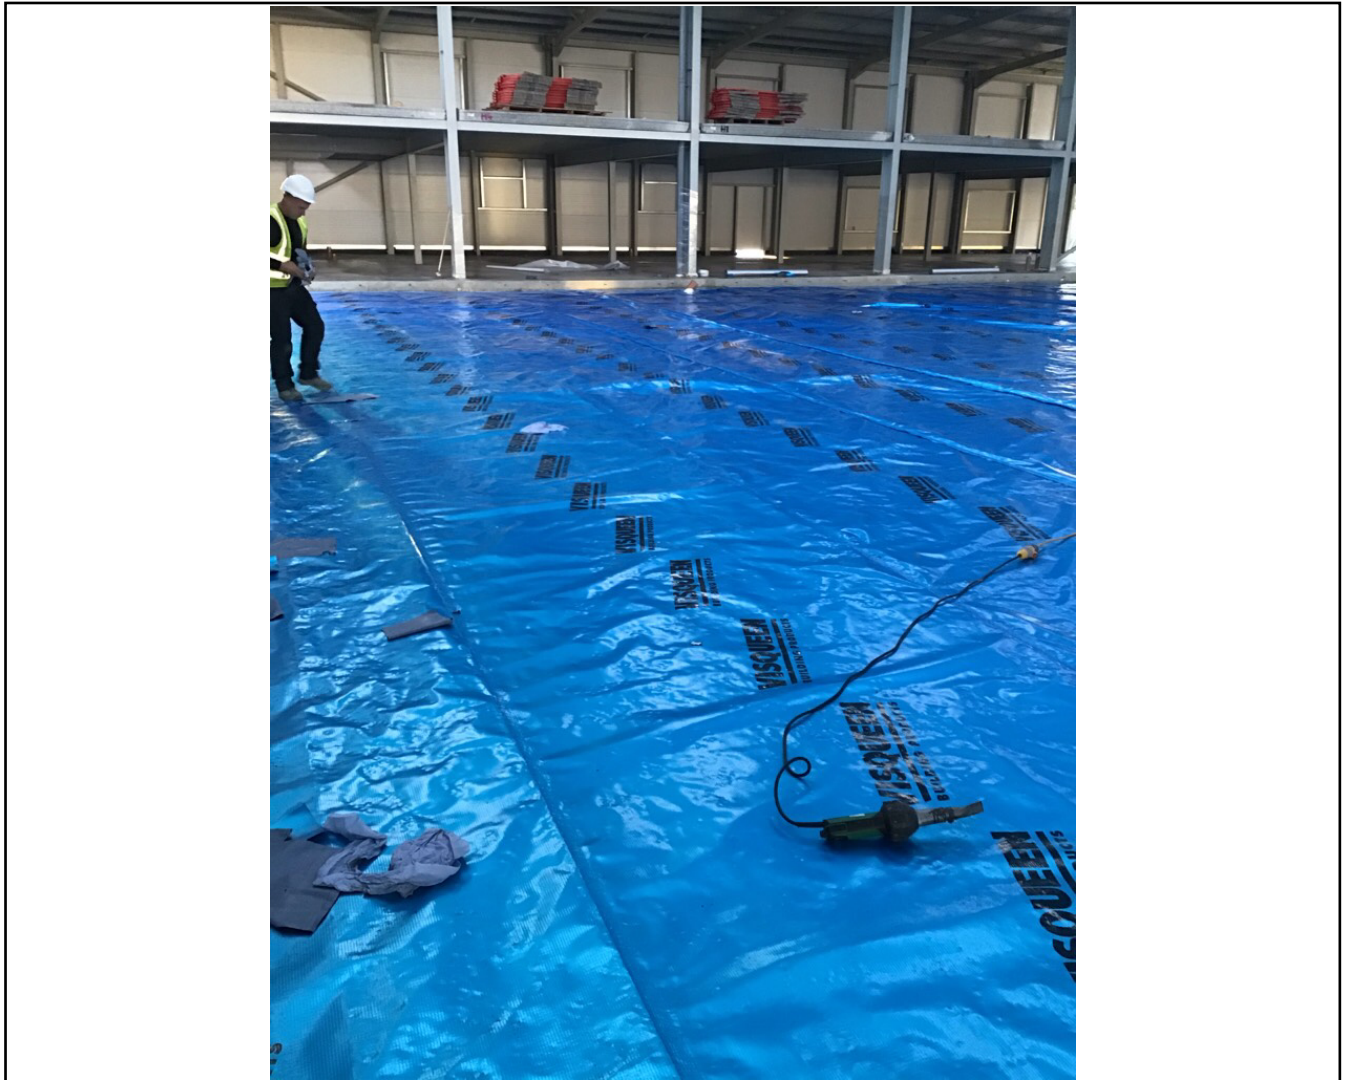
Alternative overview photograph showing general installation to Pour 2.

Visqueen standard gas barrier installed.

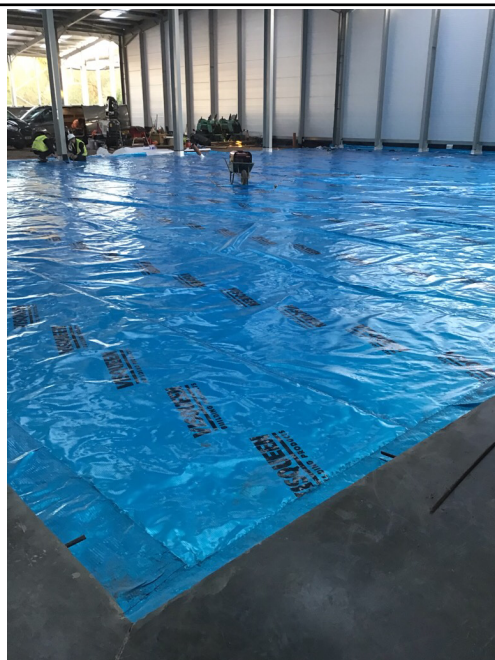
First photo above shows an overview of the installation completed to pour 2.

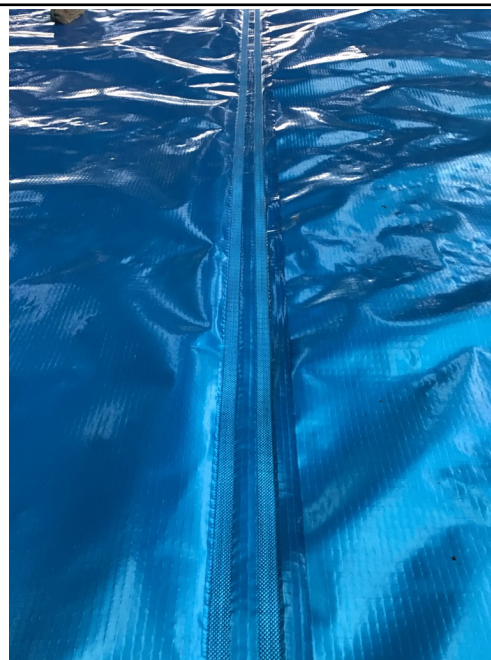
All joints and laps between the Visqueen Blue Gas Membrane have been welded by either using the Twinny S Leister machine, or a hot air Leister. Either a 40mm consistent weld, or a double weld as shown below, is present on all weldlines within this verified area.

Second photo shows a complete weld line, installed using the Twinny S Leister machine.

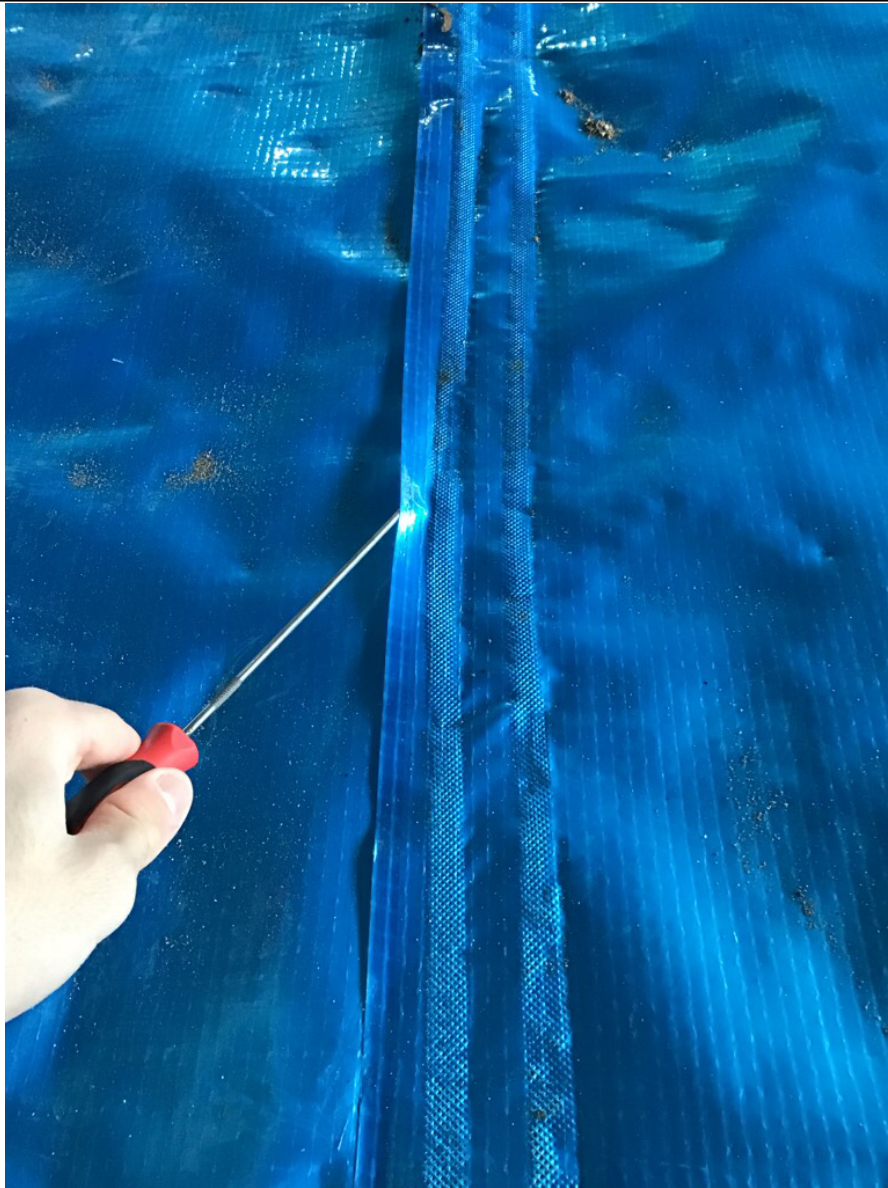
The photograph above demonstrates a pick and probe test being carried out to a welded joint in the Visqueen standard gas barrier.

All joints and laps have been tested using the aforementioned method or air lance integrity tested. Verified in accordance with CIRIA 735.

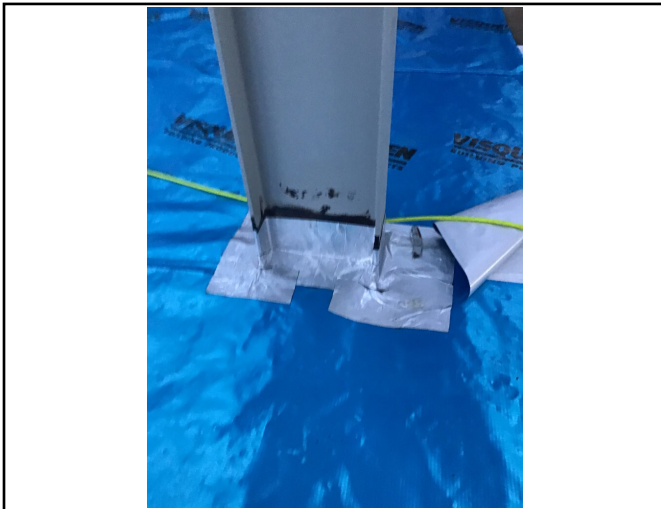
All visqueen gas Resistant Self Adhesive Tape has been heated using a hot air Leister prior to installation, to aid with adherence. The first photo above shows a steel column sealed to manufacturers specification.

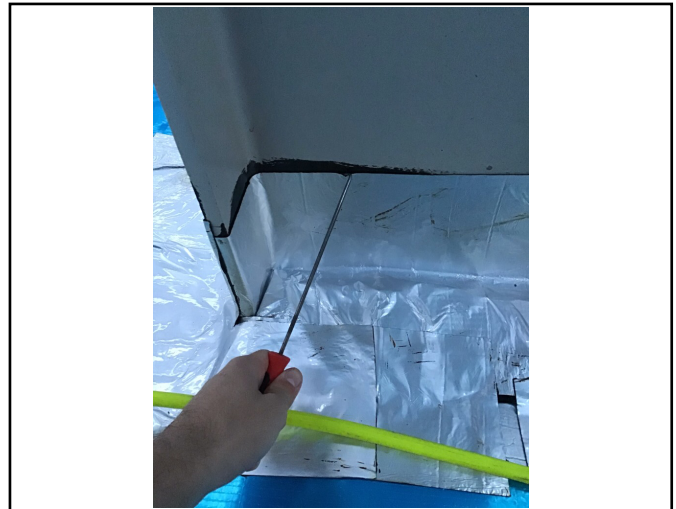
The second photograph above shows a pick and probe test being carried out to a sealed steel column.

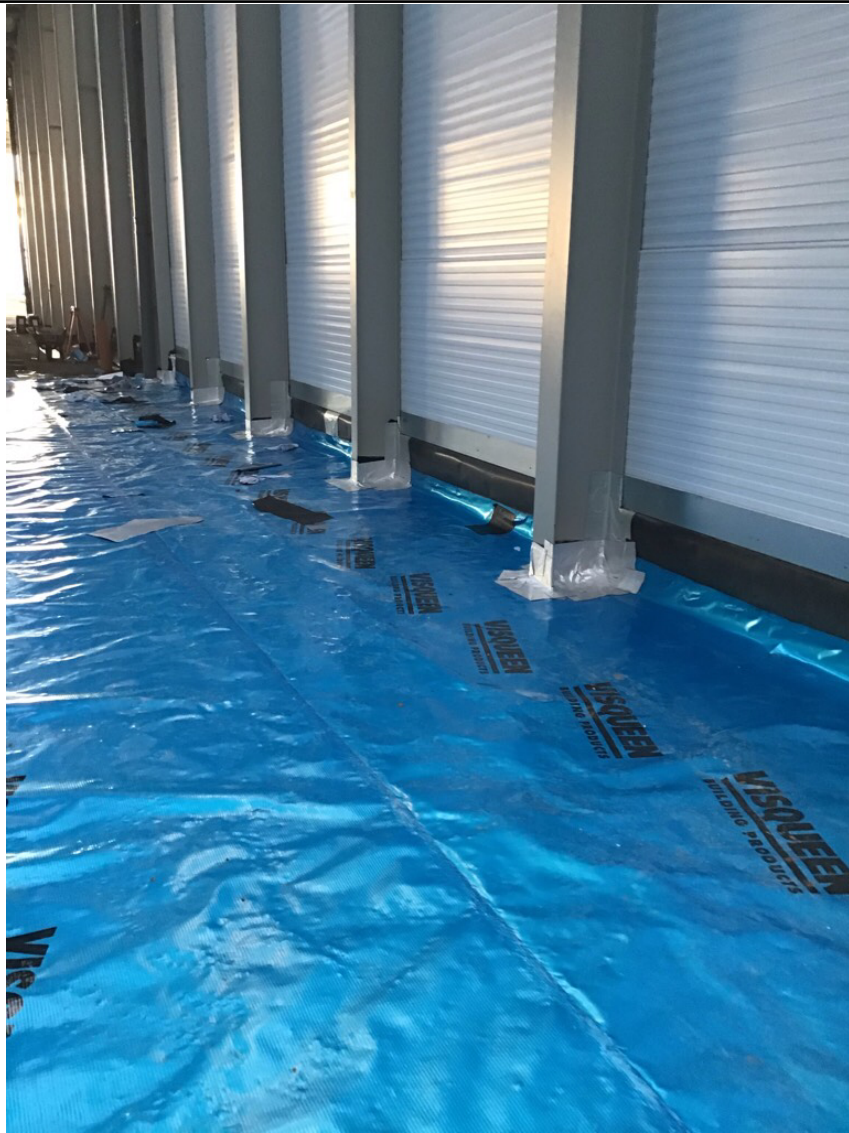
The photograph above shows the perimeter detail, as well as some steel columns

that have been sealed within pour 2. The Visqueen gas barrier has been welded to

the previously installed Visqueen gas resistant DPC membrane, along the perimeter

of the building. The steel columns have then been sealed using Visqueen GRSAM.

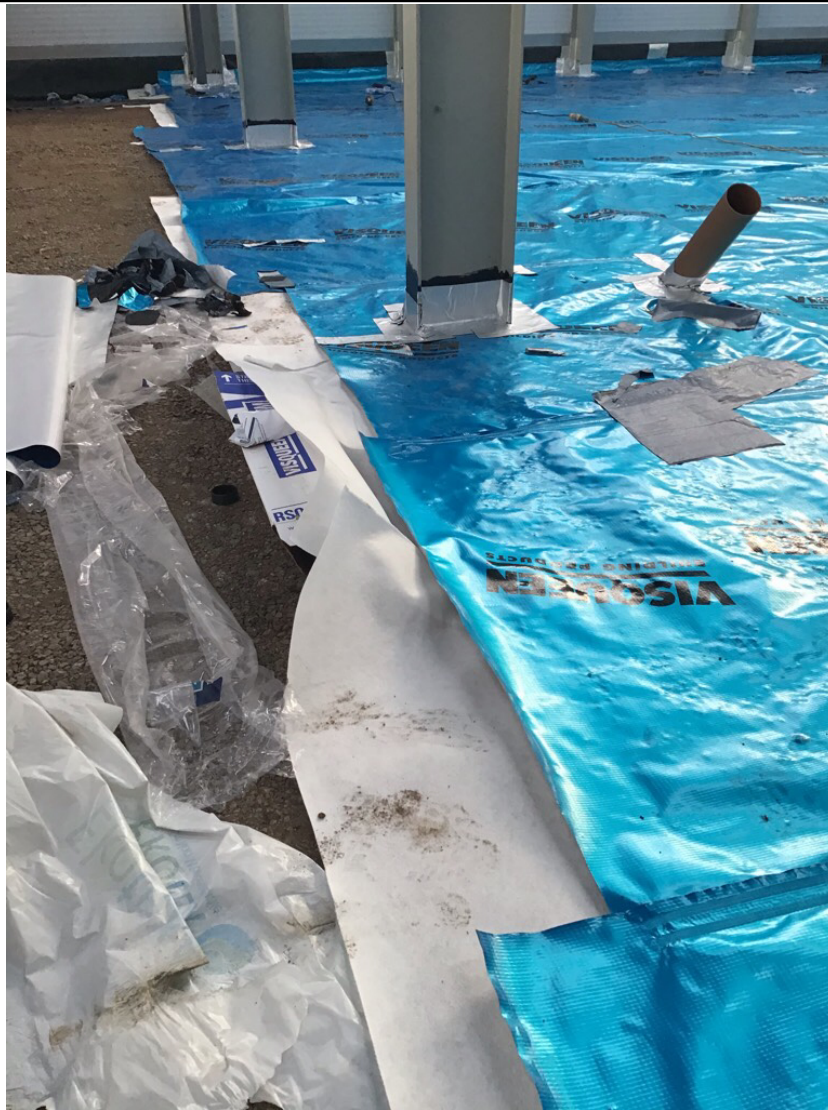
The photograph above shows the Geotextile protection fleece that has been installed on top of the stone substrate, and below the gas membrane.

The protection fleece will minimise the damage that can occur from the stone substrate piercing the material.

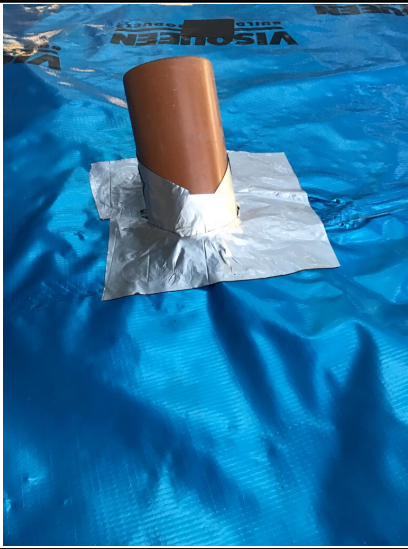
Large pipe penetration sealed to

BS8485:2015.

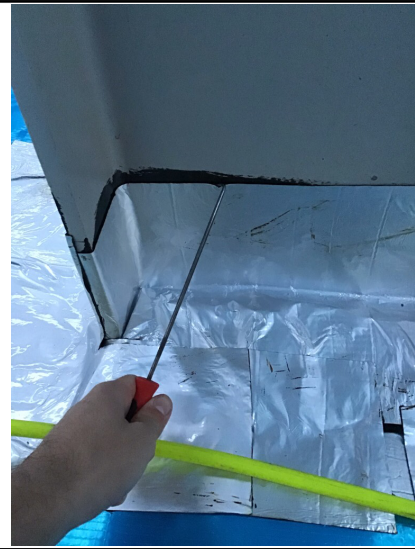
Pick and probe test to steel column

detail.

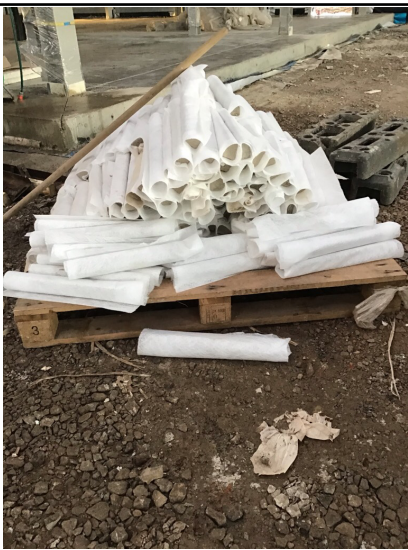
Concrete Mars bars wrapped in

protection fleece.

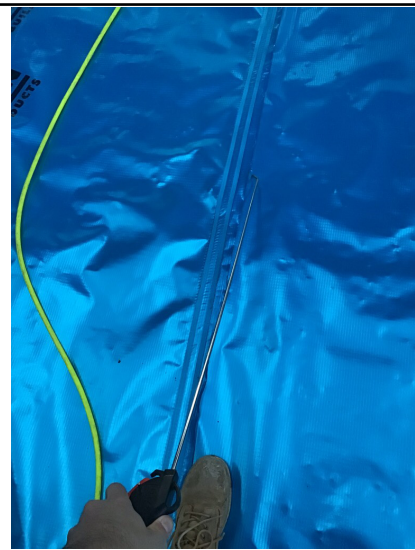
Air lance test being carried out.

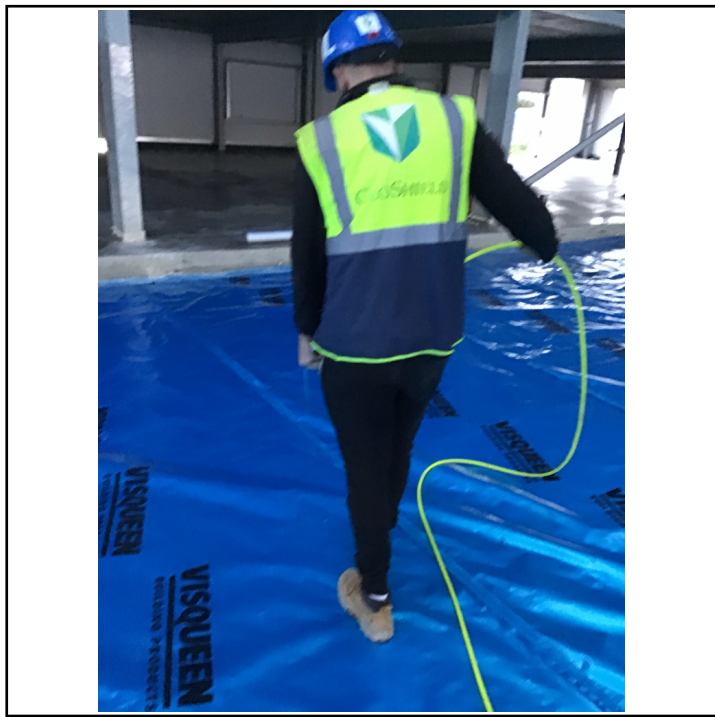
Air lance integrity test being carried out to welds.

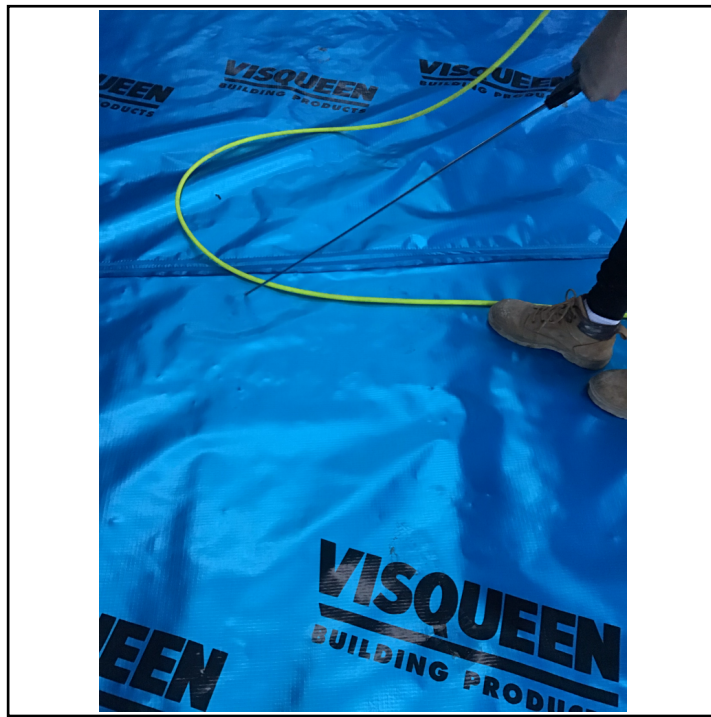
Air lance test again being carried out.

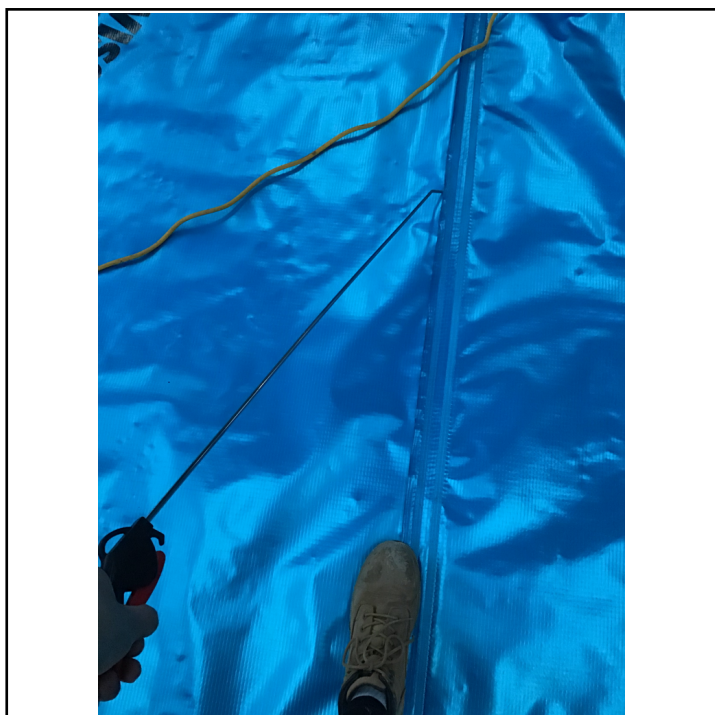
Air lance integrity test carried out to weld.

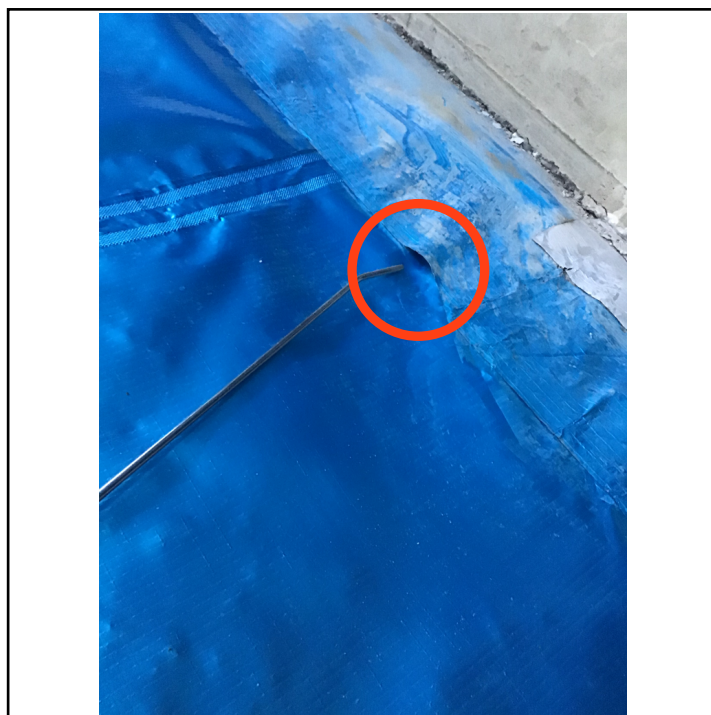
| TEST NUMBER: | FAILED OR PASSED | DETAIL, COMMENT AND RECOMMENDATIONS |
|---|---|---|
| 4 | Failed | Miss-weld identified - patched and respired during visit. |
| 7 | Failed. | Miss-weld identified - patched and respired during visit. |

Example of miss-weld fault identified.

All failed weld joints have been repaired during the visit, and re-verified to ensure sealed.
