# GEOSHIELD Verification Report

New Warehouse Building

Land adjacent Fulflood Road

Gas membrane to specification BS8485 2015

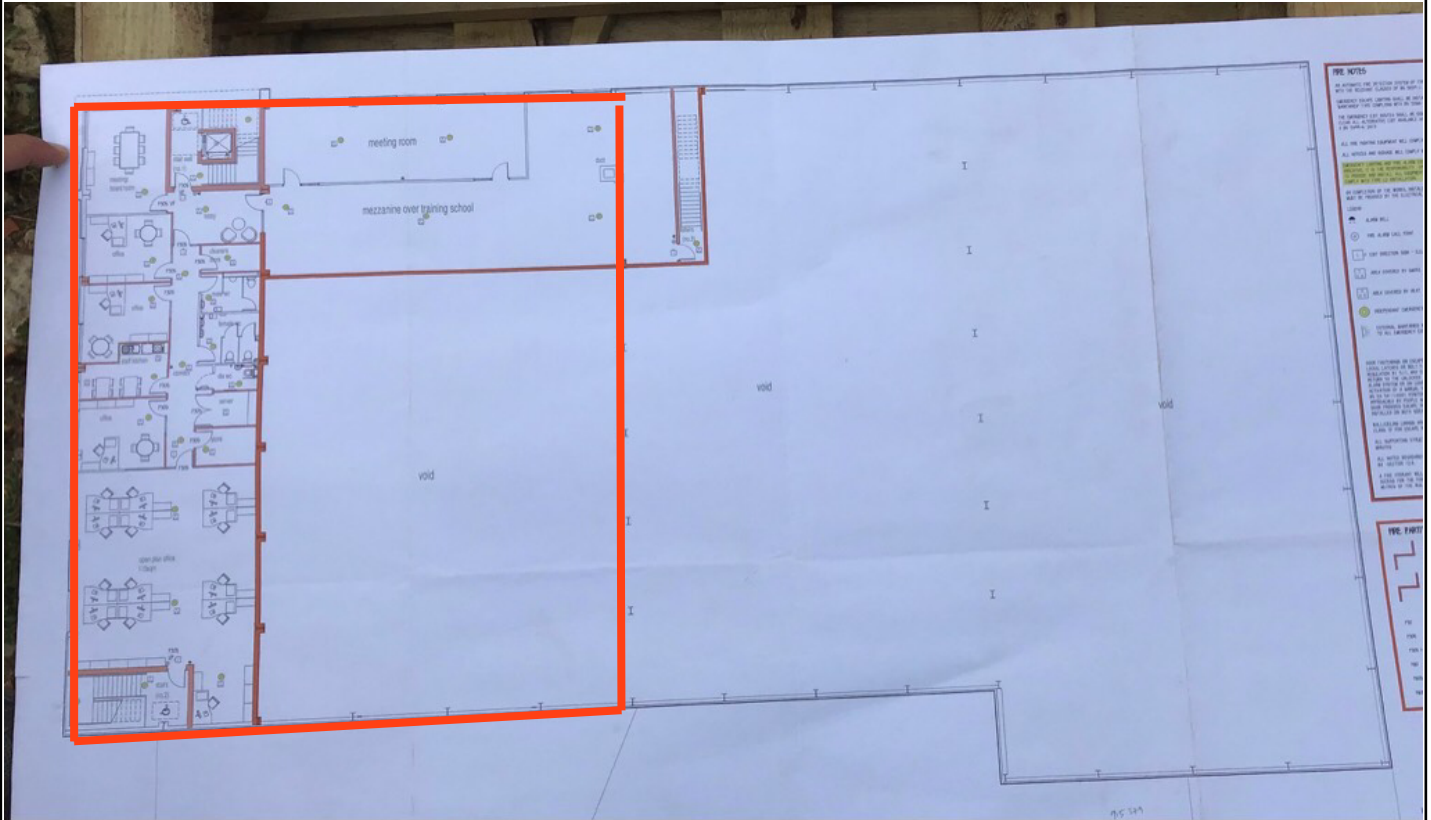
The above photo shows the highlighted area to Block A & D where

verification took place.

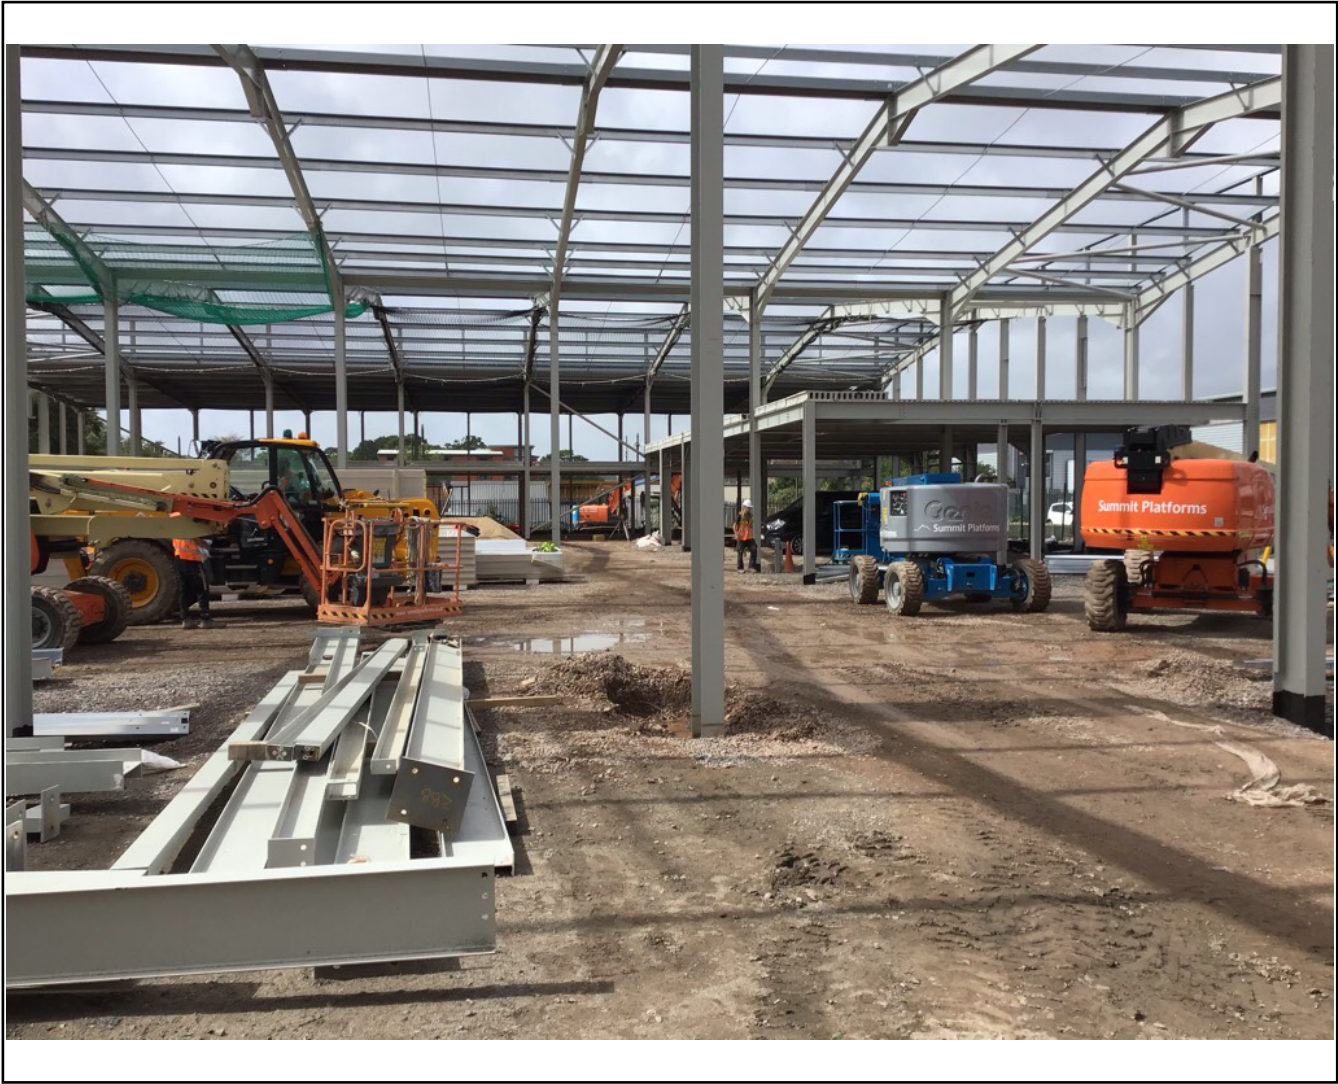
Overview photo looking at verification area

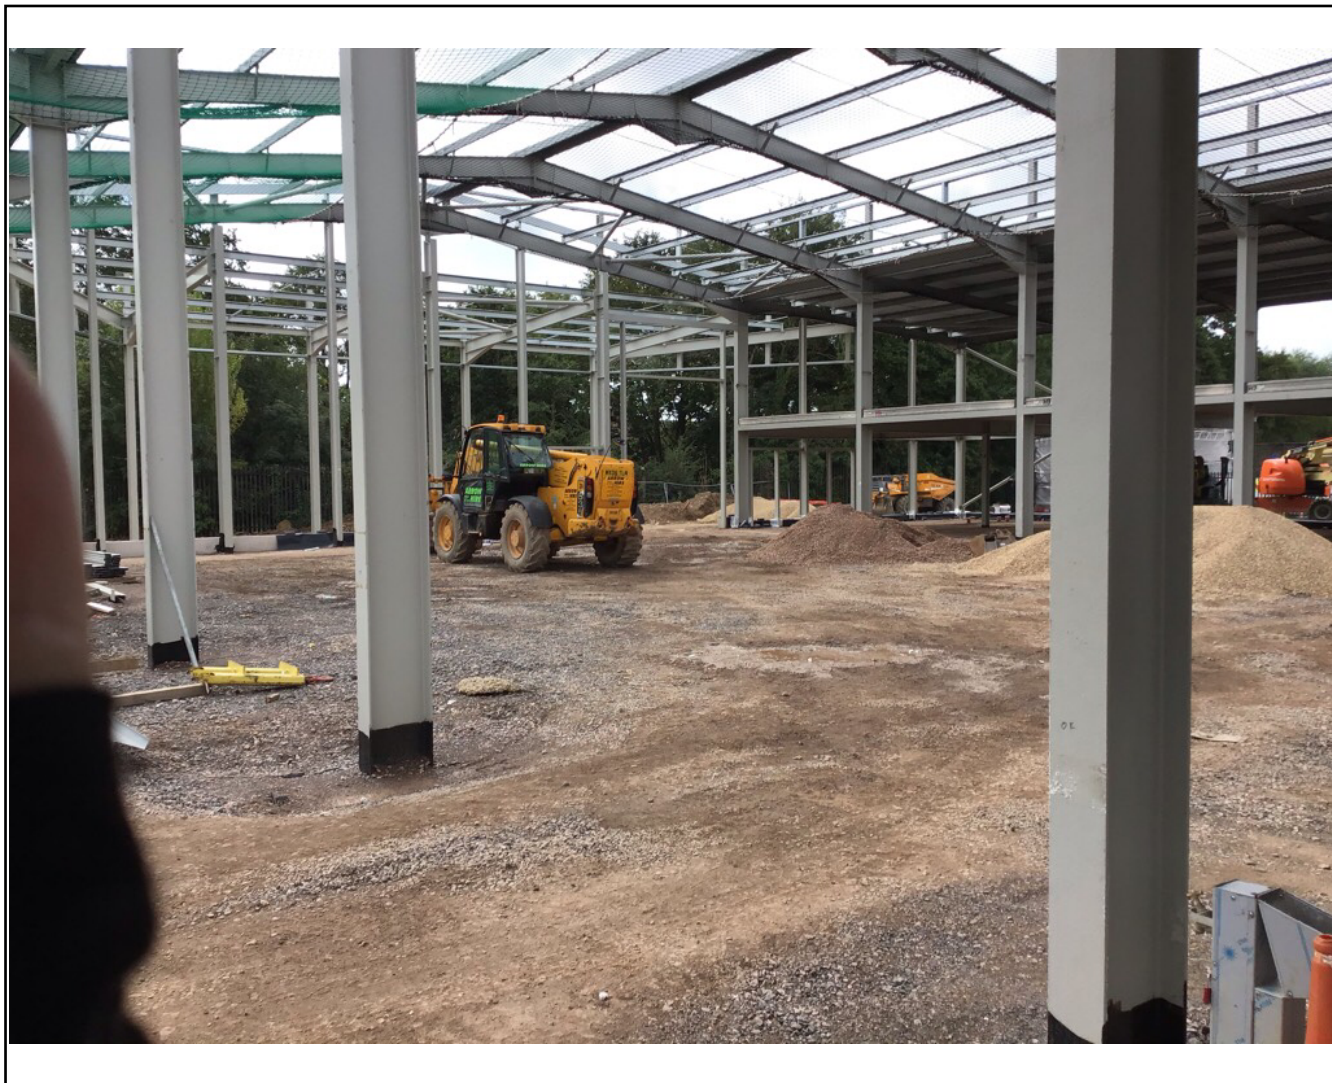
An overview photo looking over perimeter completed with

Visqueen product

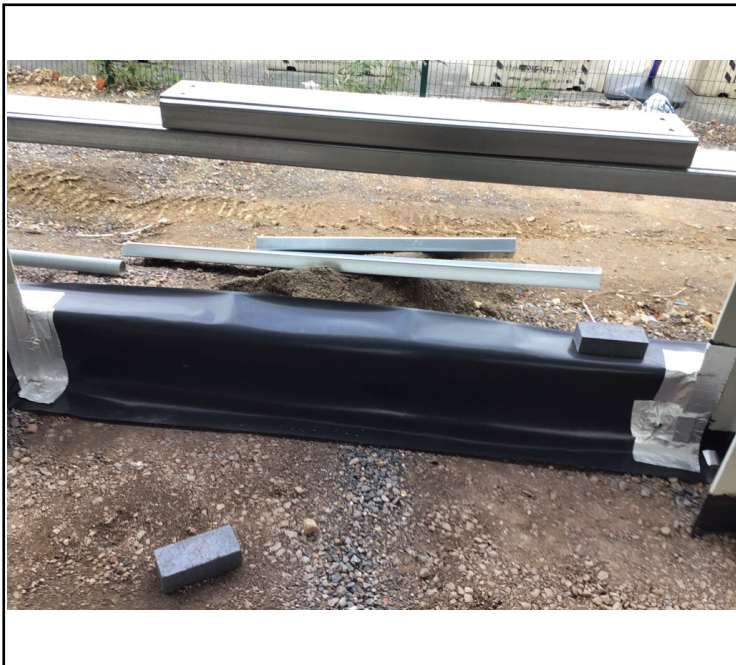
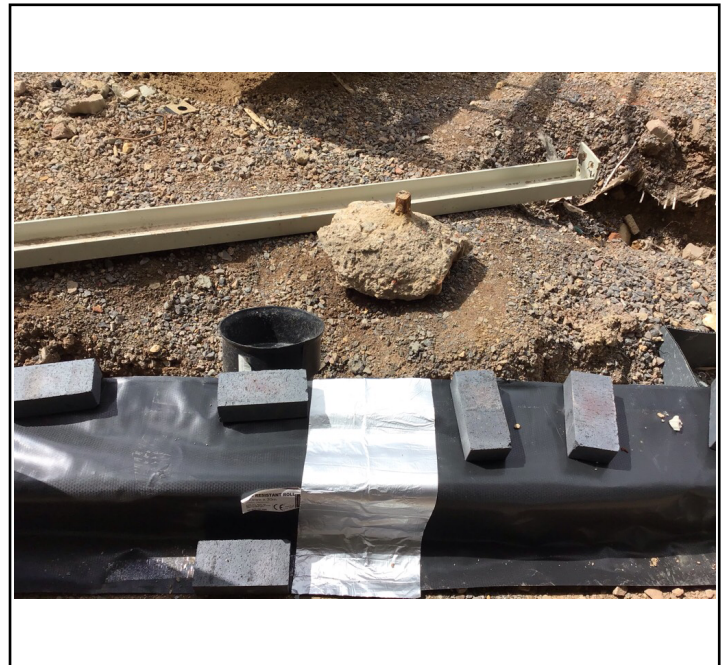
LOCATION/GRID LINE: Perimeter.

The below photograph shows a welded lap joint which has been correctly sealed using Visqueen GR SAM heated with a heat gun by the installers.

Pick and probe device located no defects with this lap joint.

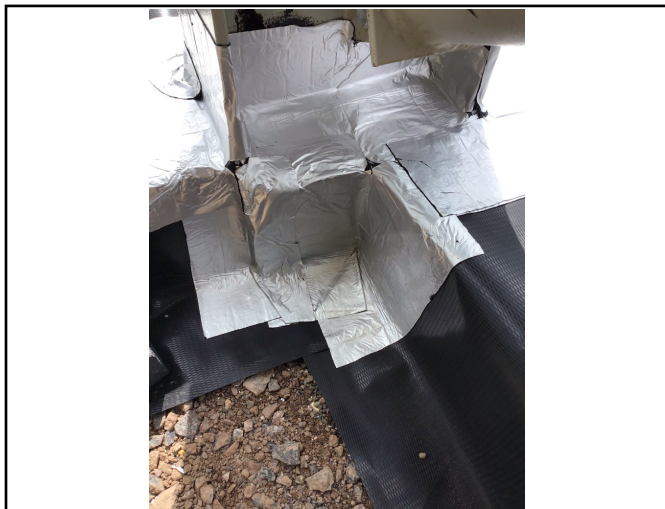
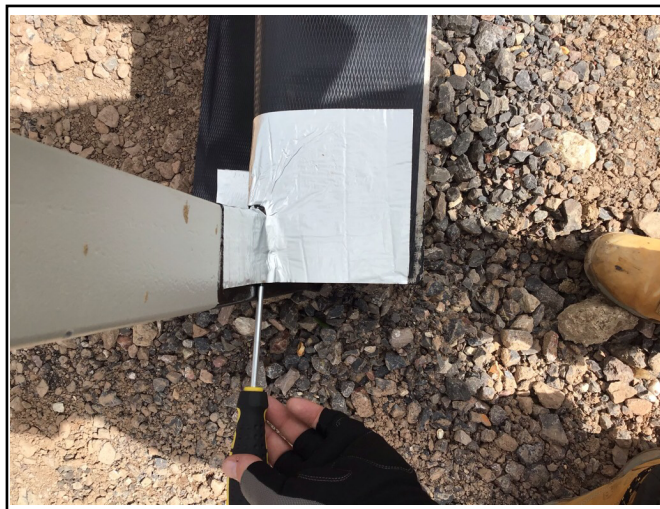
LOCATION/GRID LINE: Ground floor perimeter

The below photographs show a number of corner details of which have been detailed by the installers. A visual and pick probe test was carried out to the corner details of which visqueen GR DPC has been adequately sealed by the self adhesive membrane

The corner details are of a high standard installed by experienced applicators.

All works carried out to manufacturers specification and no defects were

found.

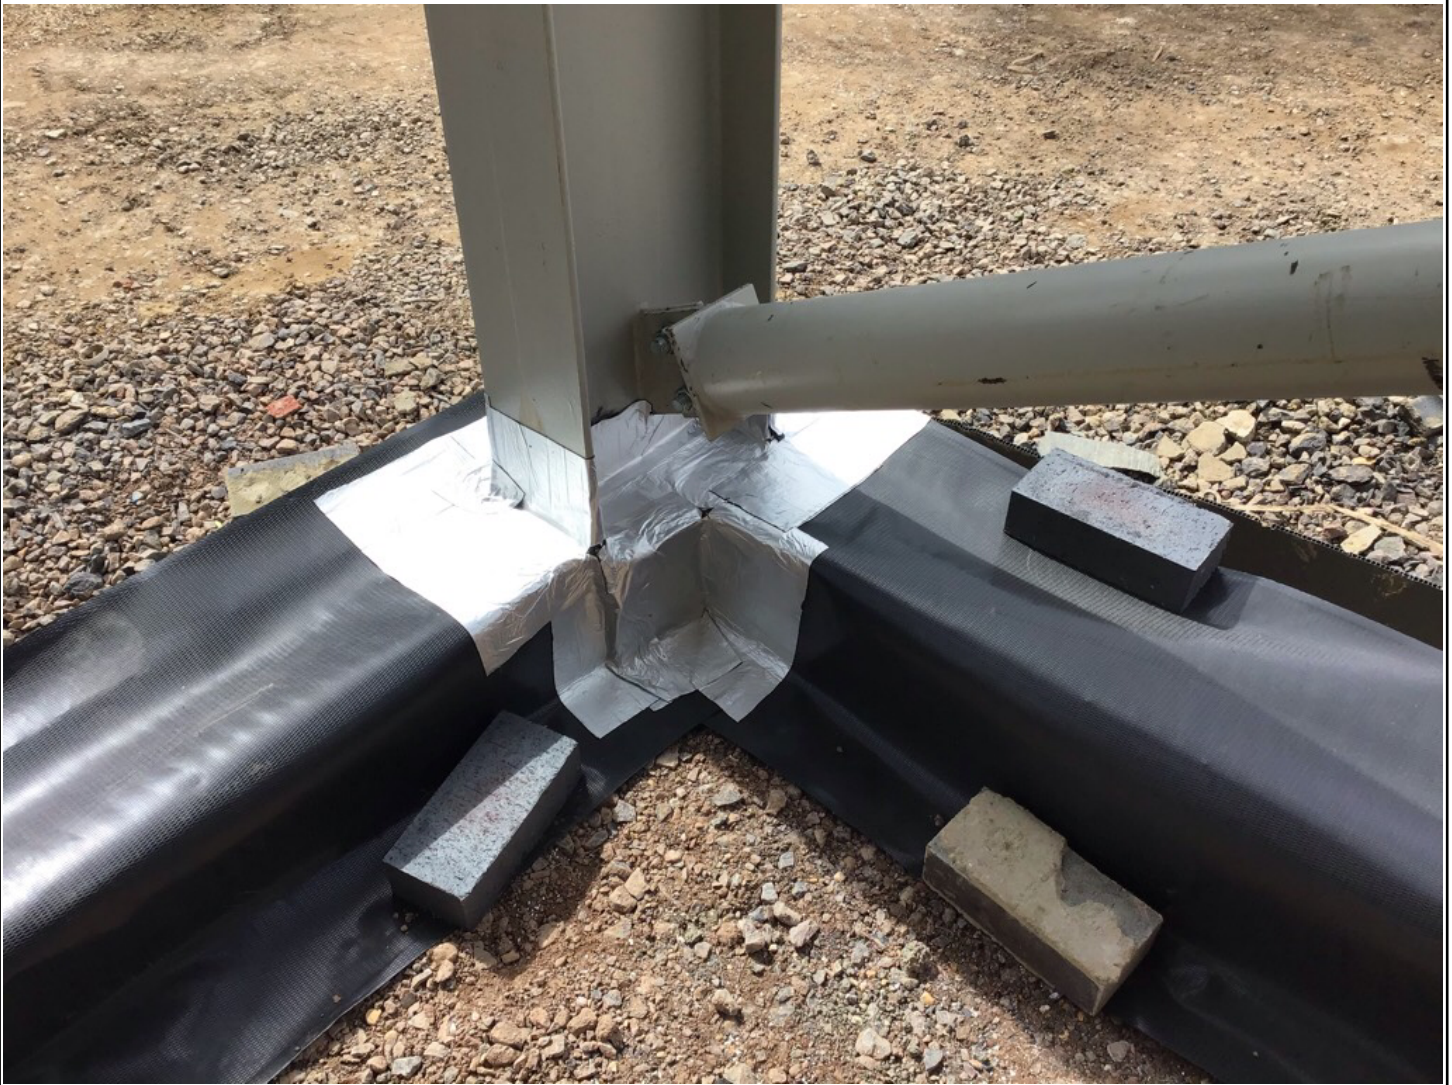
The above photo is showing a corner detail completed using SAM

tape, all areas have been fully heated down, full pick probe test was

carried out with no faults detected.

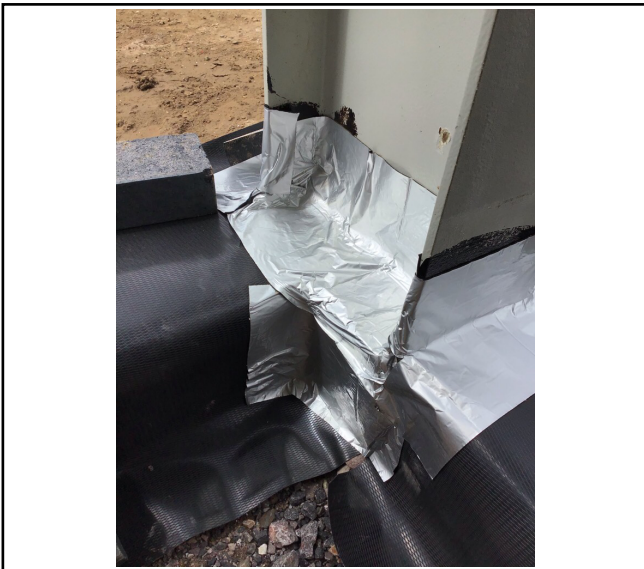
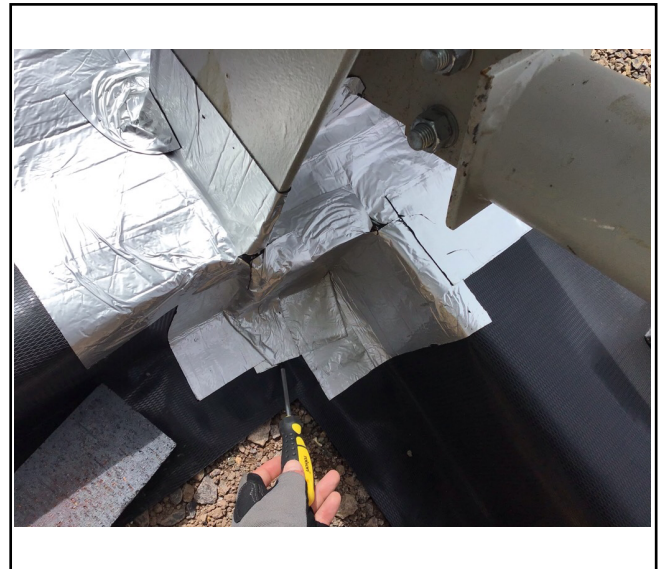
LOCATION/GRID LINE: Ground floor perimeter

Picture below shows a could no detail which has been sealed using SAM tape.

Pick probe tests determined that the tape has been tightly fitted into the corner meaning no void have been created.

Picture two above is showing that pick prob testing was carried out to the

column detail, no faults found, the SAM tape has been heated down

using the heat gun

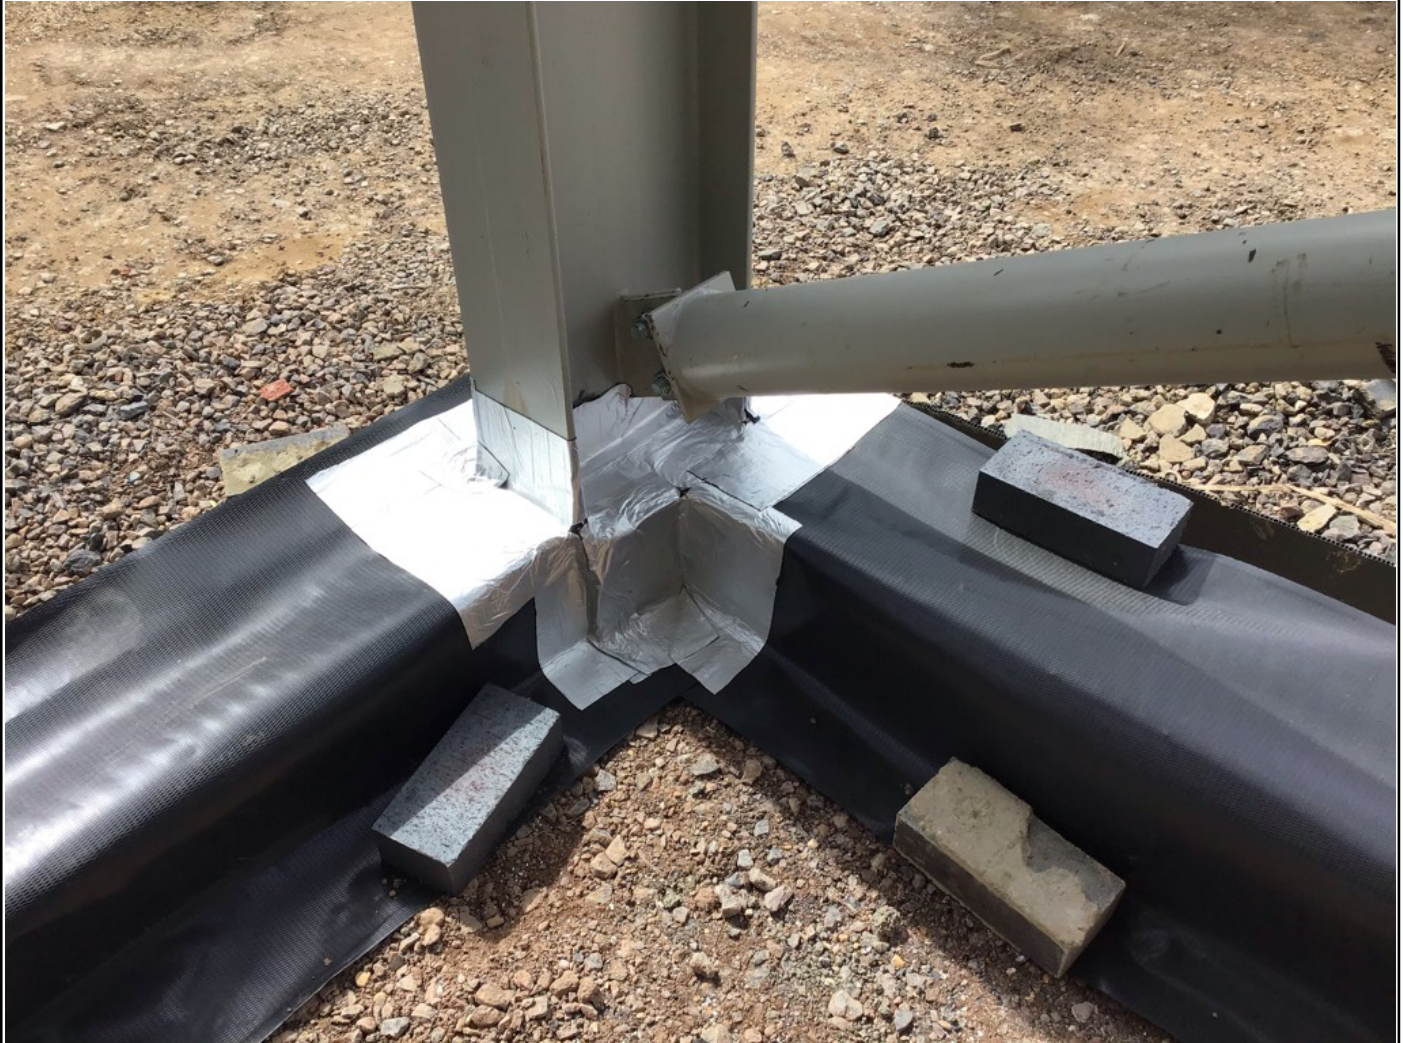
The above photo is showing a steel column detail, all SAM tape

has been tightly fitted and heated down.

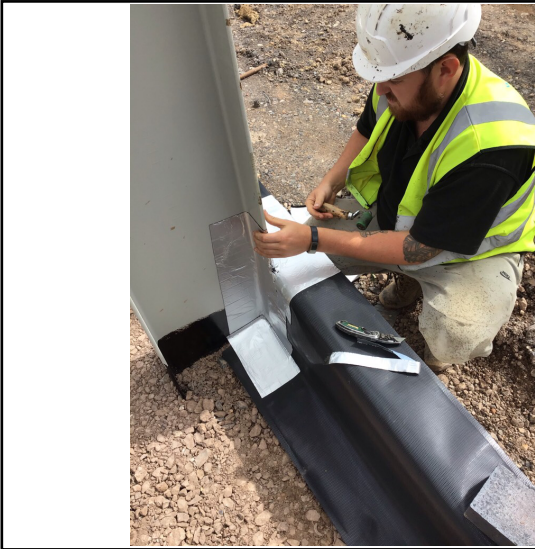
Installer carrying out works to perimeter

by applying SAM

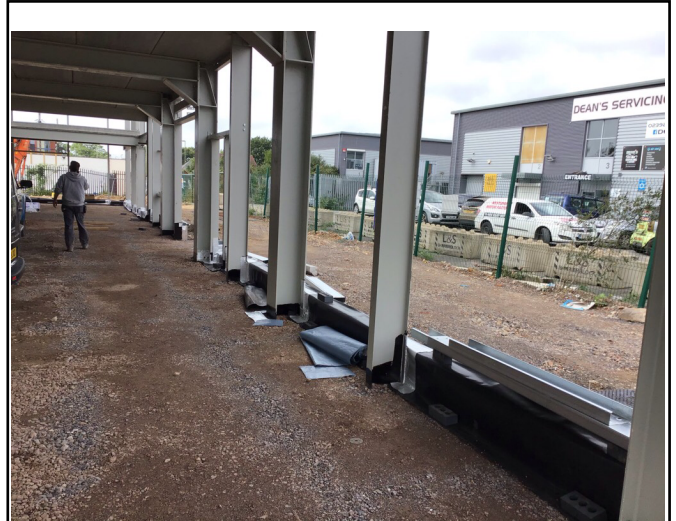
Overview photo shown the completed

DPC membrane

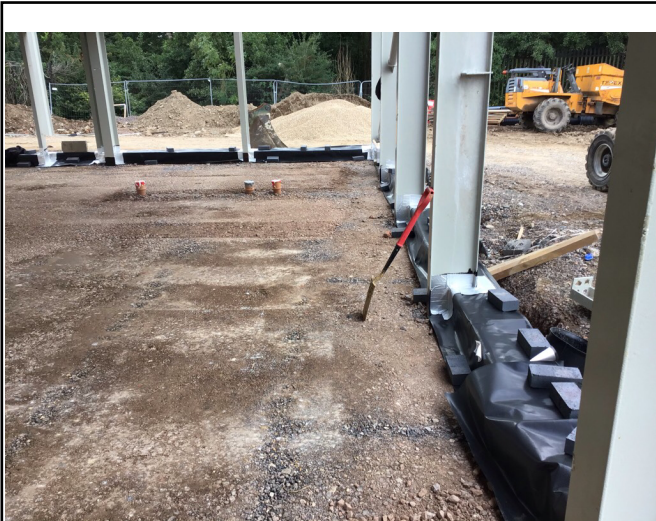
Alternative angle of installation area

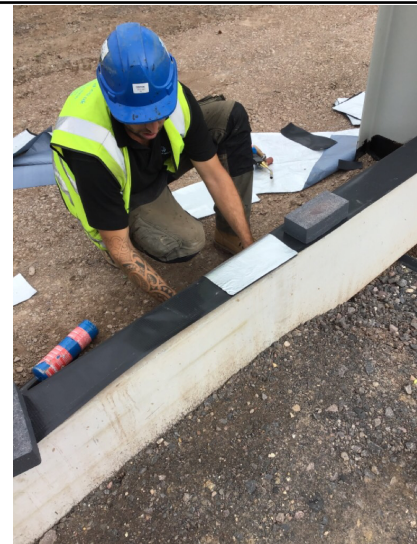
Installer carrying out work to dpc

detail.
