**Tree condition survey**  
**at**  
**Hall Place, 20 South Street, Havant, PO9 1DA**  
**for**  
**Mr S Burridge**

Reference: J1336  
February 2021  
© Sapling Arboriculture Limited 2021

Site Hall Place, 20  
 South Street,  
 Havant  
 Date of survey 20th April 2021  
 Job reference J1349  
 Surveyor Ben Abbatt  
 Resurvey To be complete by  
 the 1st June 2024

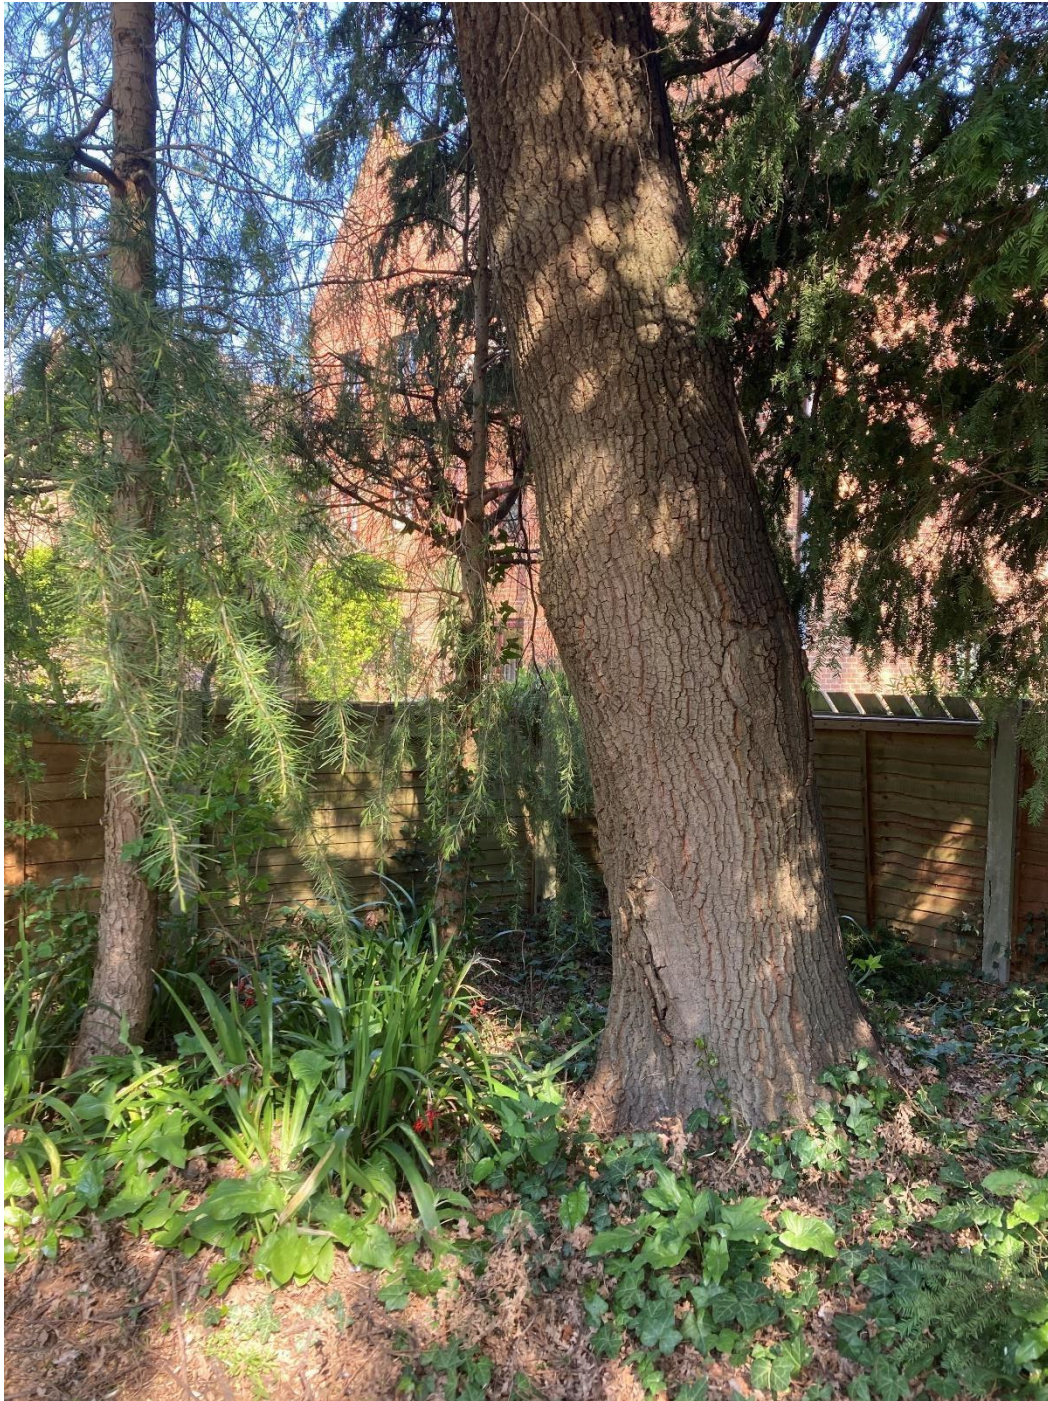
| Designation | Reference number | Species | Height (m) | Age class | Physiological condition | Structural condition | Condition notes | Condition related tree works | Priority |
|---|---|---|---|---|---|---|---|---|---|
| T | 3 | Turkey oak<br><i>Quercus cerris</i> | 17 | Mature | Good | Fair | Lean to south. Nylon hammer identifies hollow area between buttresses on south side. Client previously observed fungal fruiting body on the east to south side of the tree on the lower stem. | Crown reduce by 5 m and reduce radial spread by 4 m to leave a final height of 12 m with a radial canopy spread of 5 m. Crown lift to 5 m. | Low |

SAL1 T3 with disrupted bark at base.

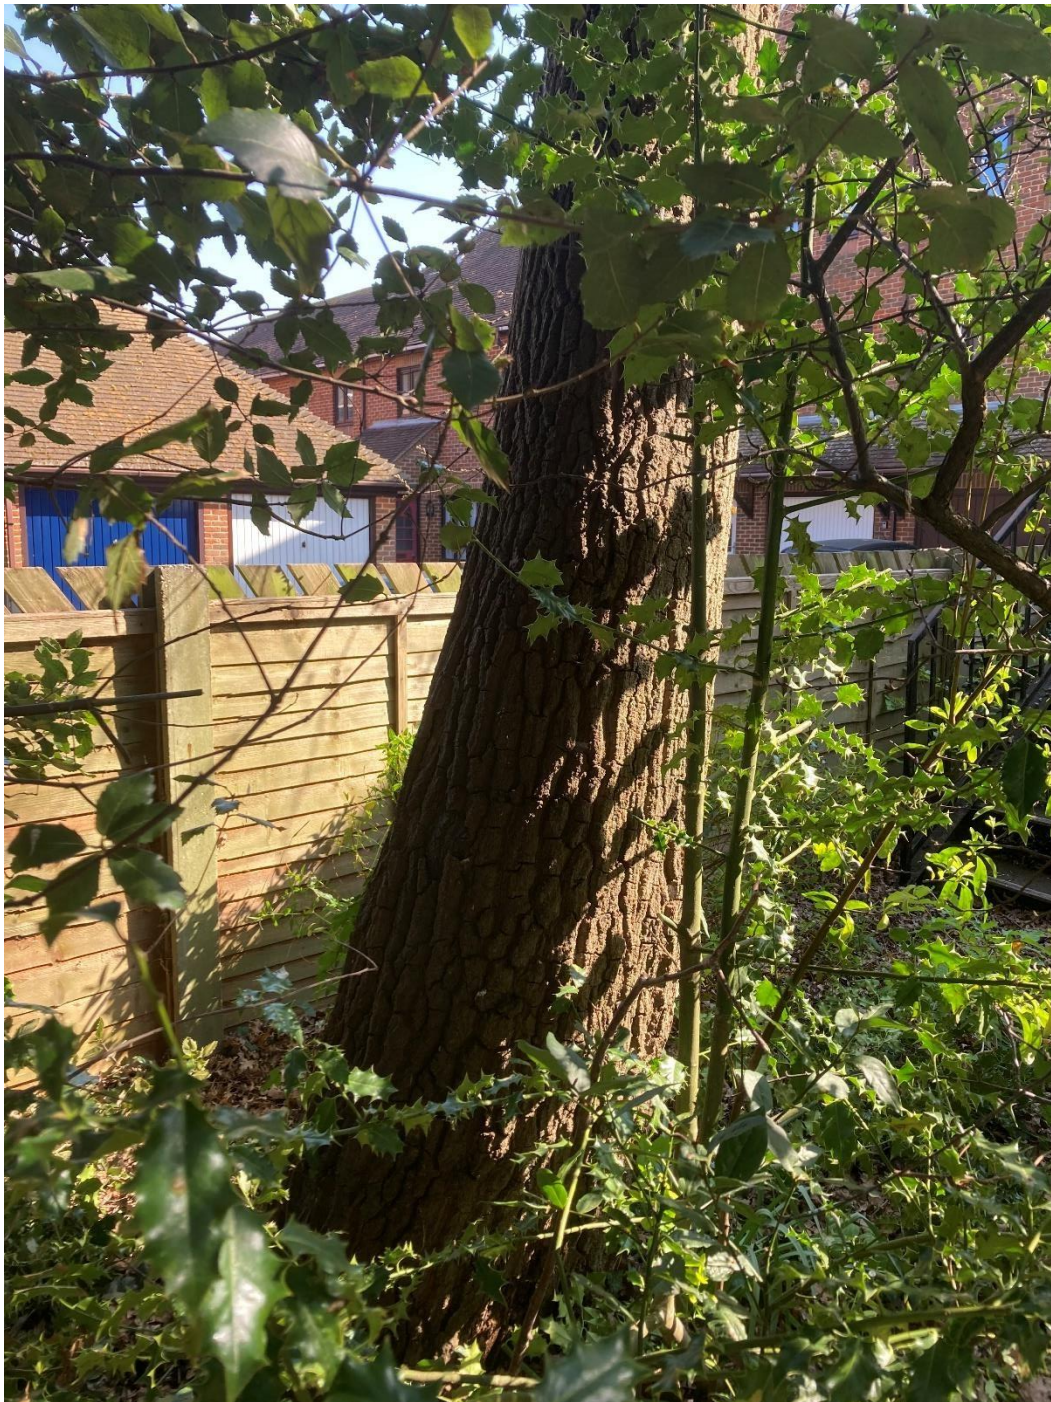
| Designation | Reference number | Species | Height (m) | Age class | Physiological condition | Structural condition | Condition notes | Condition related tree works | Priority |
|---|---|---|---|---|---|---|---|---|---|
| T | 6 | Turkey oak<br><i>Quercus cerris</i> | 17 | Mature | Good | Fair | Asymmetrical canopy towards the north east. Previously crown reduced. Typical moderate (25 to 100 mm diameter) deadwood. Bottle Butt at base. | Crown reduce by 5 m and reduce radial spread by 5 m to leave a final height of 12 m with a radial canopy spread of 5 m. Clear building by 2 m retaining overhanging branches outside this distance. Crown lift to 5 m. | Low |

SAL2 T6 with bottle butt (swelling of the lower stem often an indicator of internal decay).

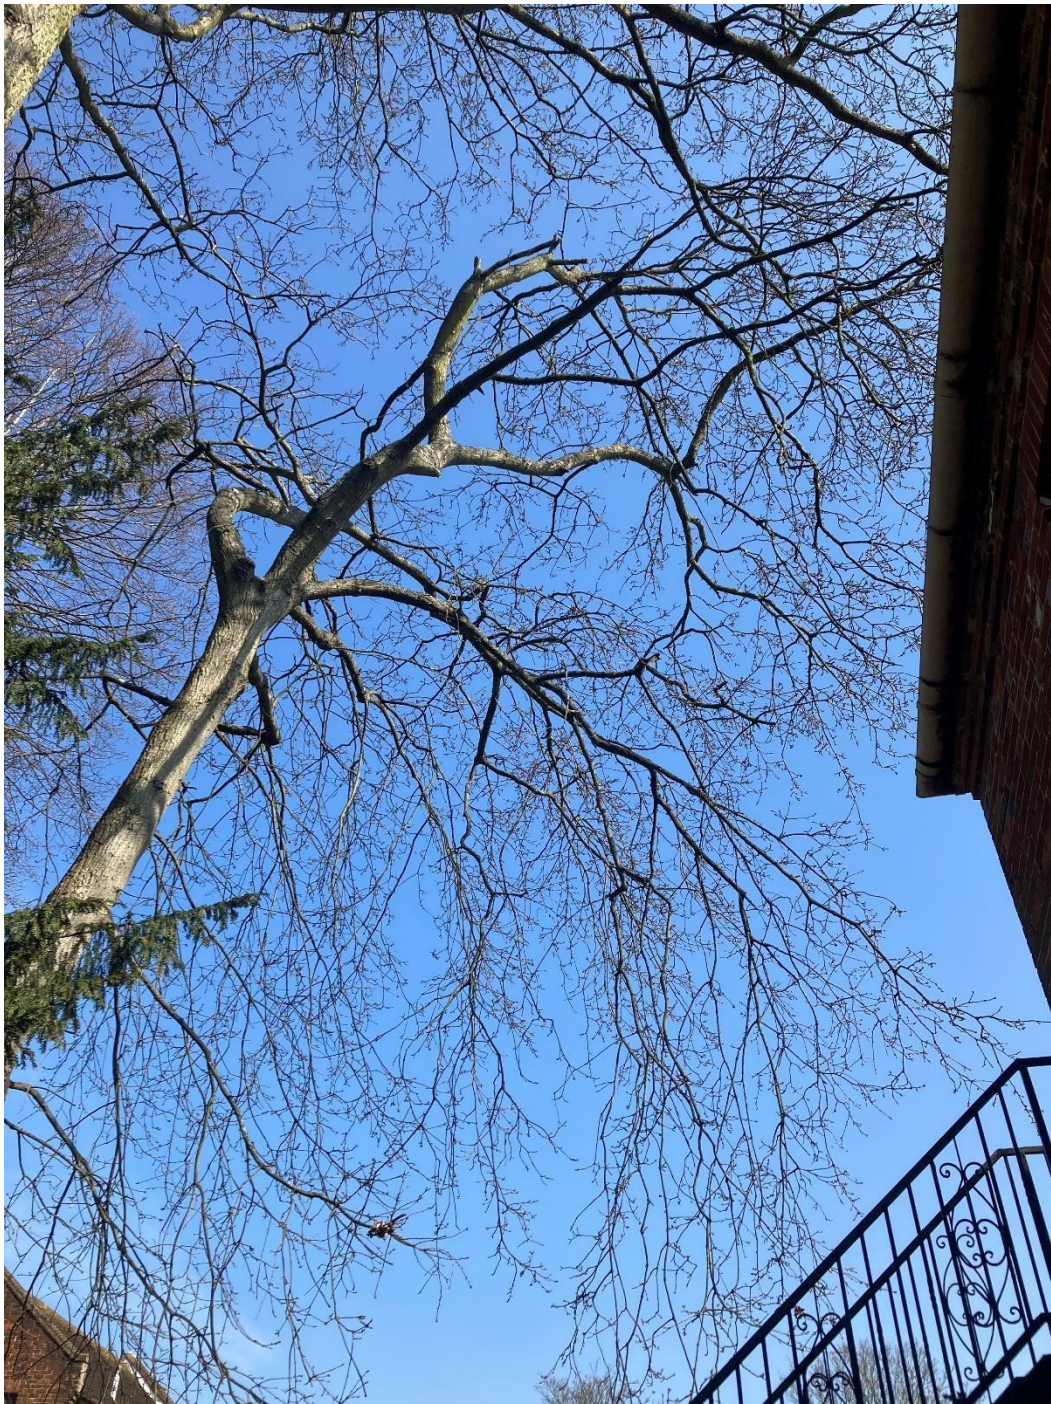
SAL3 T6 with asymmetrical canopy and prior crown reduction with regrowth.

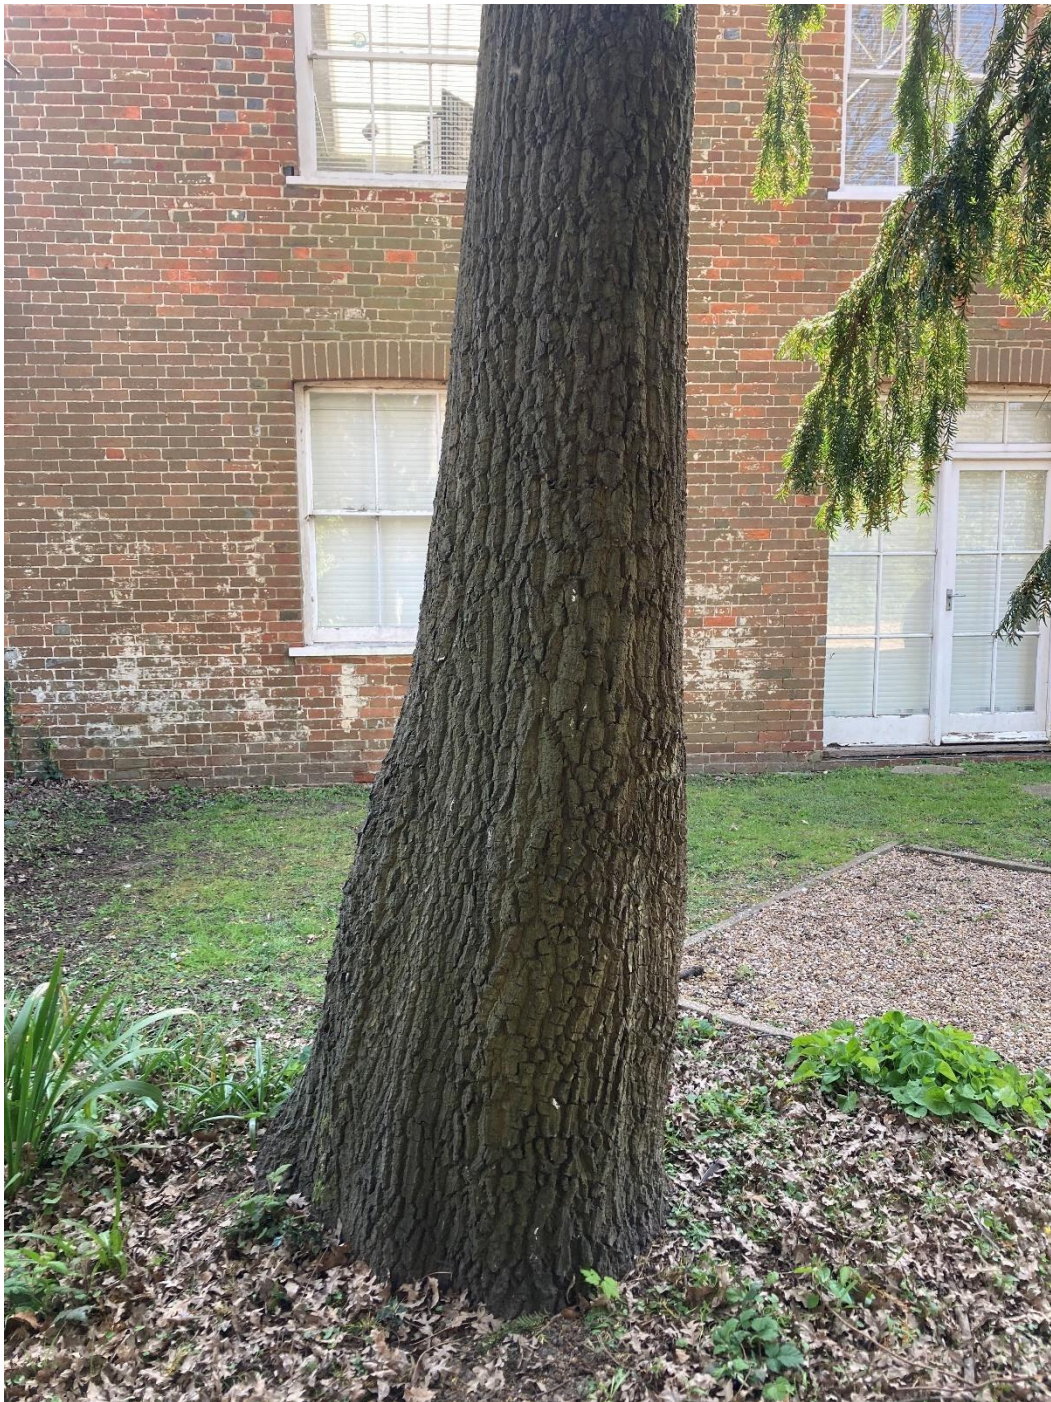
| Designation | Reference number | Species | Height (m) | Age class | Physiological condition | Structural condition | Condition notes | Condition related tree works | Priority |
|---|---|---|---|---|---|---|---|---|---|
| T | 7 | Turkey oak<br><i>Quercus cerris</i> | 20 | Mature | Good | Fair | Asymmetrical canopy towards the south. Previously branch reduction adjacent to the property. Typical moderate (25 to 100 mm diameter) deadwood. Bottle butt at base. Historic wound at 0.5 m on north side with adaptive growth. | Crown reduce by 8 m and reduce radial spread by 4 m to leave a final height of 12 m with a radial canopy spread of 5 m. Clear building by 2 m retaining overhanging branches outside this distance. Crown lift to 5 m. | Low |

SAL4 T7 with bottle butt (swelling of the lower stem often an indicator of internal decay).

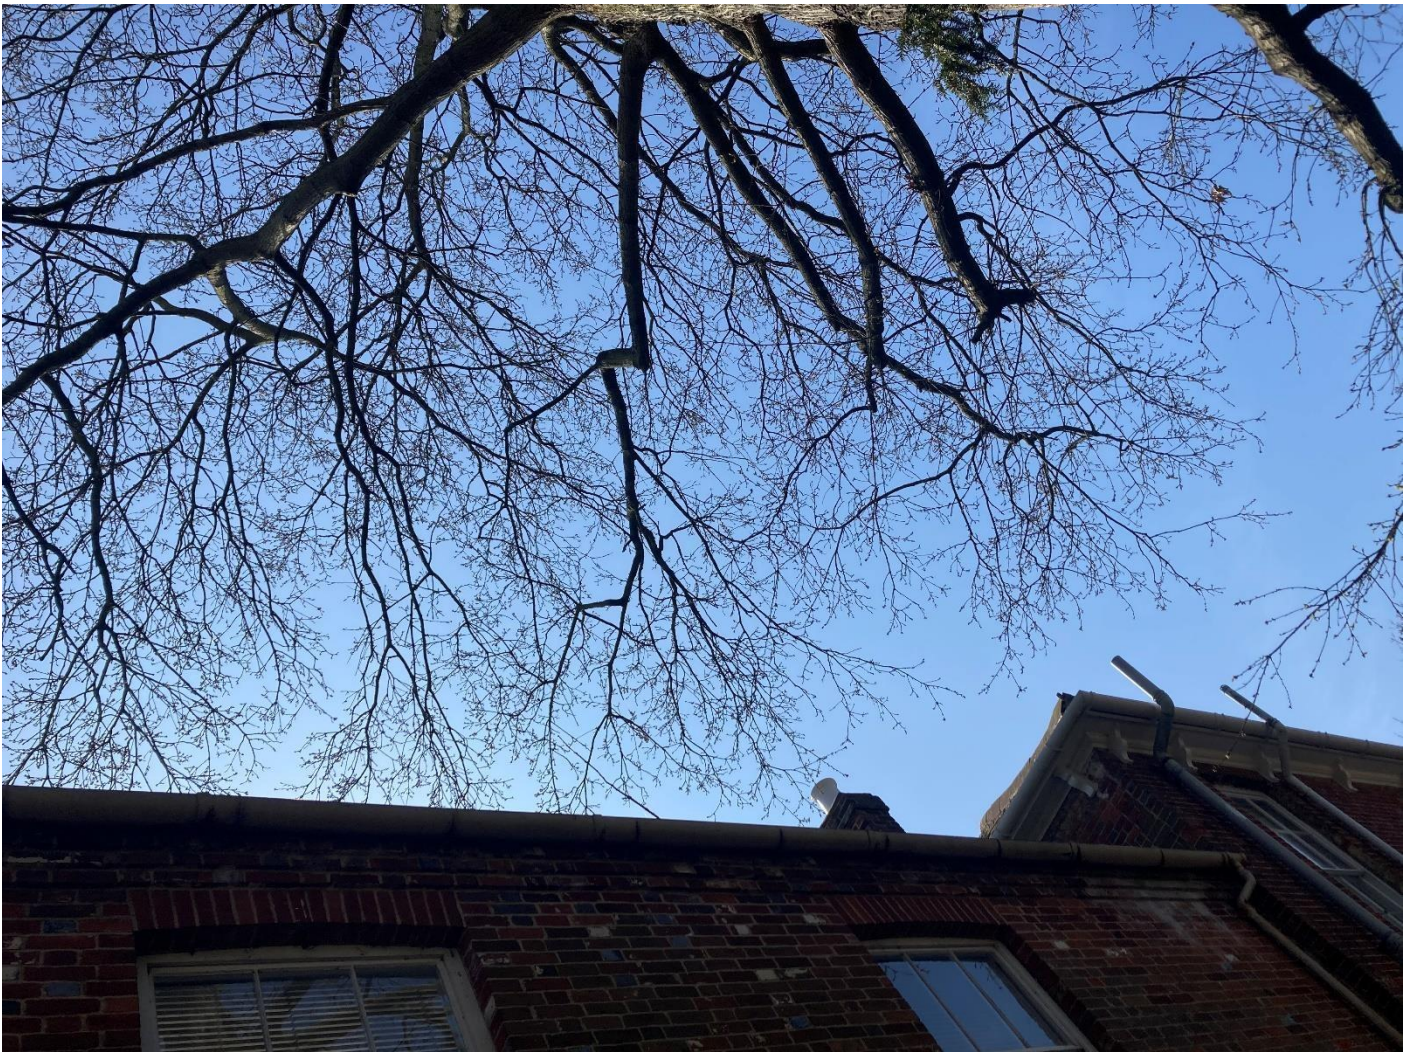
SAL5 T7 with canopy over adjacent dwelling and prior tip reduction works with regrowth.

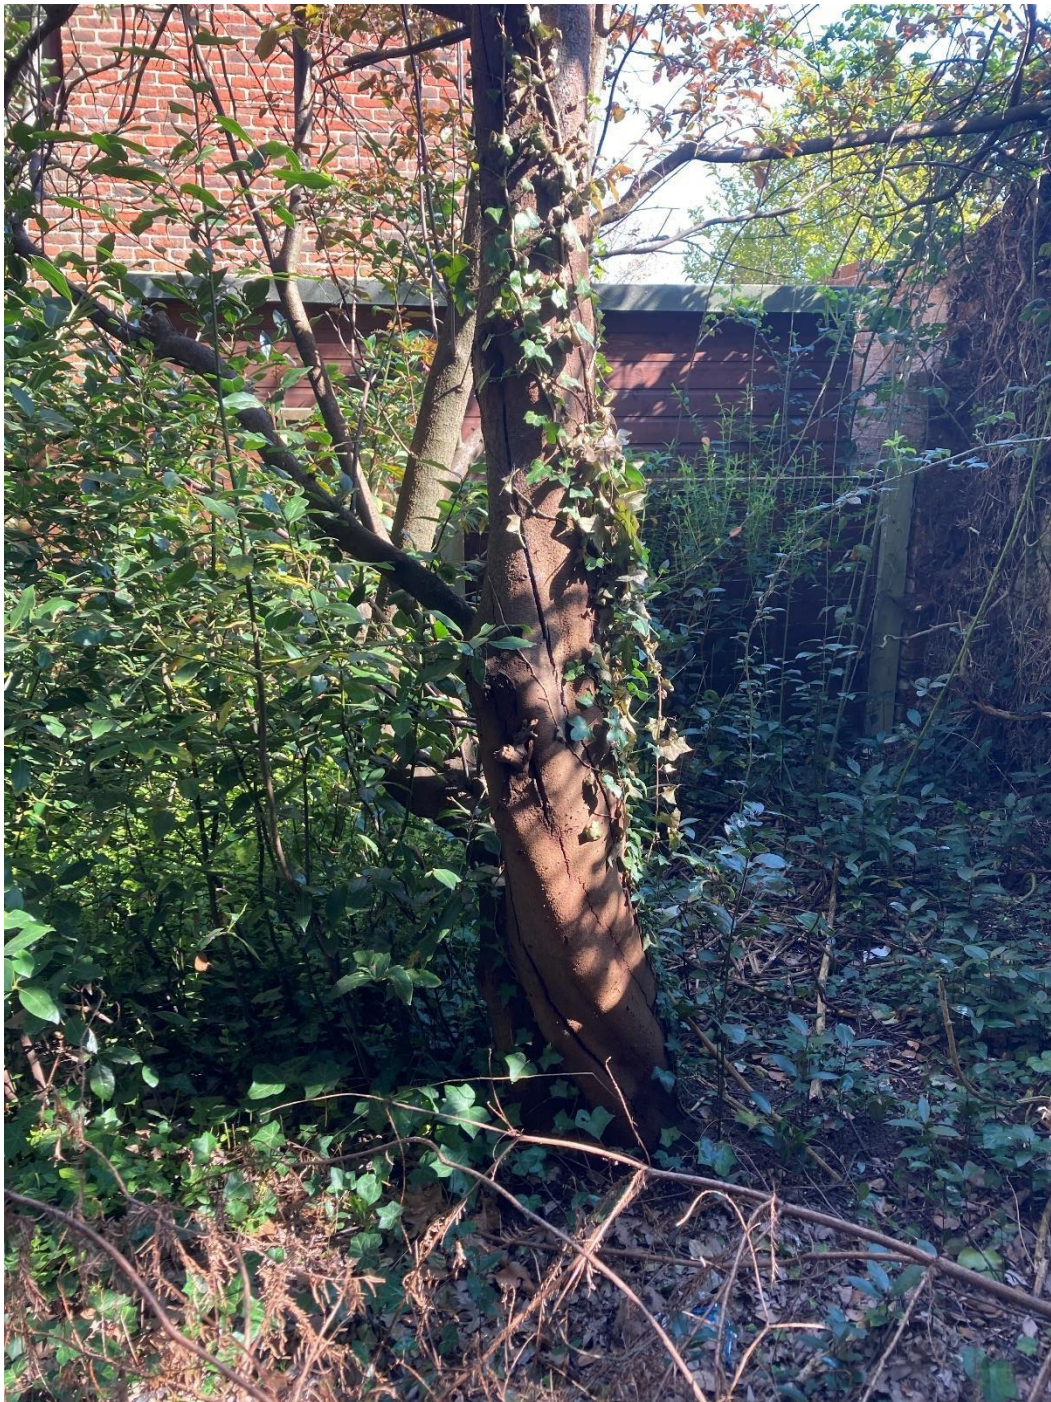
| Designation | Reference number | Species | Height (m) | Age class | Physiological condition | Structural condition | Condition notes | Condition related tree works | Priority |
|---|---|---|---|---|---|---|---|---|---|
| T | 9 | Purple plum<br><i>Prunus cerasifera purpurea</i> | 4 | Mature | Poor | Poor | Half of the canopy dead. Helical crack from base to 3 m. | Remove. Treat stump to prevent regrowth. | Low |

SAL6 T9 with helical crack on lower stem.

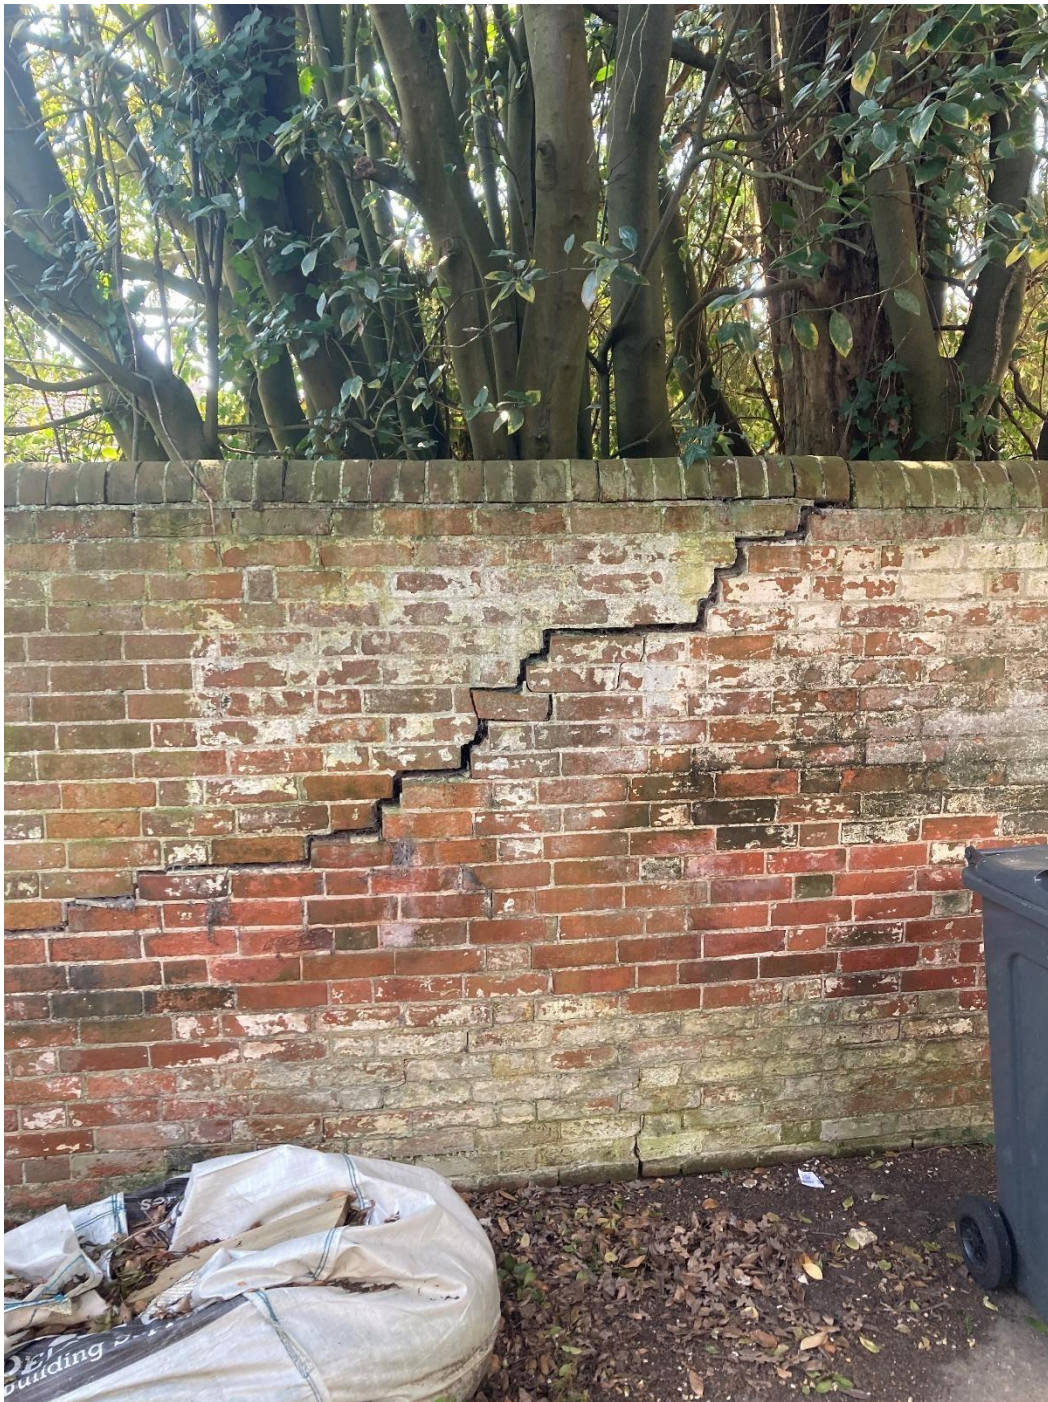
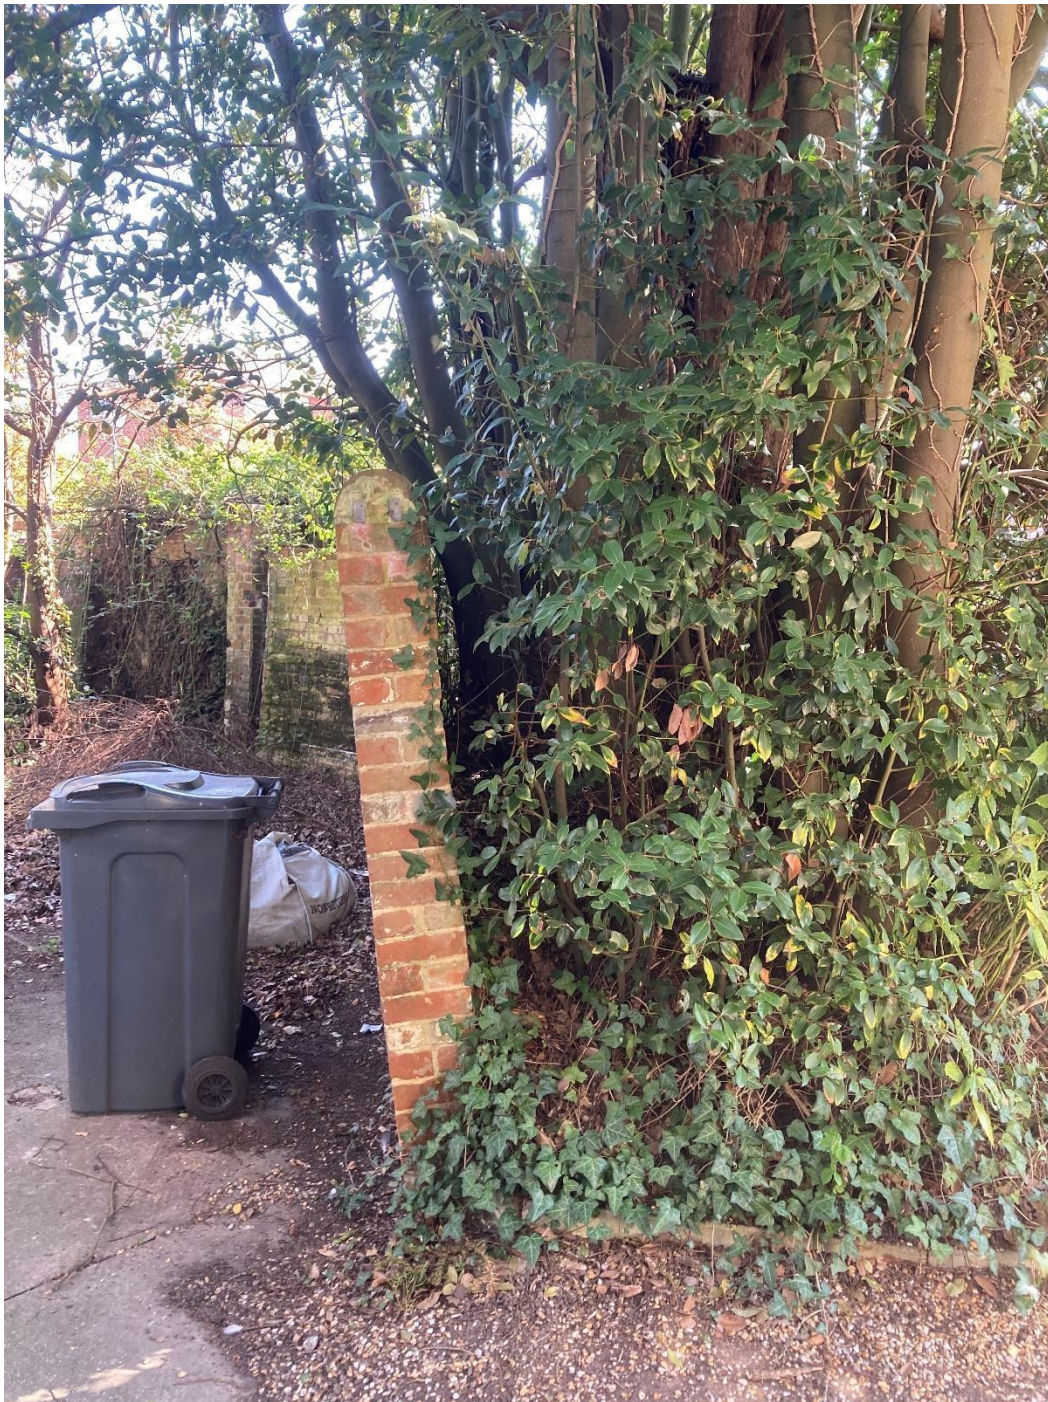
| Designation | Reference number | Species | Height (m) | Age class | Physiological condition | Structural condition | Condition notes | Condition related tree works | Priority |
|---|---|---|---|---|---|---|---|---|---|
| G | 10 | Bay Laurel <i>Laurus nobilis</i> | 10 | Mature | Good | Poor | Multiple stems around yew. Direct damage to adjacent wall. | Remove to prevent continuing damage to adjacent wall. Treat stump to prevent regrowth. | Low |
| G | 11 | Yew <i>Taxus baccata</i> | 10 | Mature | Good | Fair | Multiple stems from 3 m. Direct damage to adjacent wall. | Crown reduce by 5 m to leave 5 m, crown lift to 3 m and clear building by 2 m to prevent continued damage to adjacent wall. | Low |

SAL7 Direct damage to adjacent wall from G10 and potentially G11.

SAL8 Direct damage to adjacent wall from G10 and potentially G11.
