HAVERANT BOROUGH COUNCIL  
**Design, Access and Heritage Statement**

## Introduction

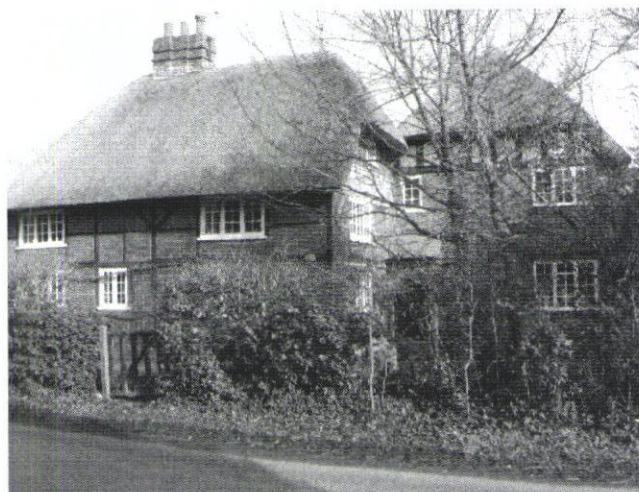
Fig 1: View from St Peters Road

Meadowsweet comprises two separate buildings, joined together at one corner for internal access. The older cottage shown on the left in Fig 1, is located adjacent to St Peters Road and is believed to date from AD 1530. The newer 'added-on' cottage on the right in Fig. 1 is partly constructed in a 'Mock Tudor' style; it is located adjacent to Clovelly Road and dates from AD1920. This application concerns changes to the older cottage, (i) renovation of the southern and western elevations and (ii) installation of stainless steel liners inside the chimney stacks.

There are three chimney channels in the older cottage, see Fig 1. The central pipe serves a now unused fireplace in a first floor bedroom/study. The two remaining pipes connect to large A-shaped chimneys which were built to function with large open log fires in both ground-floor lounges. At present modern closed wood-burning stoves are in use, connected to the chimneys via pipes and closure plates. For safety and to satisfy current regulations we wish to have these chimneys lined using 7" diameter twin wall rigid insulated stainless tubes. These pipes will be suspended from a closure plate at the top of the chimney and will be supported approximately three meters from floor level by a bracket fixed to the inside wall of the chimney. A fire safety certificate is to be issued on completion of the work. Permission for the installation of chimney liners in Meadowsweet was already granted by HBC Building Control; please refer to plan number 05/4622/BN.

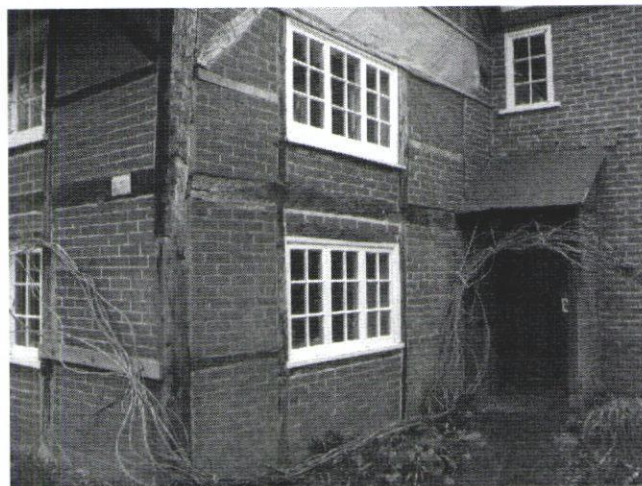
Fig 2: SW Elevations

The wall shown in Fig 2 is in presently in a very precarious state, with some loose brickwork panels in danger of falling outwards, potentially endangering people who pass below. The oak frame has lost its structural integrity, due to serious decay and attack by wood-boring beetles. Both horizontal tie beams are badly affected by this, and have become dis-jointed from the upright corner post. Many of the smaller beams are not keyed into the surrounding wood frame, thus further destabilising the wall and its individual masonry panels. The lower part of the vertical corner post was replaced using soft wood some time ago, and the resulting joint between these sections has caused the corner to buckle outwards; see Fig 2. In turn, this movement has caused the lower two brick panels on the west-facing corner wall to buckle inwards.

The faulty wall has been carefully investigated by several experts in the field with a view to renovating the wall with a minimum of disturbance to the structure and materials involved. Following a general survey, concern was raised about the southern gable end of the older part of Meadowsweet cottage; see Ref. 1 below. Some time later, the condition of the existing wooden frame was assessed by a micro-drilling survey; see Ref. 2. The results of this suggested that a complete replacement of the wall might be a necessity; see Ref. 3. Fortunately a further more detailed investigation showed that it is still be possible to renovate the wall without completely dismantling it, see Ref. 4. By careful consideration and paying attention to detail, only those parts which have ceased to be functional should be removed and then replaced using materials which are compatible with the original fabric of the wall. This should minimise the impact on the ancient features and general appearance of the wall, whilst still securing its strength and durability. Findings and recommendations are enclosed with this application:

We would like to accept the plan of work proposed by Mr Andrew Holloway in 3. above. These recommendations result from a further study undertaken jointly by Mr Holloway and Mr Nigel Challis of Andrew Waring Associates. Mr Challis is happy to monitor and advise on the engineering aspects of the work and to issue an 'Engineers Letter of Adequacy' on completion of the works.

We also wish to replace the 2 windows in the southern wall which have deteriorated beyond economical repair. The installation of chimney linings should take place concurrently with the work on the wall. Relevant engineering drawings for the work on the wall are enclosed; see pages MC 26-28.
