## Verification Report

002

GMI - Fulford Road

Gas membrane to specification BS8485 2015

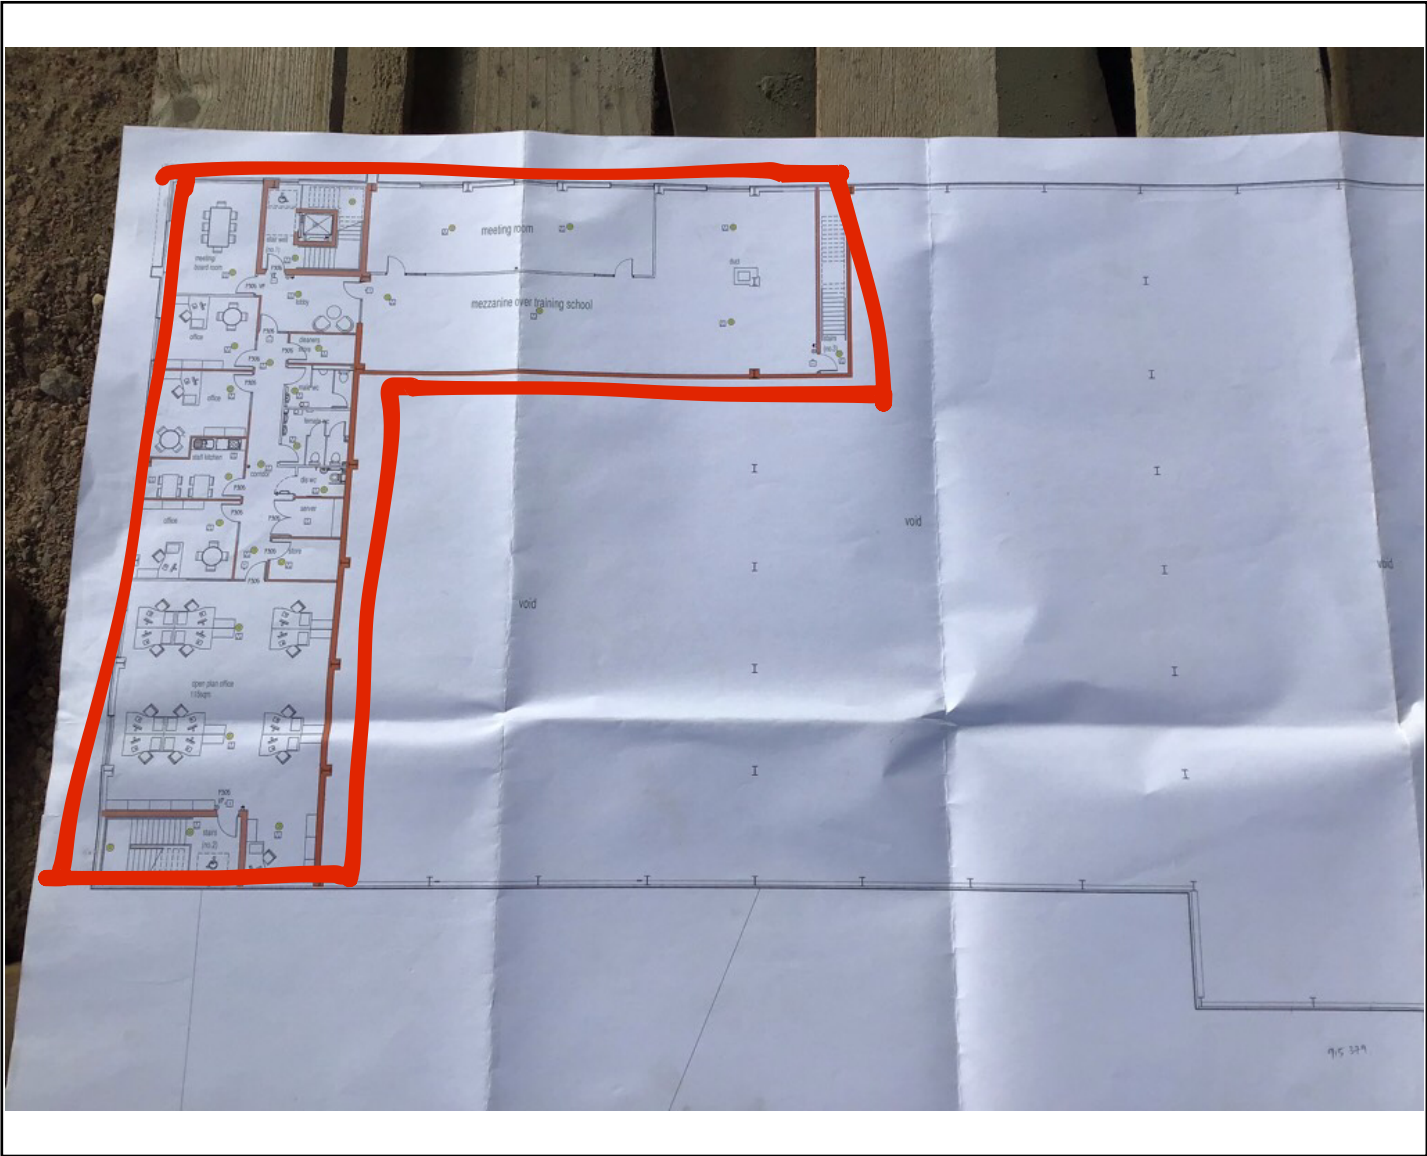
Pour 1 highlighted above

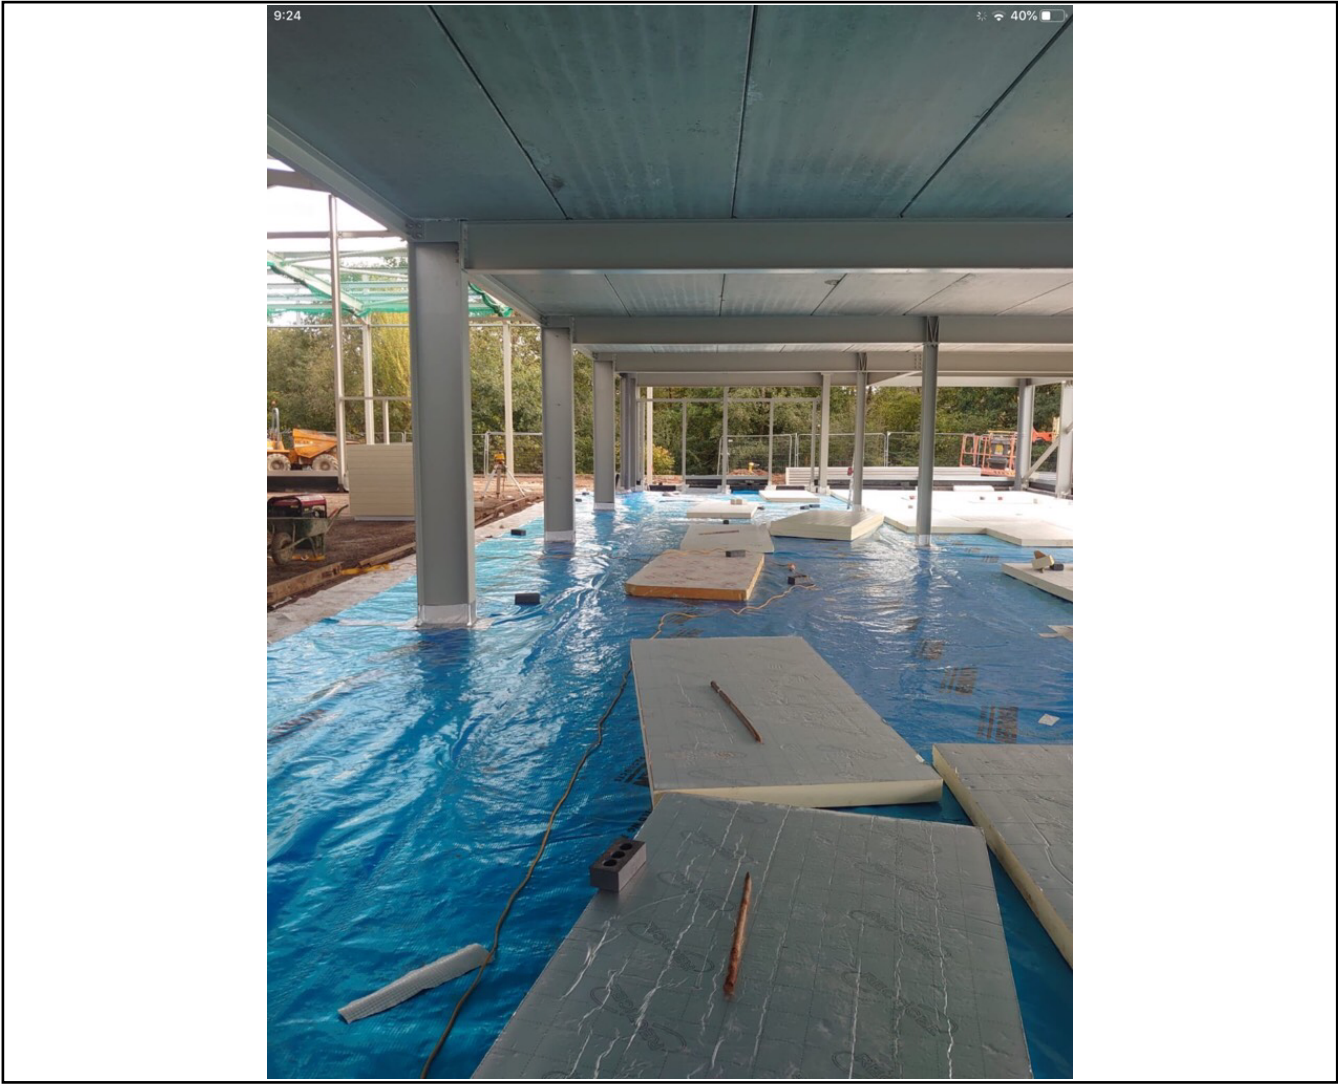
Overview of Pour 1

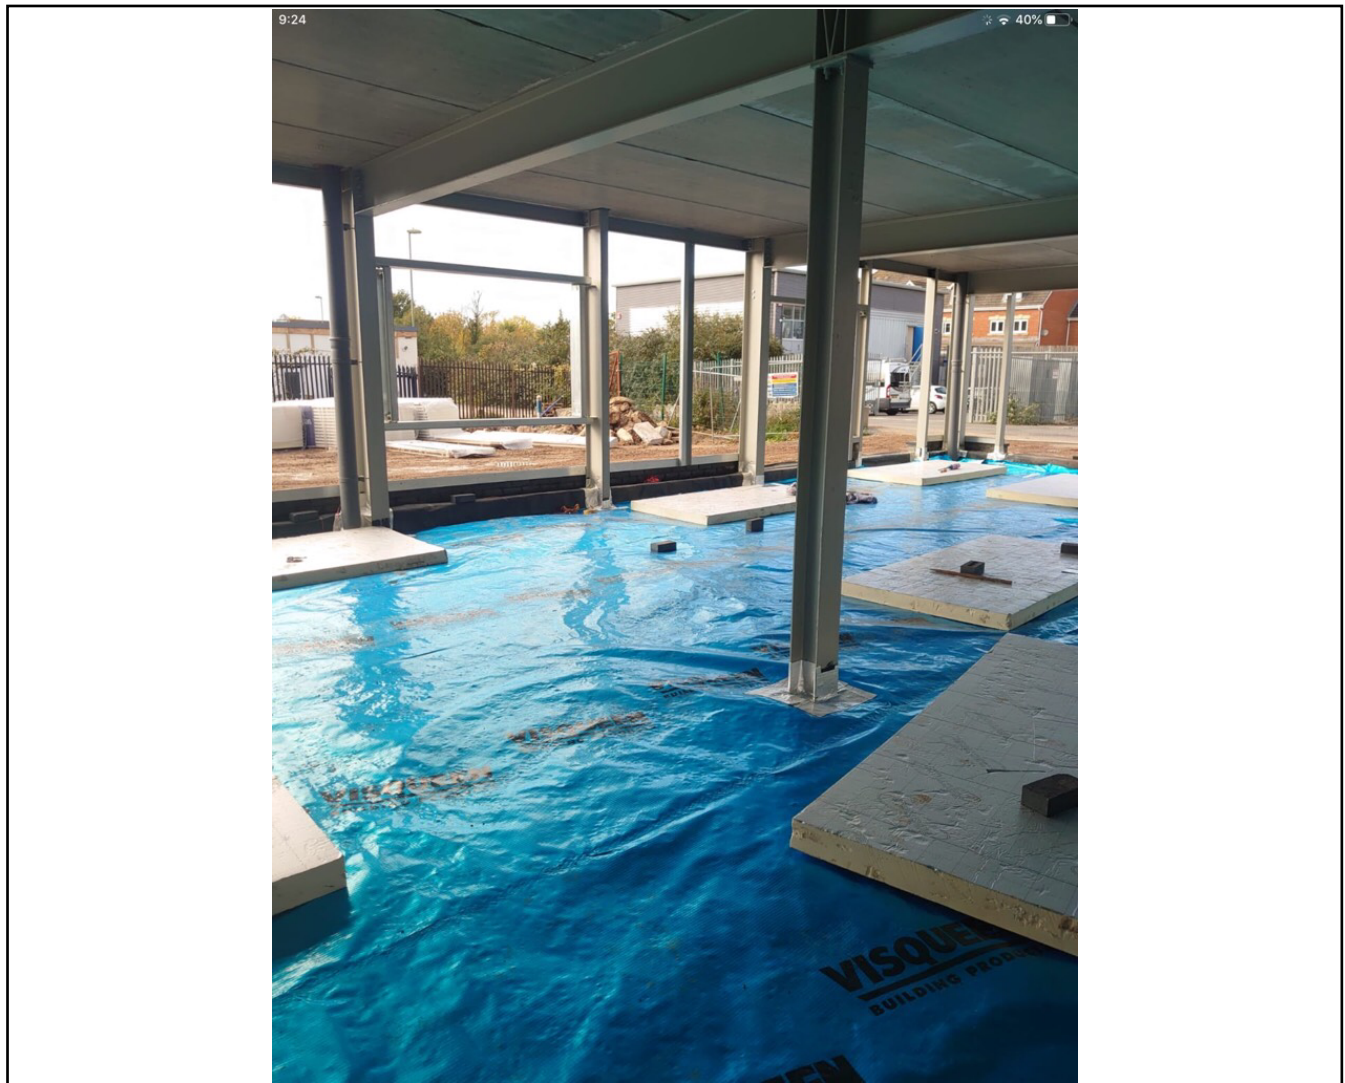
Overview of Pour 1

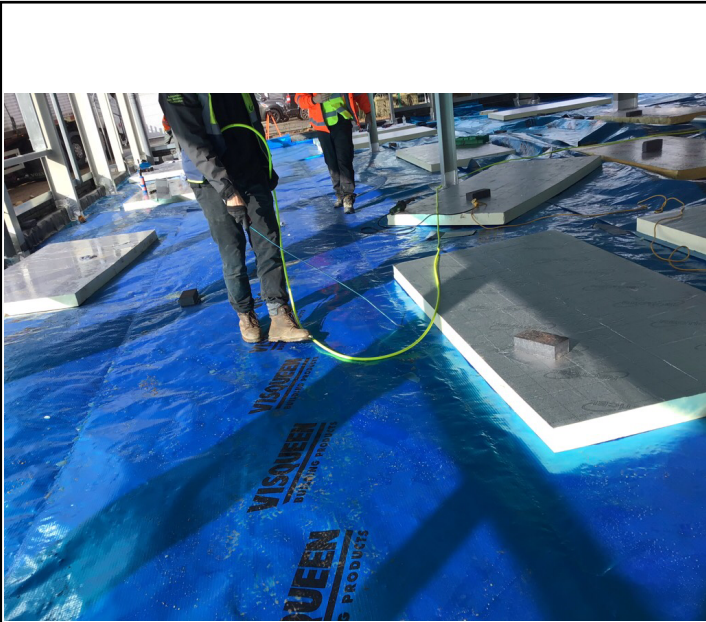
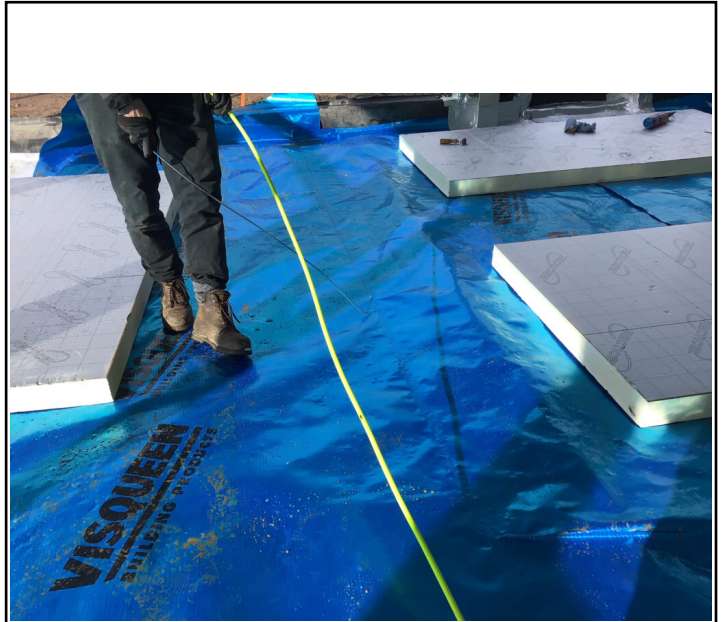
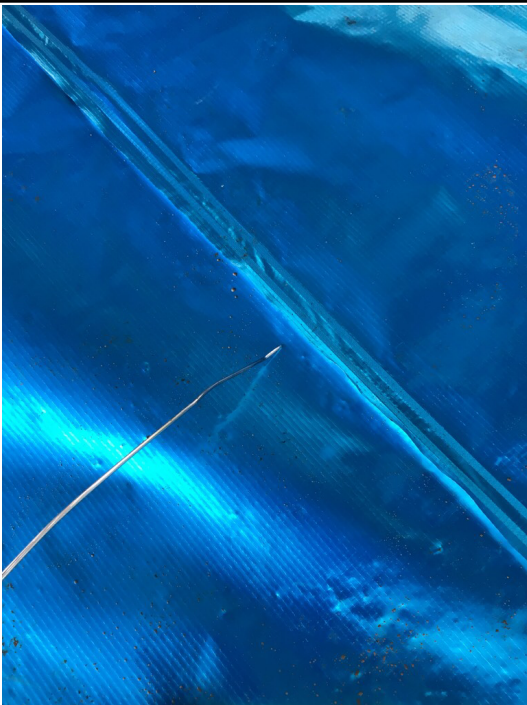
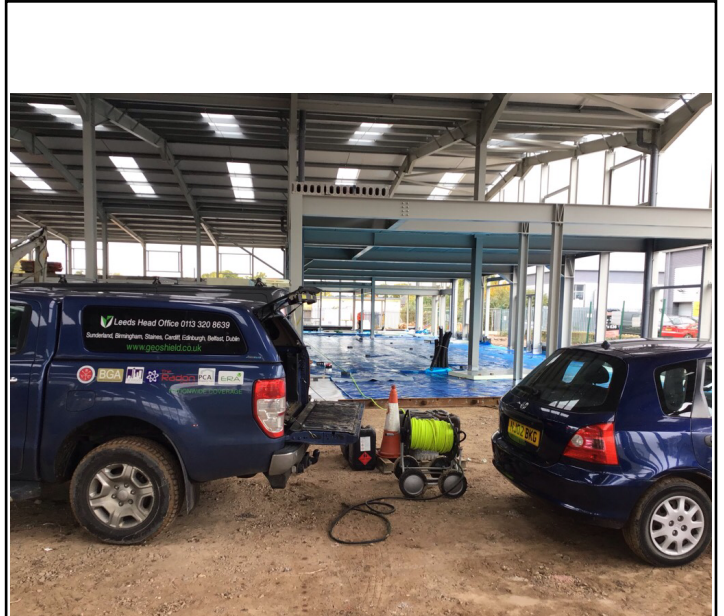
## AIR LANCE INTEGRITY TESTING

**AIR LANCE TEST: ASTM D4437-08:2013** Inspects all seams for unbonded areas using a 4.8mm air nozzle held not more than 51mm away from the seam. 50 Psi is the minimum requirement. The air nozzle is directed on the upper edge seam, ripples indicate a unbonded seam. Each seam is numbered and failure marked with a F/1 F/2 classification and a description given

| TEST NUMBER: | FAILED OR PASSED | DETAIL, COMMENT AND RECOMMENDATIONS |
|---|---|---|
| All Joints | Passed | No faults found |
