**BS5837 2012**

**TREE REPORT**

**15 Hallett Road  
Emsworth**

**September 2016**

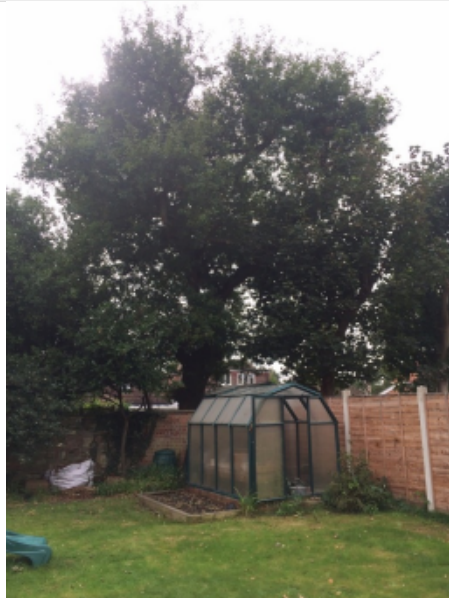
Oak Tree T1

- **Tree T1:** This is a 7 to 8m tall mature oak situated within the neighbouring rear garden behind a well-built brick garden wall. It's in good condition with good vitality. No significant defects were noted.

- It has stem diameter of 550mm giving a standard circular root protection area (RPA) radius of 6.6m / 162m<sup>2</sup>. The average crown spread (N/ S/ E/ W) is 3m respectively.

- Future growth is expected to be relatively moderate and based on its position in relation to the new buildings future shading and dominance will not be considered significant. The tree has been reduced previously to control size.

- It has a moderately high potential to contribute to amenity and has been assessed as a category B tree within BS5837 2012.
- Based upon the tree's position and adjacent wall structure it is estimated that the root zone of this oak would most likely be non-circular and will be asymmetric in shape and contained mostly in the garden it stands in. However, the tree plan is shown with a circular RPA.

- Barriers to define an exclusion zone surrounding this tree shall be used and should be placed to protect the RPA of T1 and the approximate location for tree protection barriers is shown on the tree protection plan below. Barriers shall be maintained for the duration of the build.

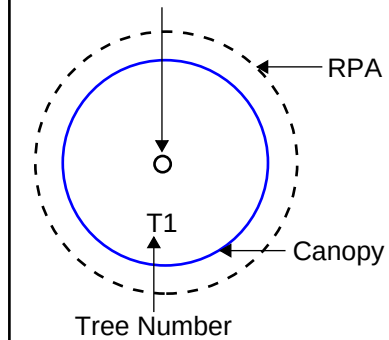
Drawing: Tree Plan

- Based upon the proposed new dwelling footprint plans it will stand within 6m of the south-west corner of the build.
- On this site it will be necessary to work within the RPA of T1.

- The encroachment within T1 RPA will be to enable the construction of the SW corner foundations and patio and importantly the

encroachment will equate to less than 10% of a circular RPA. **The impact is rated low.** Please see below;

13m<sup>2</sup> out of  
162m<sup>2</sup>  
affected-  
<10% of  
circular RPA.  
Low impact
