# GEOSHIELD Verification Report

New Warehouse Building

Land adjacent Fulflood Road

AREA SURVEYED: Installation to - Pour 2.

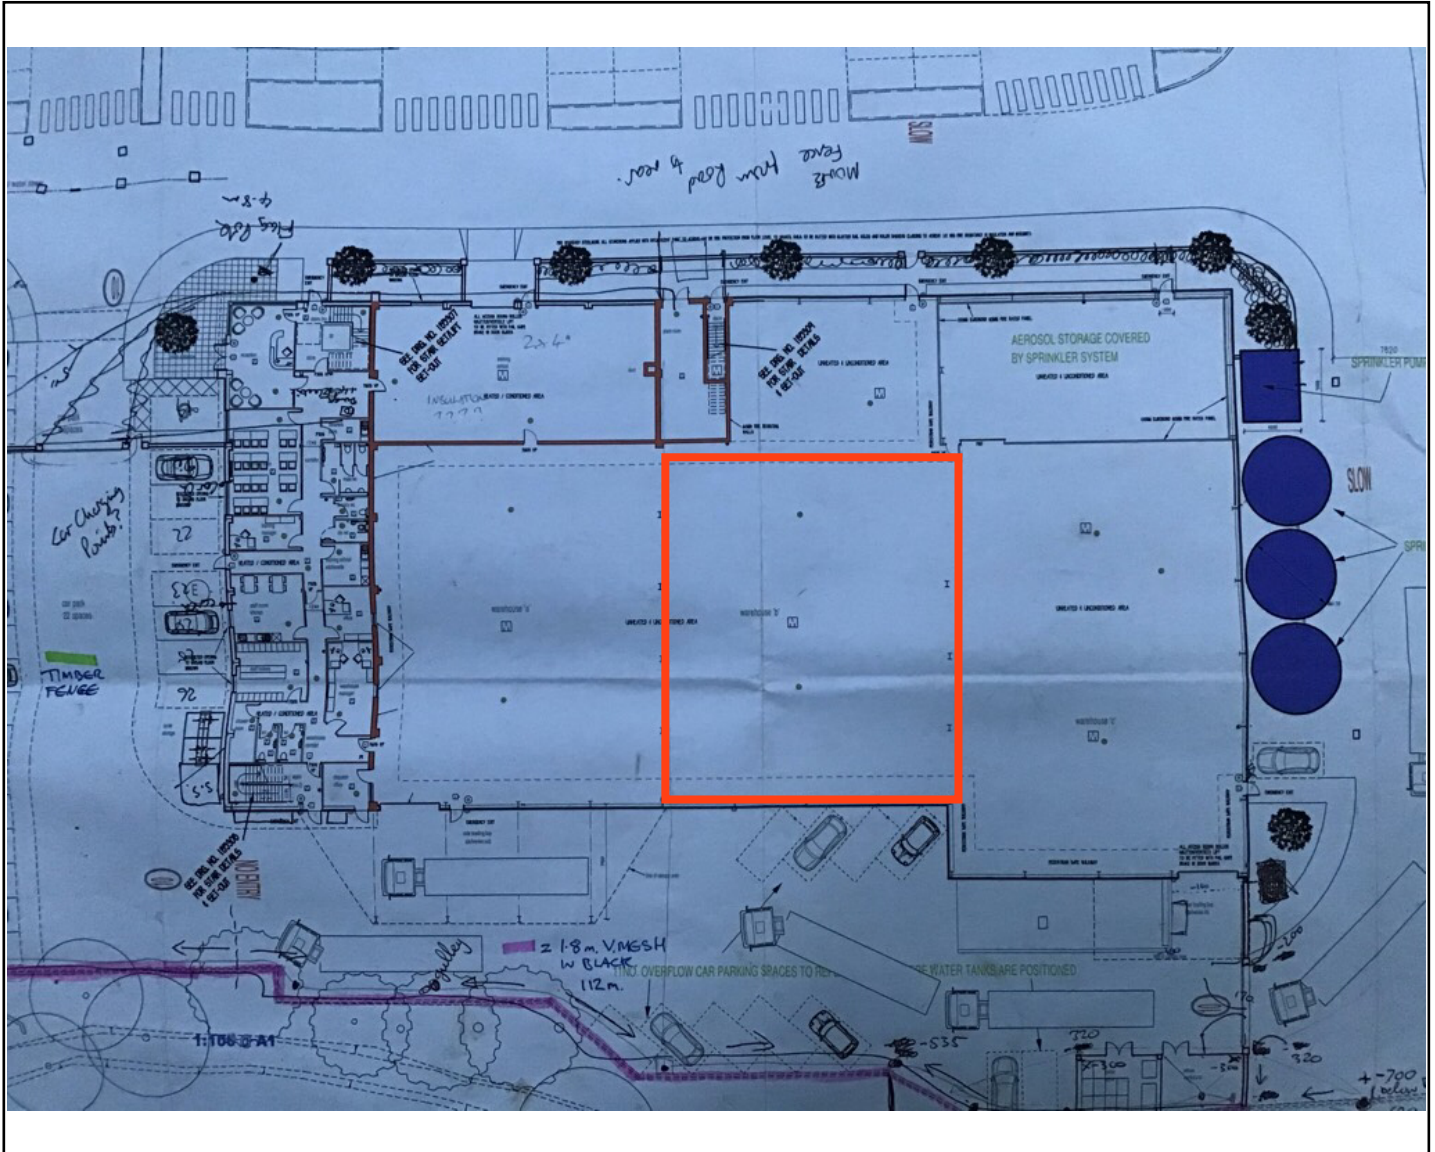
The above photo shows the highlighted area to Block A & D where

verification took place.

Installation to Pour 3 of building.

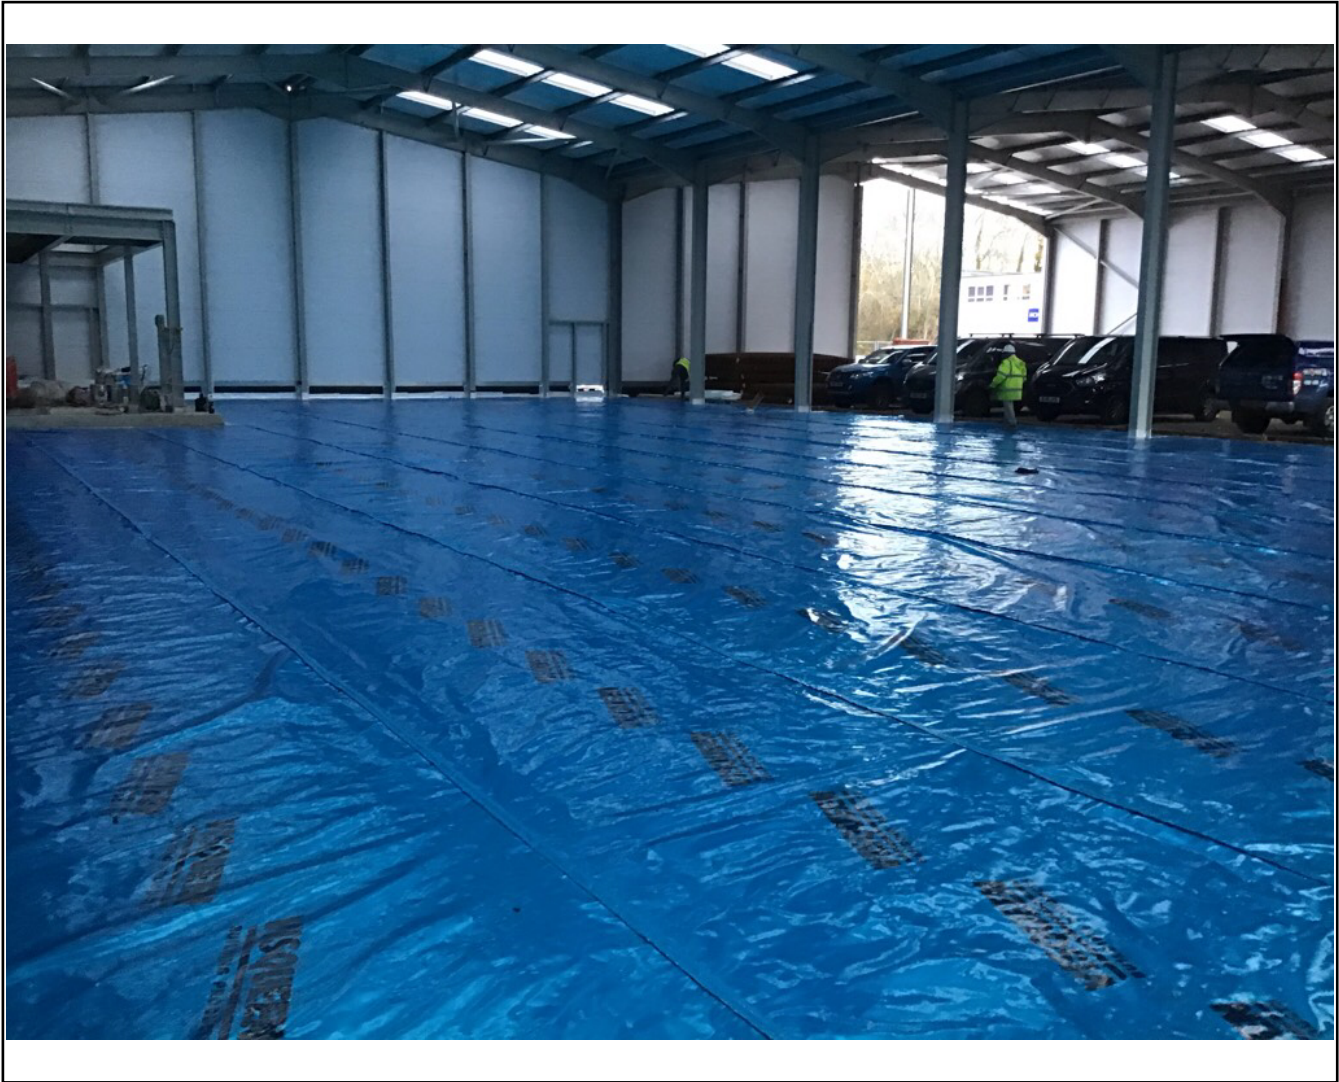
Overview photograph showing installation completed to Pour 3.

Visqueen standard gas barrier installed.

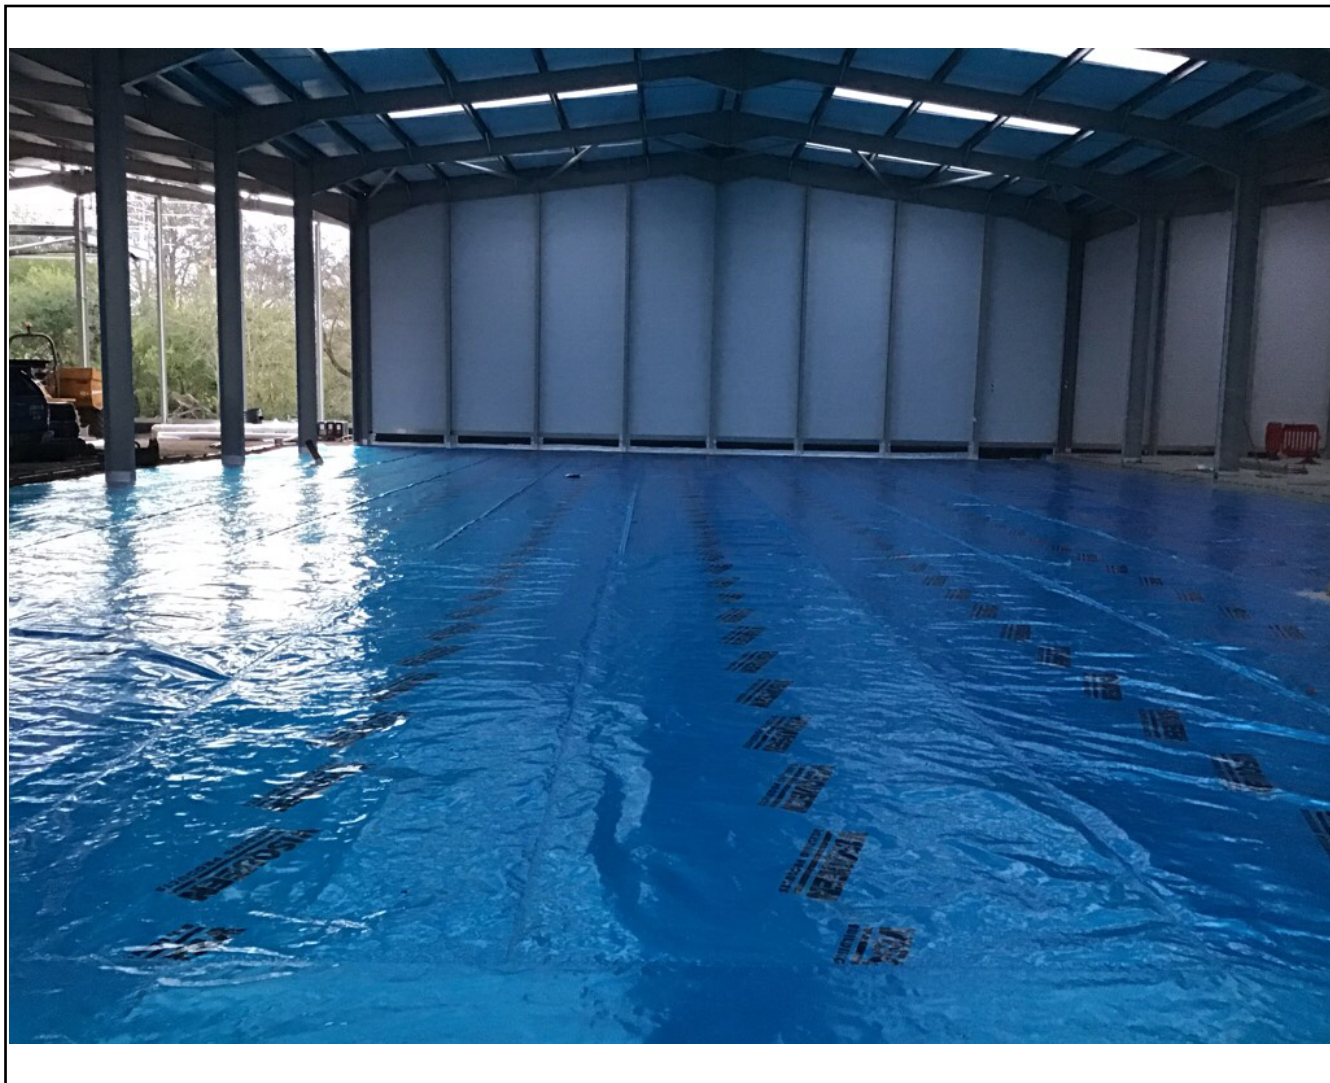
Alternative overview photograph showing general installation to Pour 3.

Visqueen standard gas barrier installed.

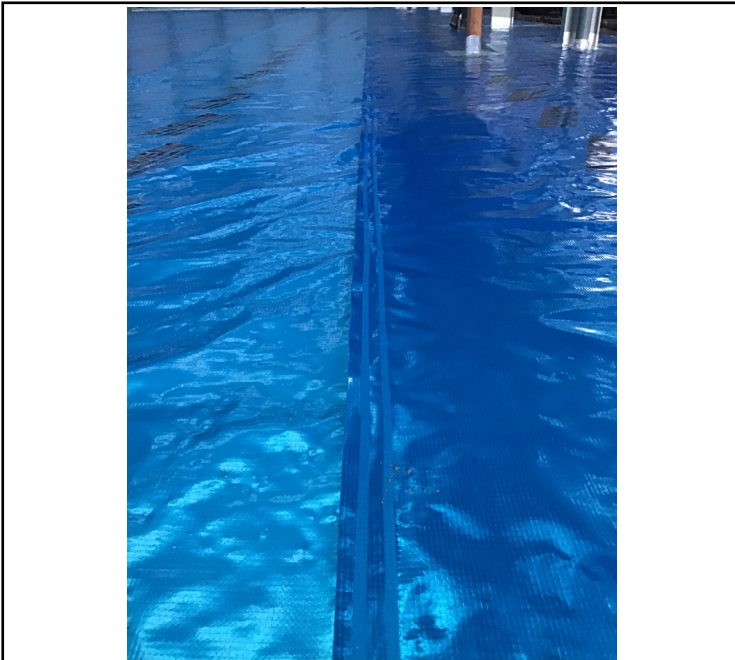
NOTES: Welded lap joints.

Picture one: is an over view photo looking down a welded sealed joint, this installers has completed this by sealing with the twinny welder, a good strong seal has been achieved.

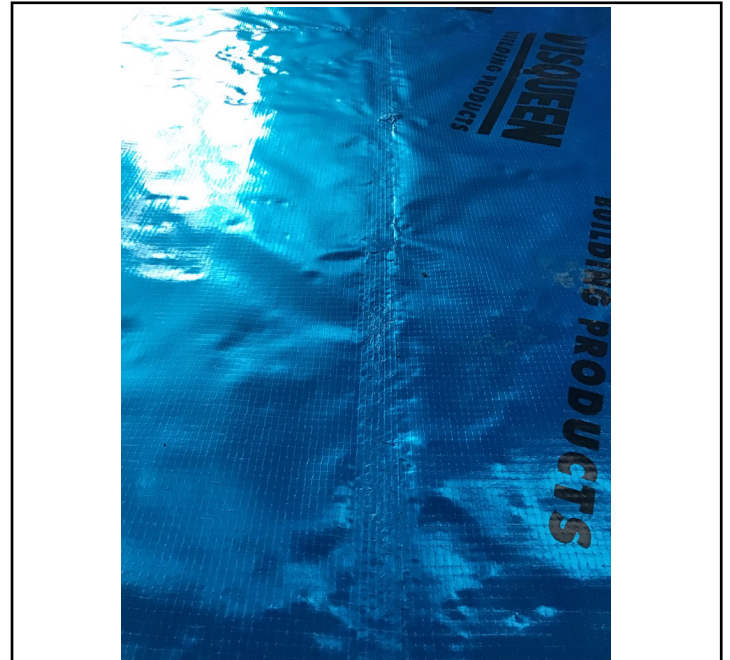
Picture two: is another overview photo but the installers have hand welded the lap joint with the leister gun.

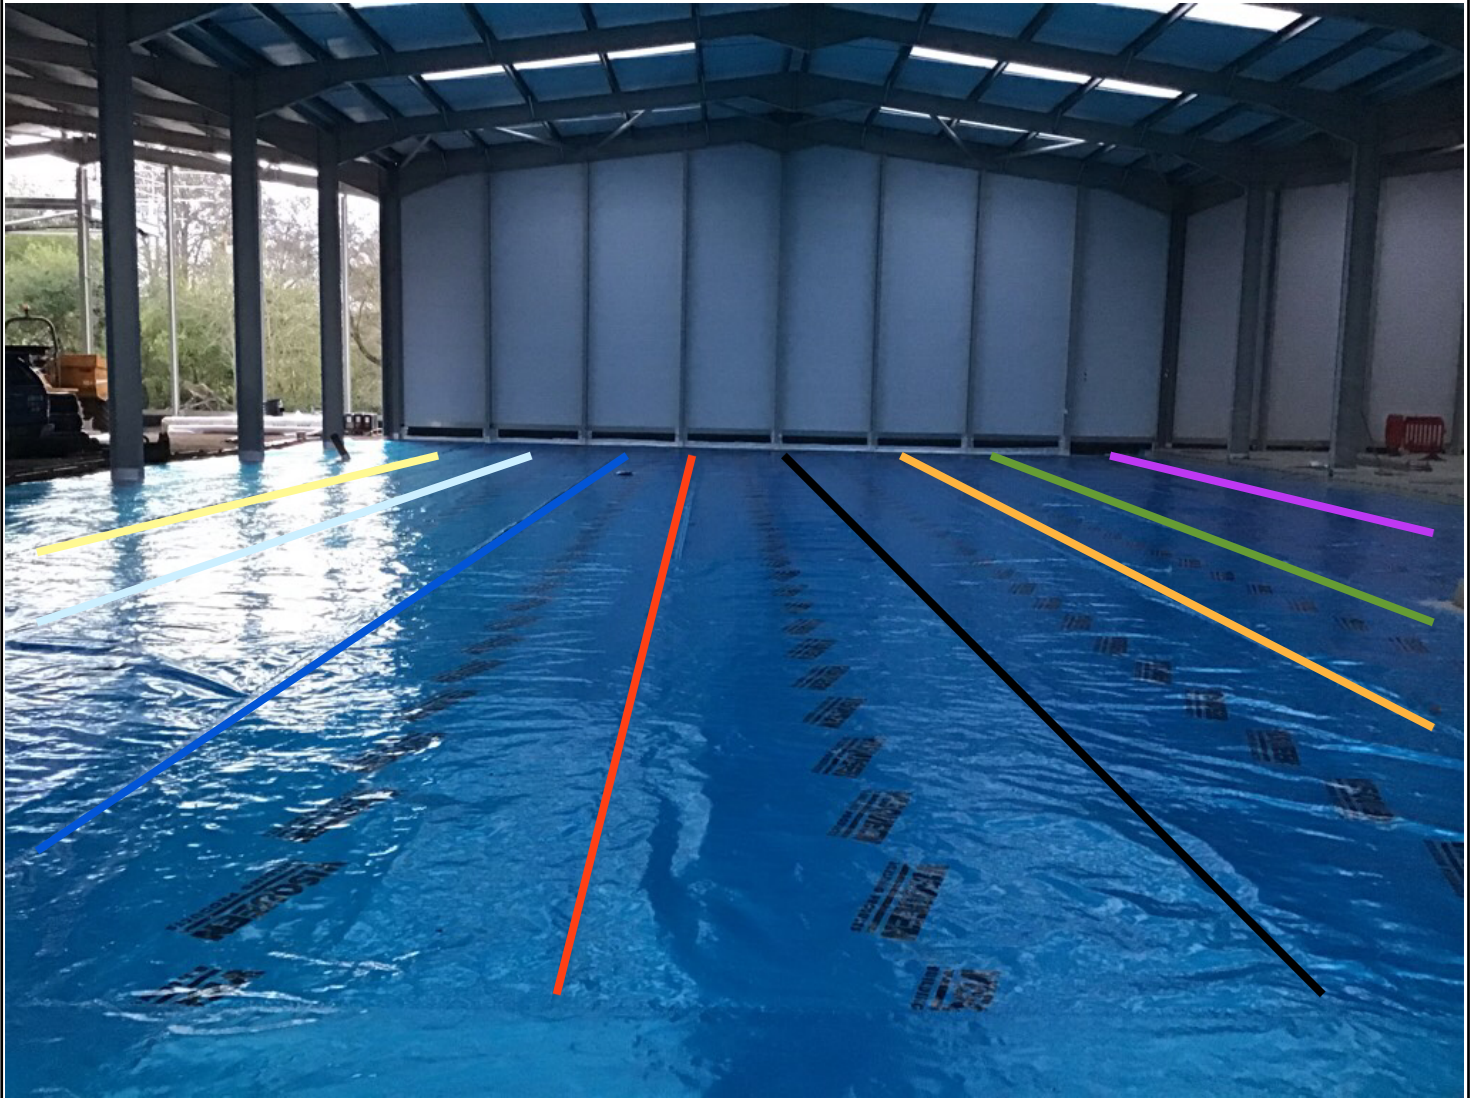
The above photo is demonstrating where pick probe and air lance testing was

carried out,, all areas have been verified in accordance with CIRIA 735 and

installed to BS8485 2019.

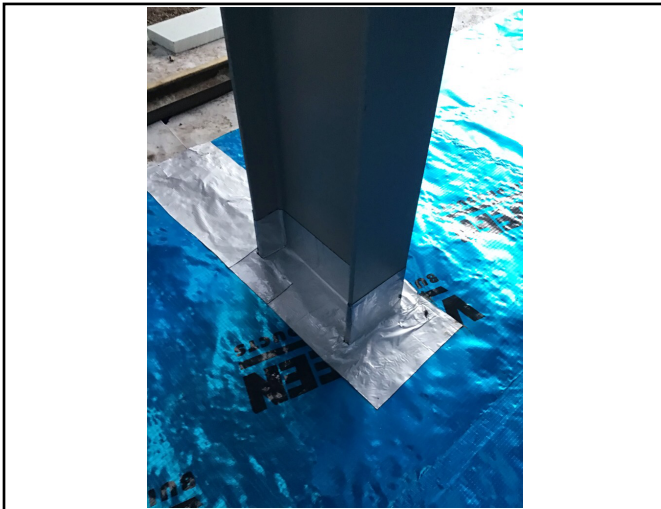
NOTES: Details sealed using Visqueen GRSAM

Picture one: is showing a completed steel stanchion detail, the installers have applied Visqueen HP Primer prior to the Visqueen GRSAM, All areas have tightly fitted meaning no voids have been created.

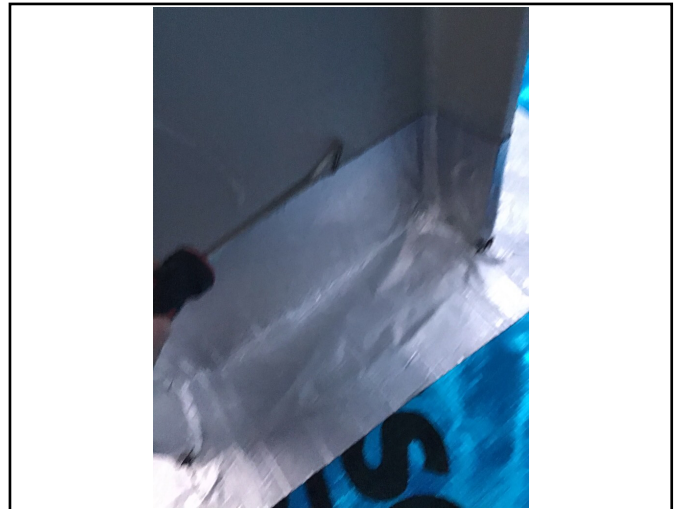
Picture two: is showing as well as air lance testing, pick probe

Testing was also carried out, no faults were detected during these

tests, all areas were heated down to gain a good bond.

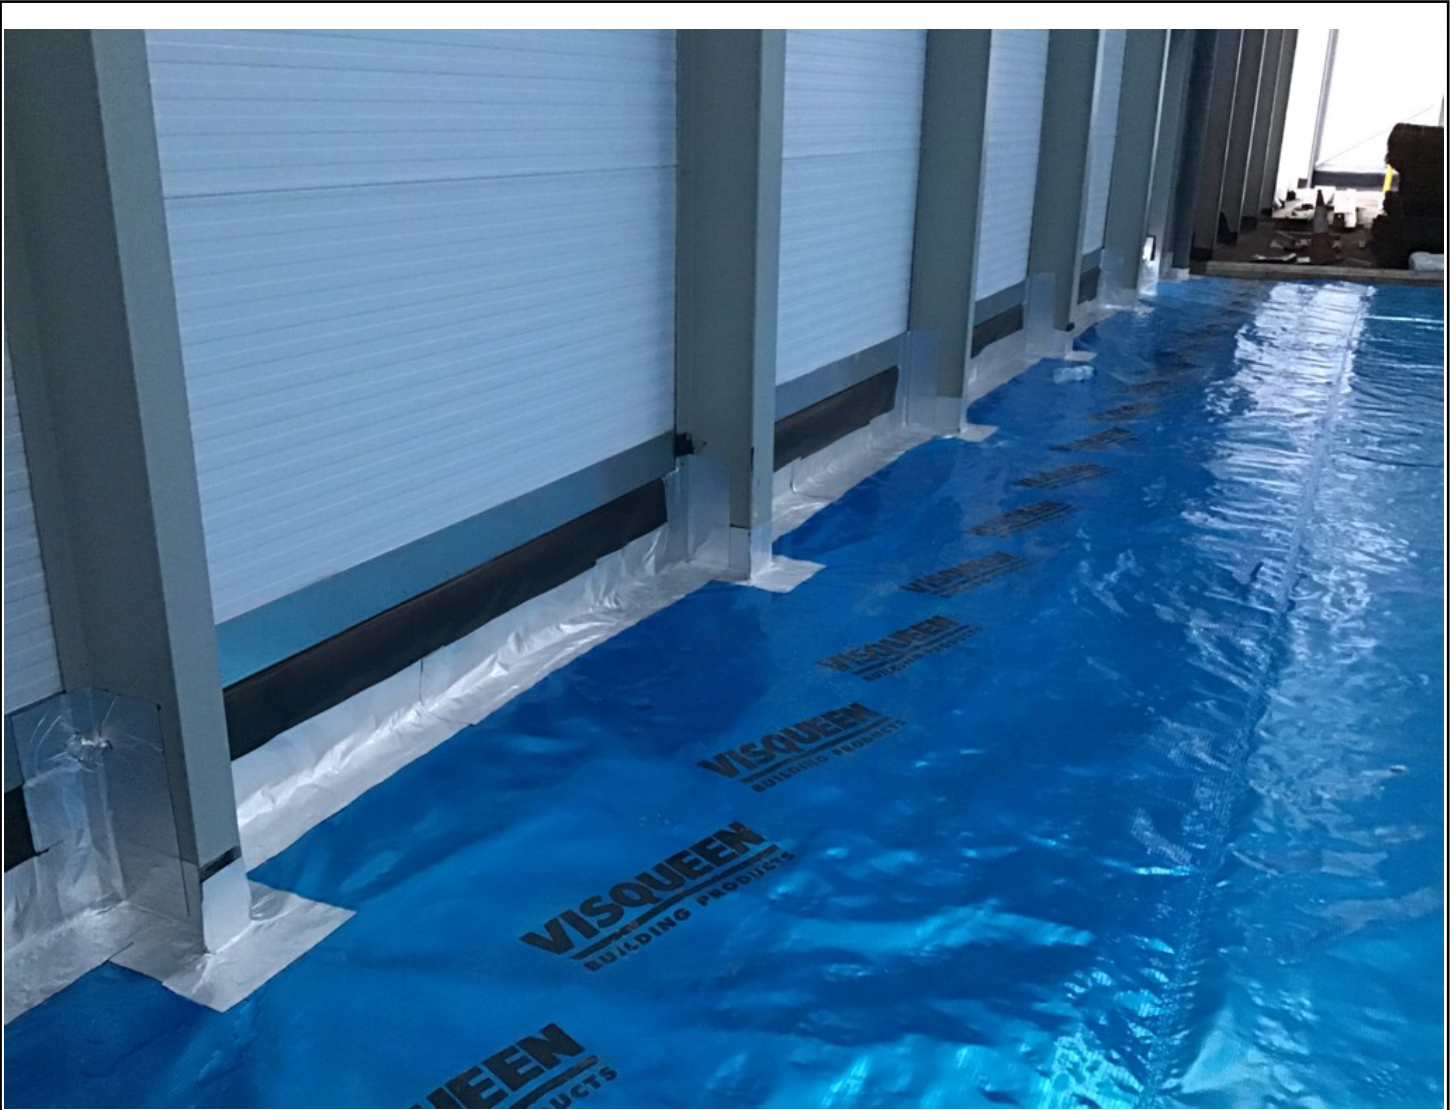
The photograph above shows the perimeter detail, as well as some steel columns

that have been sealed within pour 3. The Visqueen gas barrier has been welded to

the previously installed Visqueen gas resistant DPC membrane, along the perimeter

of the building. The steel columns have then been sealed using Visqueen GRSAM.

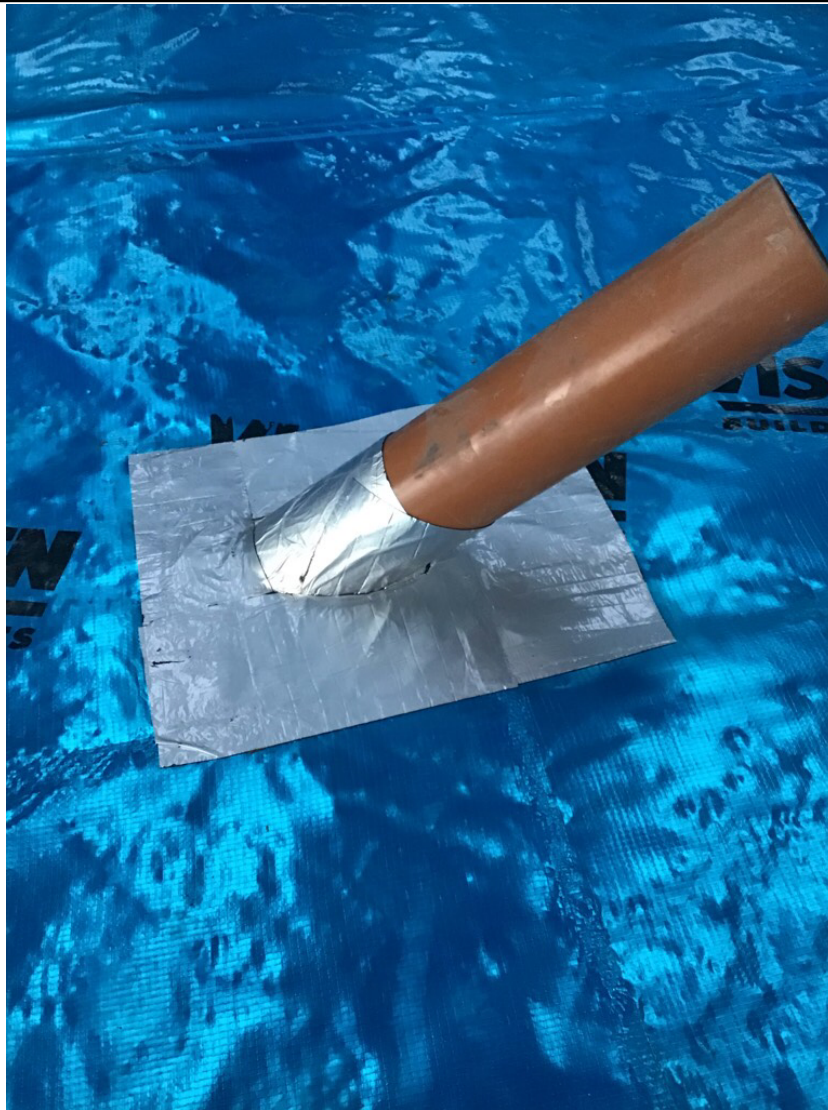
The above photo is showing a completed pipe penetration detail,

The installers have applied sections of tape around the neck and base of the detail to gain a gas tight seal, then finished with make shift top hat all completed

as per manufactures specification.

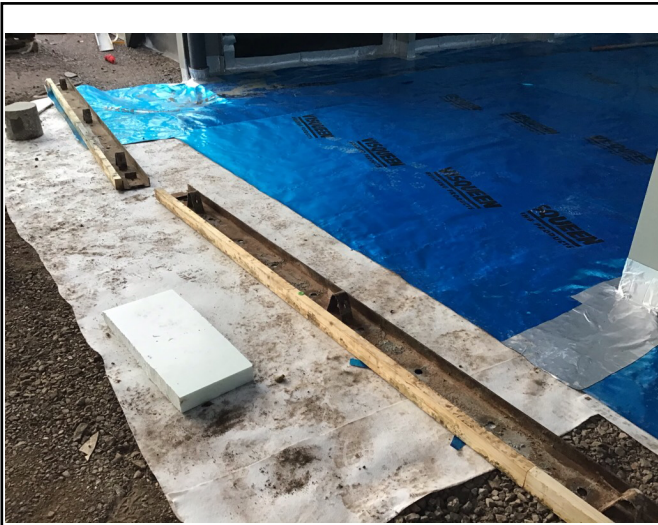
Protective fleece applied under the  
membrane.

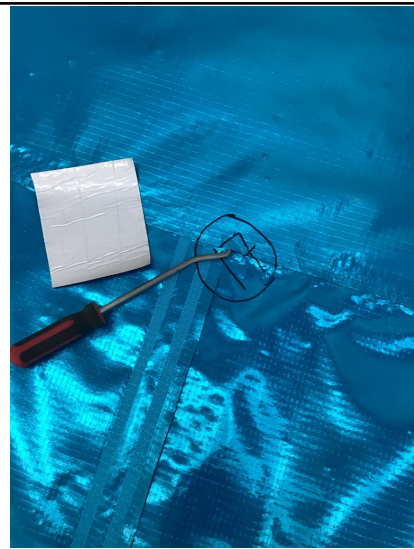
Fault found within the T-section  
of the membrane.

21 faults were detected, mainly where the membrane crossed (T-Section).

These were patched and retested.

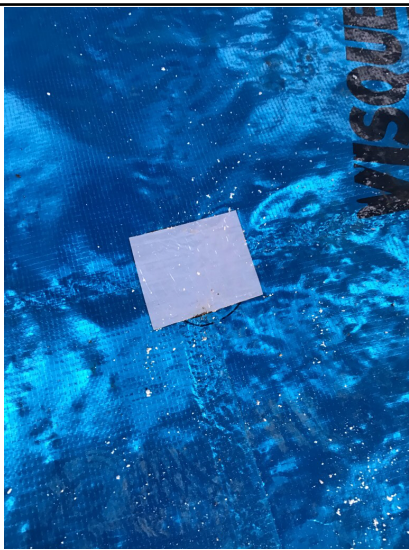
Patch work carried out to one of the  
fault areas.

All failed weld joints have been repaired during the visit, and re-verified to ensure sealed.

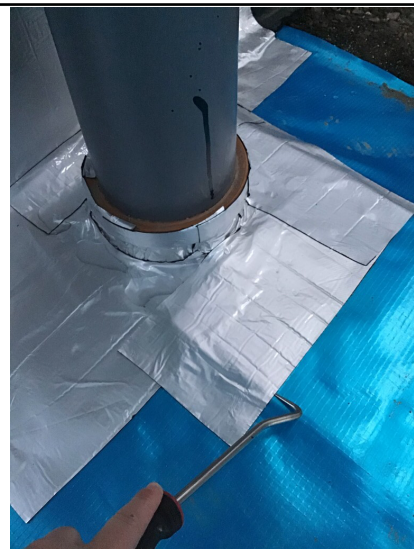
Pick probe testing carried out to a  
Pipe penetration detail.

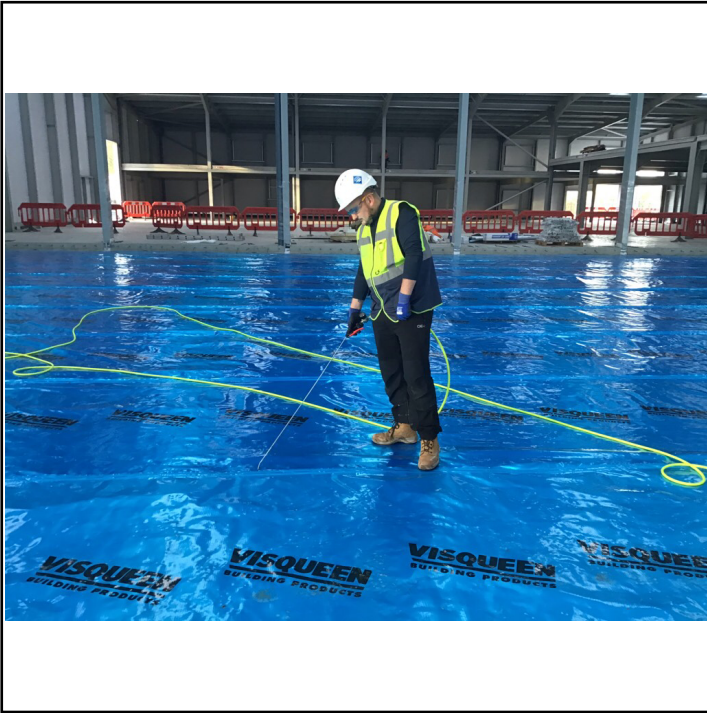
Air lance integrity test being carried out to welds.

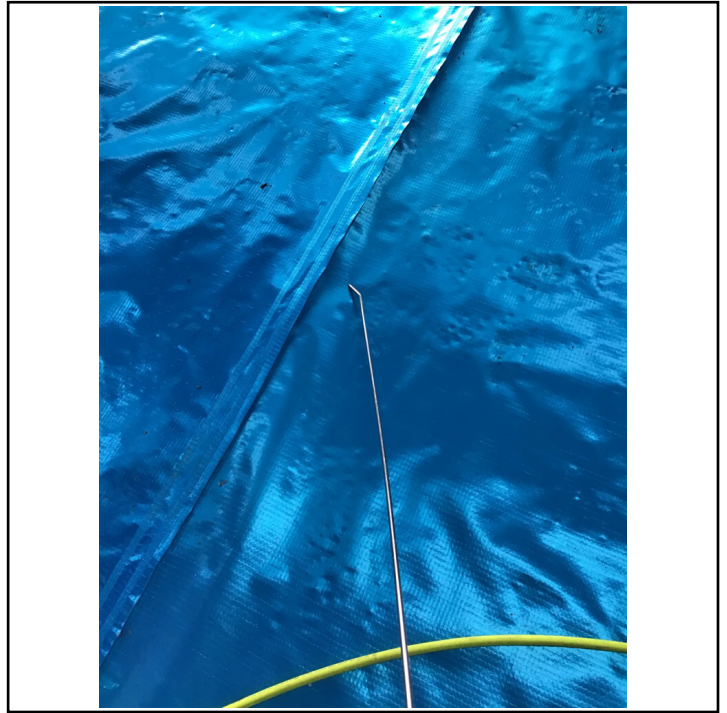
Air lance test again being carried out.

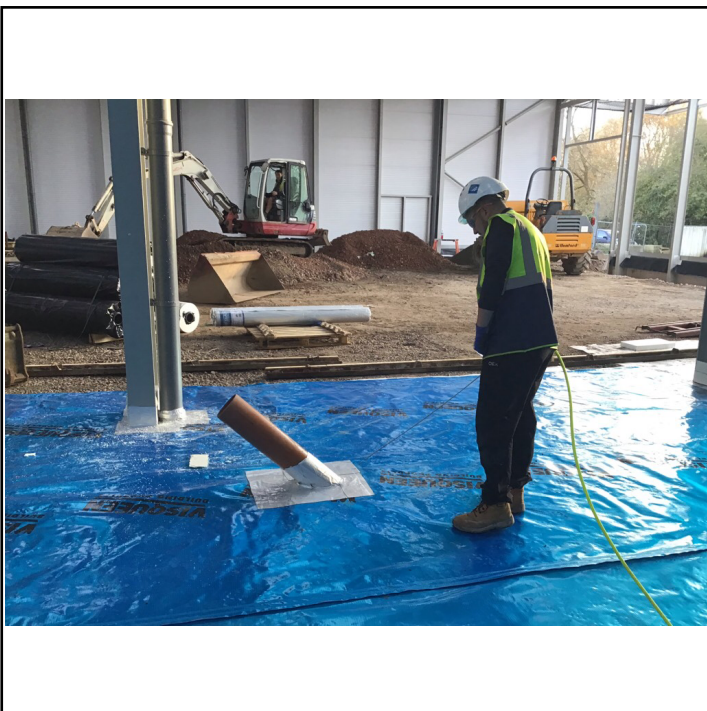
Air lance integrity test carried out to pipe detail.

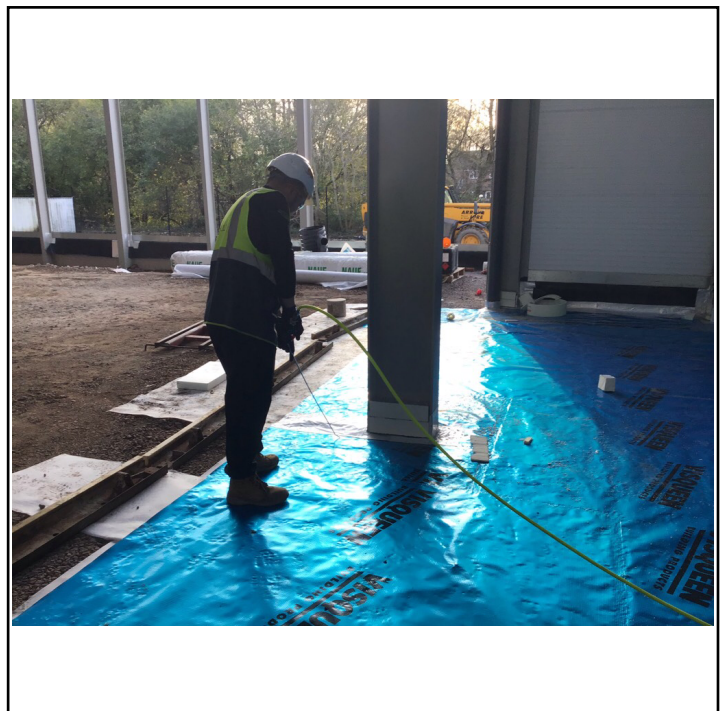
Air testing to steel stanchion.
