## **Updating Extended Phase 1**

### **Habitat Survey and PRA Field Notes**

Long Copse Lane PO10 7UL

Date: 20<sup>th</sup> May 2021

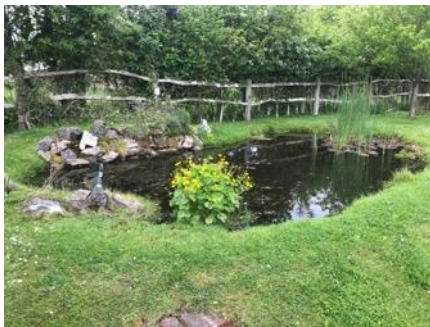
- An ornamental pond lined with rubber-type pond liner is present at the western boundary of the carpark area. It is surrounded by amenity lawn and ornamental shrubbery. The pond features minimal marginal and emergent plants and approximately 20% shade provided by the adjacent boundary hedgerow. This pond remains unchanged from the previous HSI assessment undertaken by Prime Environment in 2018, with a score of 0.60 – Average suitability for GCN.

**Photo 3: Ornamental pond located as the western boundary of The Old Dairy.**

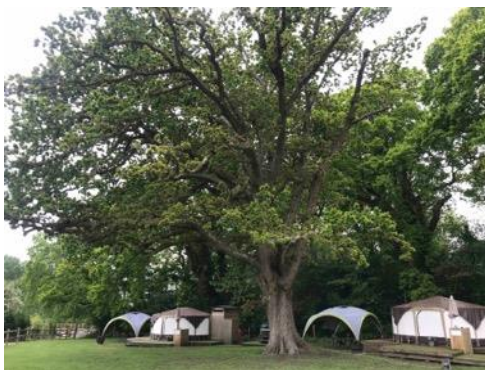
A substantial block of deciduous woodland lies adjacent to the west of the camping ground, outside of the survey boundary. A single veteran oak tree is present within the camping ground and with further mature oaks edging the western border within the woodland. Signs of recent management of these trees are present in the form of cut and removed limbs.

**Photo 5: Mature oak tree present within the camping ground site.**

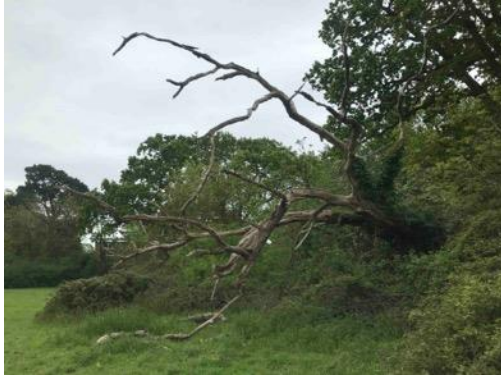
- A large unidentified fallen dead tree is present amongst dense bramble growth at the north-eastern edge of the woodland copse (see Habitats Map: Target Note 1). Two additional large fallen poplar trees are present at the western extent of the woodland copse.

**Photo 1: Target Note 1, unidentified fallen dead tree at eastern copse edge.**

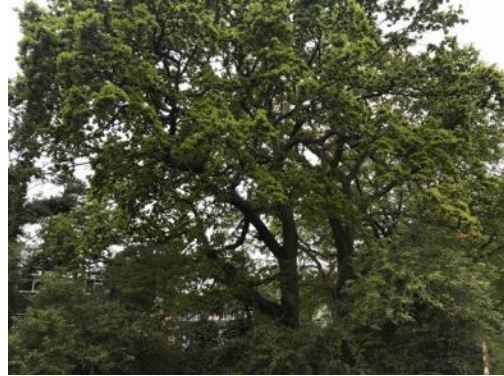
- A row of mature oak trees present at the southern extent of the copse, running alongside Long Copse Lane, all contained features suitable for bat roosting and were deemed as high potential for bats. A small number of further scattered trees present within the copse also contained PRFs.

**Photo 2: Row or mature oak trees at southern boundary adjacent to Long Copse Lane.**

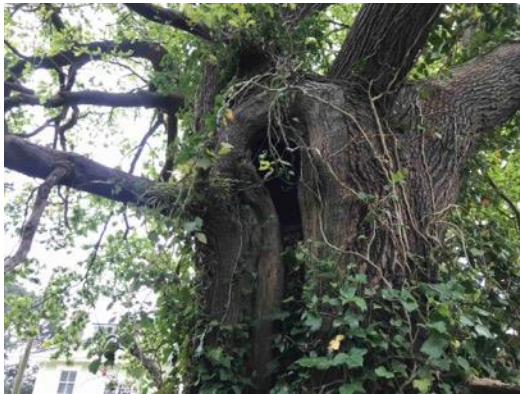
**Photo 3: Substantial bat roosting feature present within mature oak tree.**

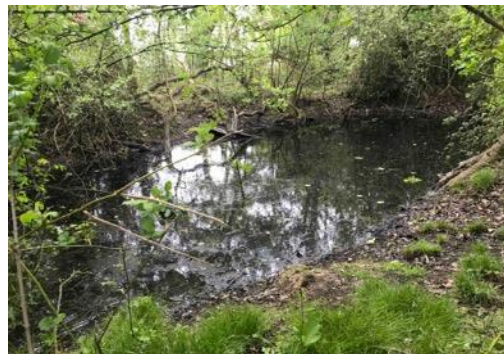
- A single pond is centrally located within the woodland copse. This pond has been previously reported to dry out annually (Prime Environment, 2018), though at the time of the survey it contained a shallow pool of water approximately 10 cm deep. The pond appears to be in a similar state to when the previous assessment was undertaken. No fish or waterfowl were present, and the pond was lacking both marginal and emergent vegetation. Furthermore, the pond was covered by 80% shade. This pond remains unchanged from the previous HSI assessment undertaken by Prime Environment in 2018, with a score of 0.58, indicating below average for GCN.

**Photo 6: Pond centrally located within the woodland copse.**

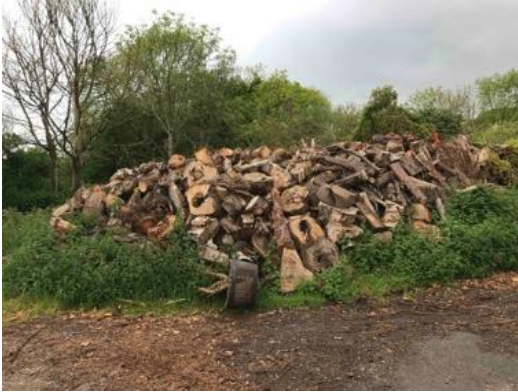
Two large spoil heaps are present to the north of the farmyard area (see Target Notes 2 and 3). TN2 consists of an extensive manure pile that remains in use. Dense growth of tall herbivorous vegetation covers much the surface of this manure pile including nettle, common hogweed, rosebay willowherb and various dock species. To the north-west of this is a large mound of cut vegetation and with an adjacent timber pile (TN3), which is surrounding by growth of bramble and nettle.

**Photo 1: Large log pile (Target note 3)**

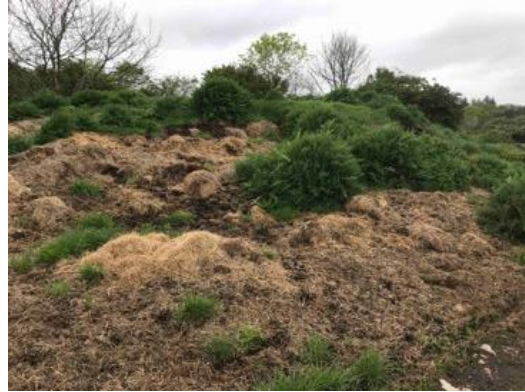
**Photo 2: Manure heap with extensive tall ruderal (Target note 2)**

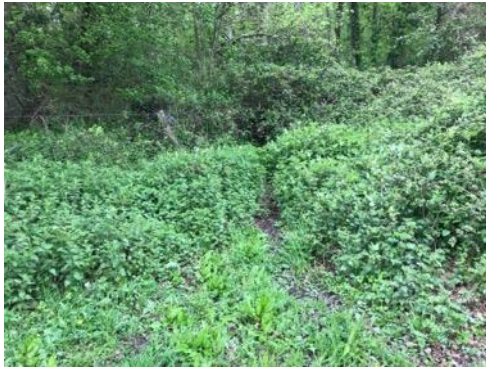
- A large block of deciduous woodland borders the entire northern boundary, with mature oak trees scattered along the woodland edge bordering the site.
- Two mammal trails leading to/from Hollybank Woods were discovered at the north-eastern boundary (see Fig 2: Target Notes 4 and 5).

**Photo 11: One of two mammal trails at north-eastern site boundary (Target Notes 4 & 5).**

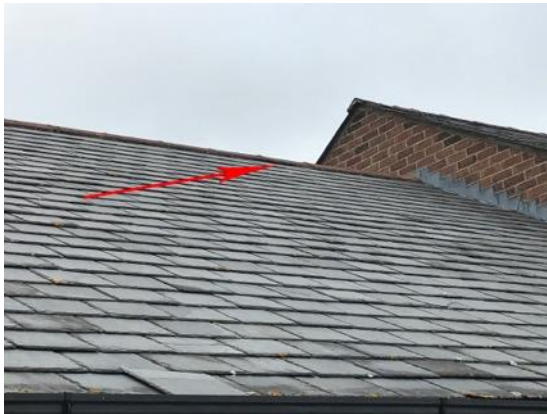
Overall, the roof was in excellent condition and slate tiles cladding the roof were flush and tightly fitting. External potential roosting features noted during the assessment included low numbers of gaps leading beneath concrete ridge tiles caused by failed mortar, as well as openings leading beneath lead flashing lining the roof at hipped joints as well as edging dormer windows. Furthermore, three openings present within timber of the porch area on the south-facing elevation led to small cavities. These were endoscoped, with no bats or evidence indicative of their presence observed.

**Photo 3:** Red arrow points to gap leading beneath ridge capping. Single-storey element.

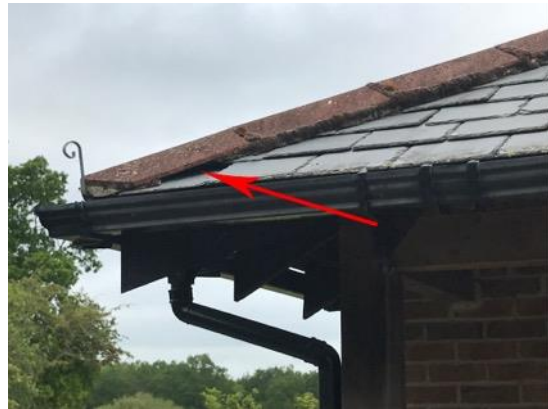
**Photo 4:** Red arrow points to gap leading beneath ridge-capping caused by failed mortar. Single-storey element.

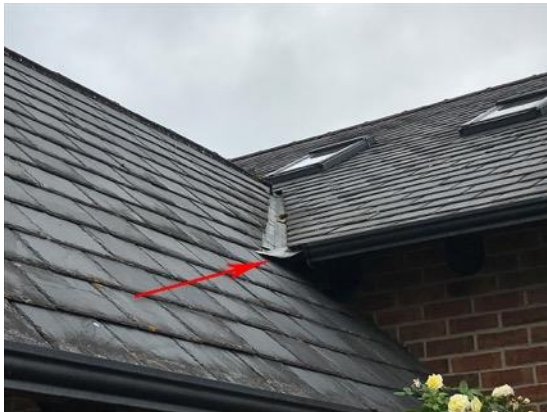
**Photo 5:** Red arrow points to gap leading beneath lead flashing at hipped joint.

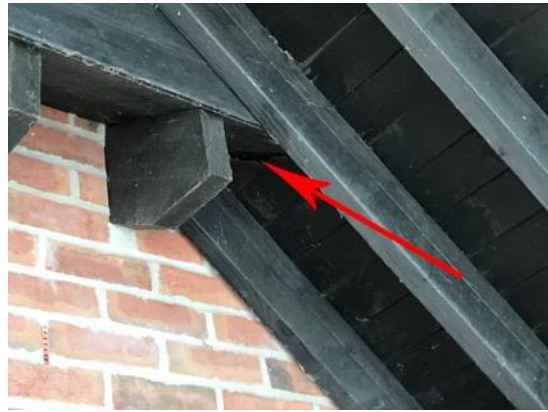
**Photo 6:** Red arrow points to opening leading to cavity within timber porch. Front south-facing elevation.

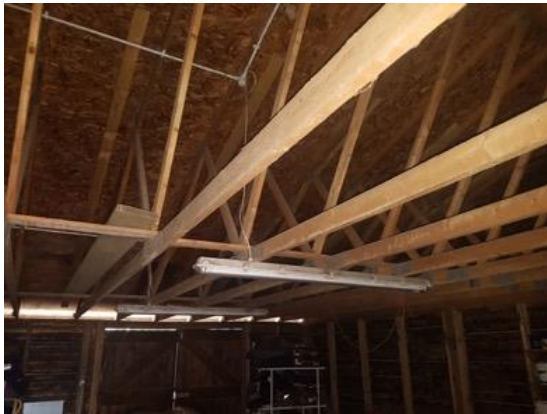
Internally, the exposed timber roof structure could offer value to perch-feeding bat species, which can easily achieve entry to the structure through its many open doorways; individual stables have a two-part stable door that could provide access to the interior of the structure if left open. Notably, each stable appeared to be in use, resulting in a high level of disturbance would be present and subsequently largely unsuitable for bat roosting. No bats, droppings, feeding remains or further evidence of bat activity was discovered during the inspection of B2. In light of the above **the structure was considered to hold low potential to support roosting bats.**

**Photo 10: Internal view of roof structure showing exposed timber beams. B2.**

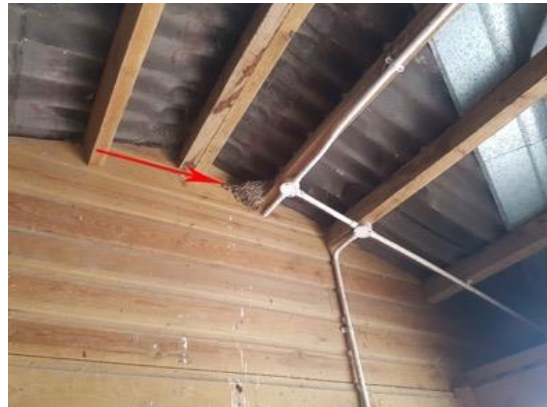
**Photo 11: Red arrow points to swallow nest. B2.**

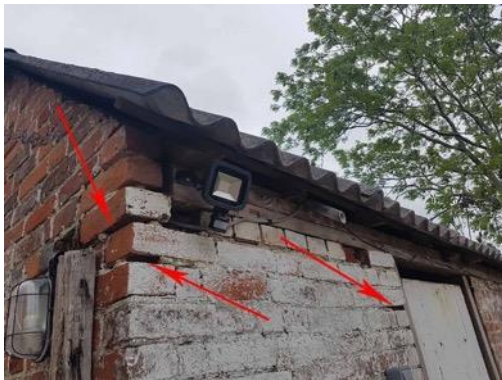
Externally, the brickwork is largely in good condition though with some areas with missing or damaged mortar, most notably on the south-western facing corner of the structure (see Photo 14). Furthermore, narrow gaps are present at eaves level on the south-facing elevation which could serve as potential entry points for bats to the interior of the structure.

**Photo 14: Red arrows point to cavities caused by failed mortar within brickwork. B3.**

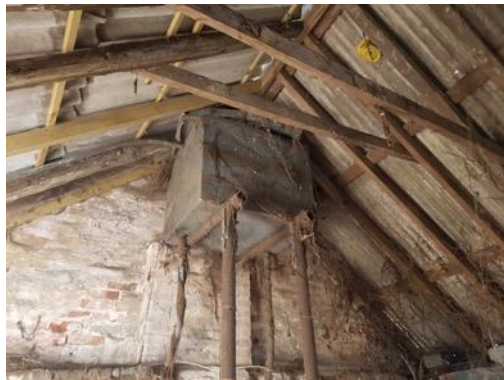
Internally, the timber-framed roof structure is exposed, providing value to perch-feeding bat species. No large entry points suitable for fly-in entry were noted during the internal inspection of B3 and the entrance door was closed and tightly fitted at the time of the survey. The internal aspect of the structure is also well-illuminated during the daytime due to a transparent panel in the hipped roof of the south-east facing elevation. No bats, droppings, feeding remains or further evidence of bat activity was discovered during the inspection of B3. In light of the above **the structure was considered to hold low potential to support roosting bats.**

**Photo 15: Internal view of roof structure. B3.**

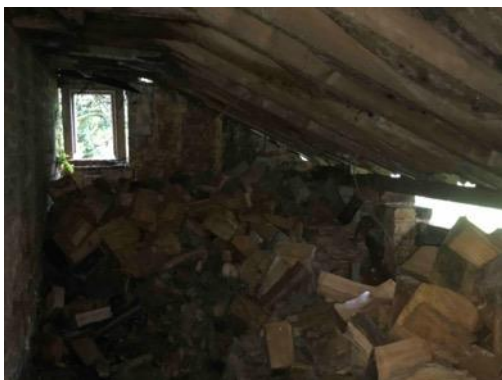
Bats could easily achieve entry into the building through an open doorway on the east facing elevation, as well as multiple gaps at eaves level. Internally, the roof is not underlined, and timber joists and purlins of the roof structure are exposed, offering value to perch-feeding bats. The main element features a opaque panel sky window within the roof structure, leading to the internal aspect to be well-luminated during the daytime.

Photo 29: Internal view of log store showing daylight visible at eaves level. B7.

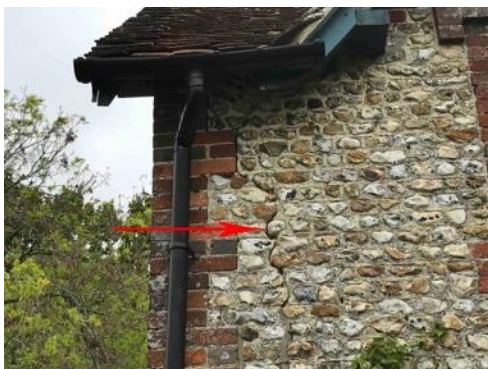
Externally some gaps and slight raises were noted under roof tiles. Additionally, gaps were present above the exposed timber verge rafters of the gable fronted wall dormers present at the south-west elevation, thus providing value to crevice dwelling species of bat.

Photo 33: Crack in stonework of south-facing elevation.

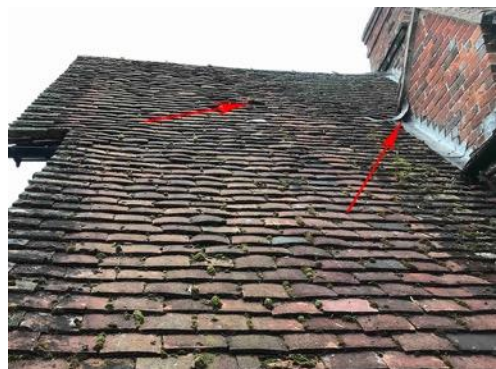
Photo 34: Gaps leading beneath lead flashing and raised clay roof tile. North-facing elevation.

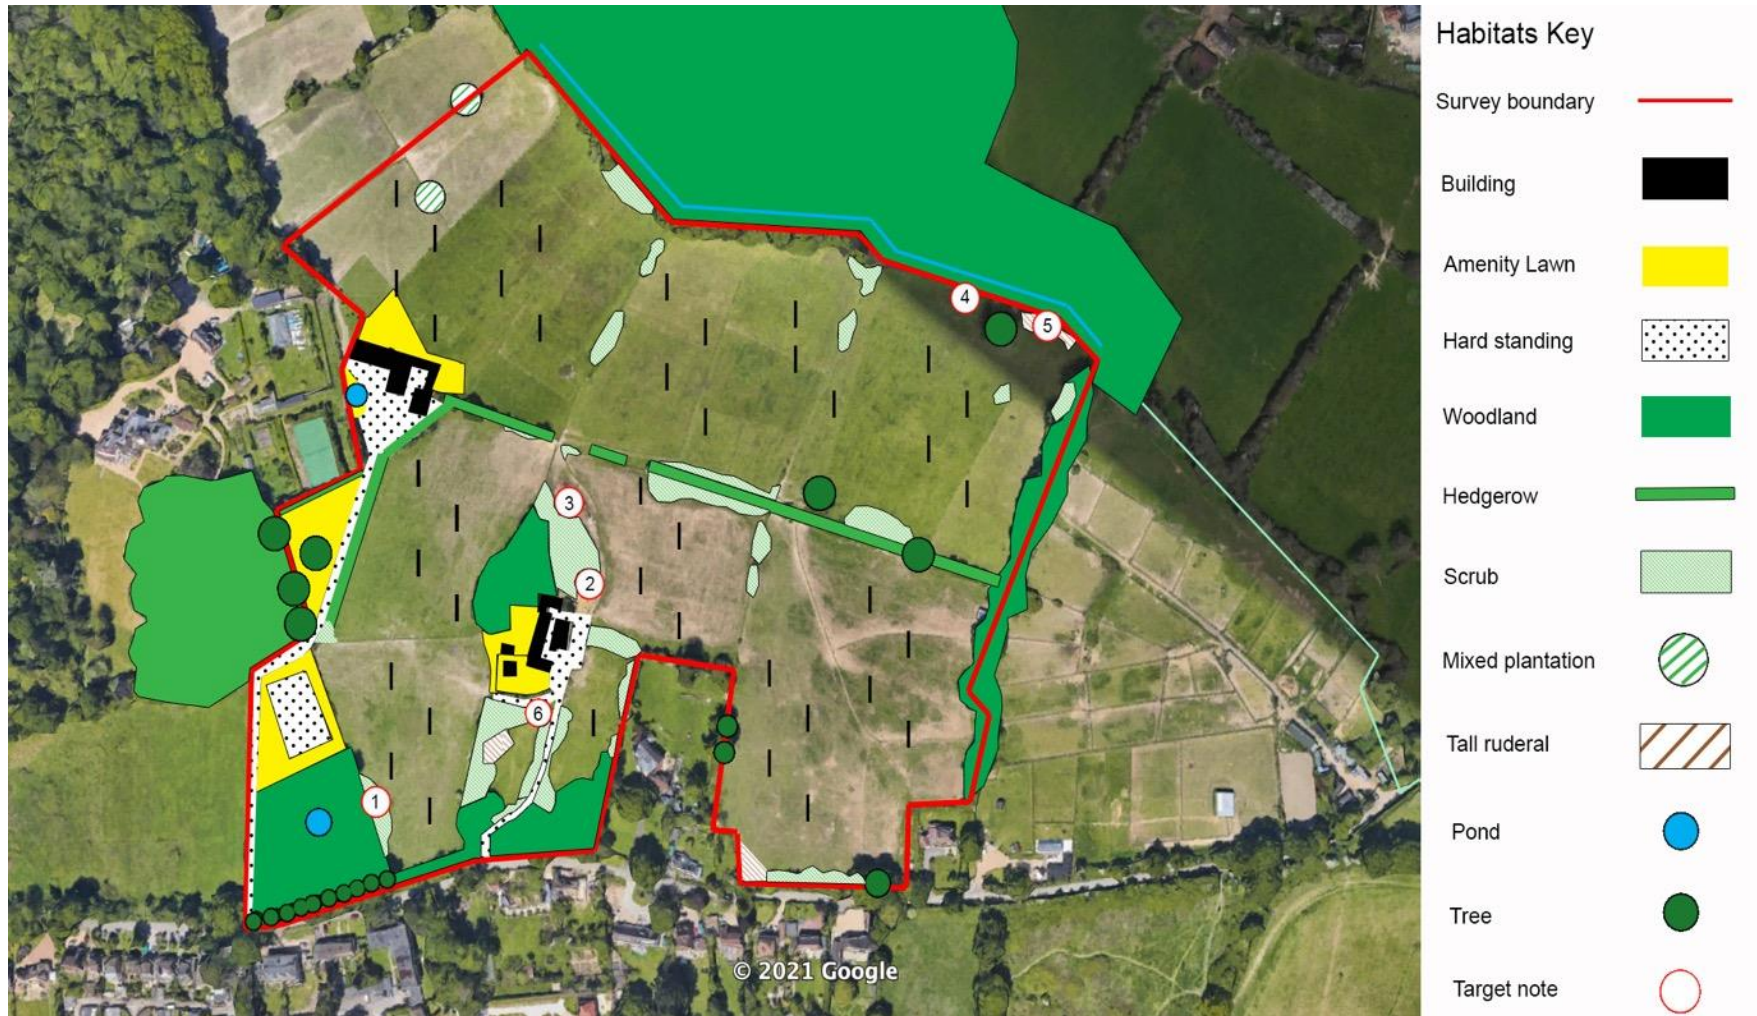
Figure 3: Bat Tree Map

Mature trees largely consisting of mature oak are scattered throughout the site as well as the site boundary (see Figure 3: Bat Tree Map). 24 trees were previously identified by Prime Environment as holding roosting value to bats during a Phase 1 Habitat assessment undertaken in 2018, all of which are still present onsite. Additional trees were identified during our site visit as having potential for bats due to their size and subsequent difficulty to fully assess from ground level, and whilst no obvious PRFs were present within many of these, it is considered that further inspection is required to confirm the presence/absence of potential roosting features (**see Fig 3: Tree Map**).

Rows of Mature oak trees are present at the site boundaries, notably to the northern and eastern extent of Zone D as well as to the west of camping ground in Zone A. Whilst these lie outside of the survey boundary (**see Fig 3: Tree Map**), a number of these feature PRFs, as well as dead limbs/hazard beams that extend into the camping ground and grazing fields.
