# SUBSIDENCE MANAGEMENT SERVICES

## ENGINEERING REPORT

**Address of Property:** 24 Ramblers Way, Waterlooovile, PO7 8RE

**Date of Report:** 2<sup>nd</sup> February 2016

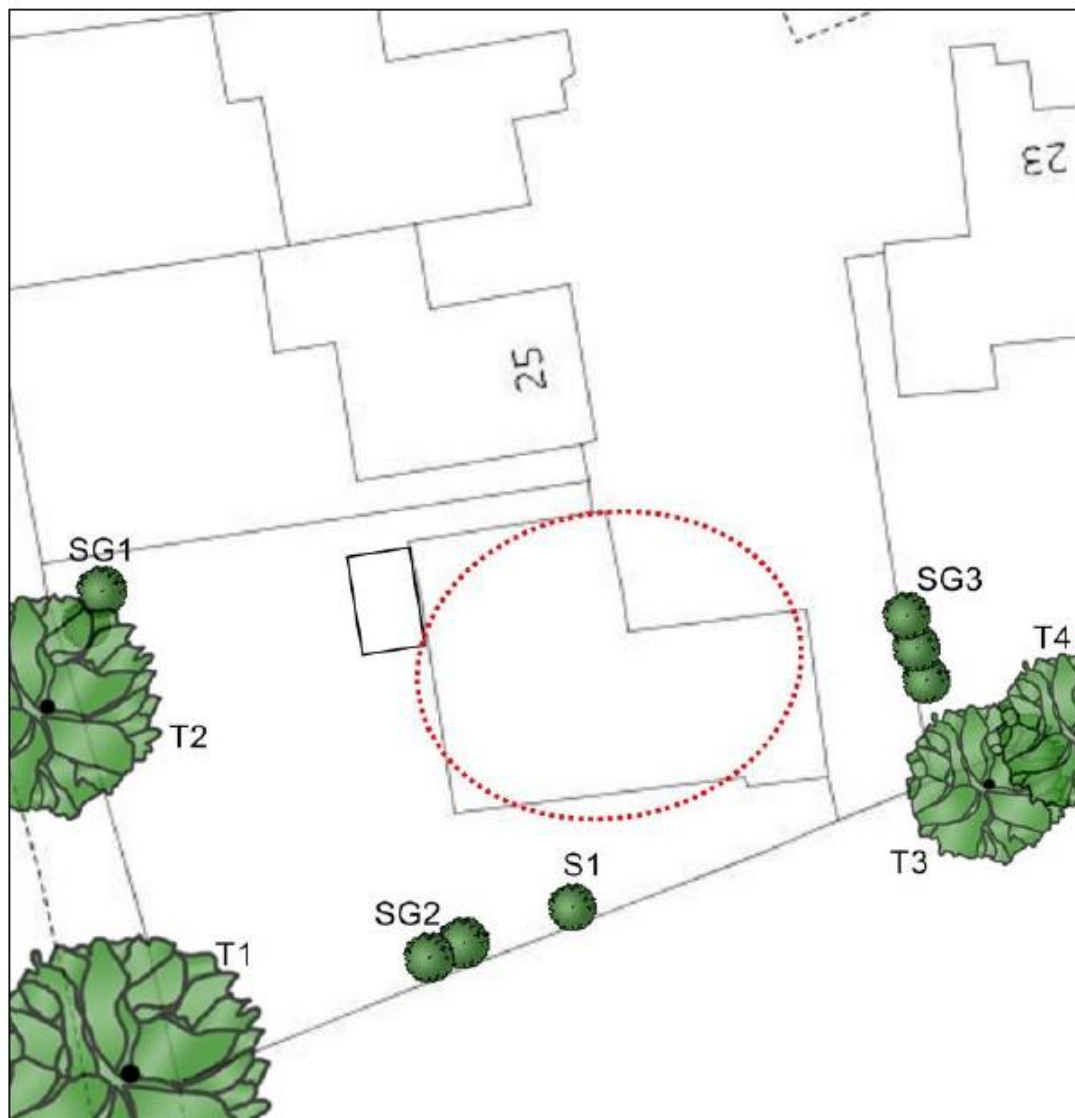
*Figure 1 – Sketch taken from Marishal Thompson Group survey showing location of the principal vegetation in relation to Property*

- 9.2. Given its proximity and the presence of *Quercus spp* roots in the subsoil, the implicated trees identified with the Arborist report as T1, T2 & T3 are the only plausible explanations for the seasonal movements recorded to the affected parts of the property.

- 3.5. Site investigations were carried out in both February 2014 and November 2015 by SubsNet from which it was concluded that the property had been affected by clay shrinkage subsidence. Marishal Thompson Group subsequently recommended removal of the Oak trees at the rear (reference T1 & T2). Additionally, it was recommended in the same report, that the local authority hawthorn tree (T3) be removed to guard against future risk. The LA oak tree (T4) and three other trees in the ownership of the Insured were recommend to be maintained at their current dimensions to avoid any future risk issues

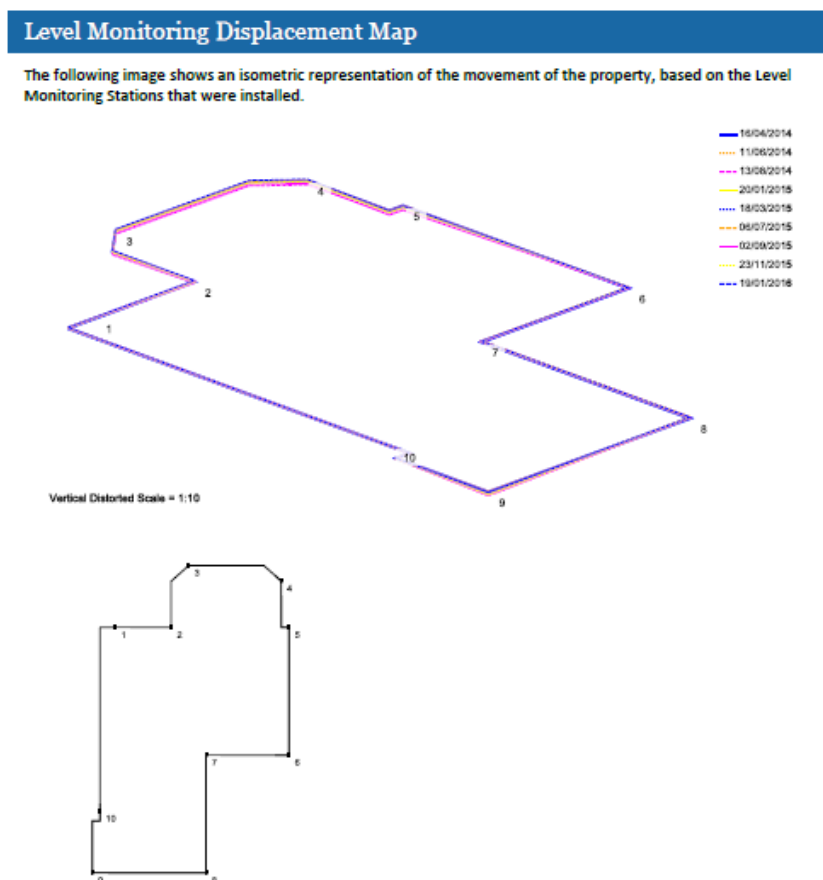
Figure 6 – Monitoring location positions

- 8.4. The maximum degree of seasonal downward movement occurring at point 5 of -12.5mm and -.7.8mm at point 9.
- 8.5. The remaining areas to the main dwelling have shown minimal movement in comparison and what has been observed would be within accepted tolerances.

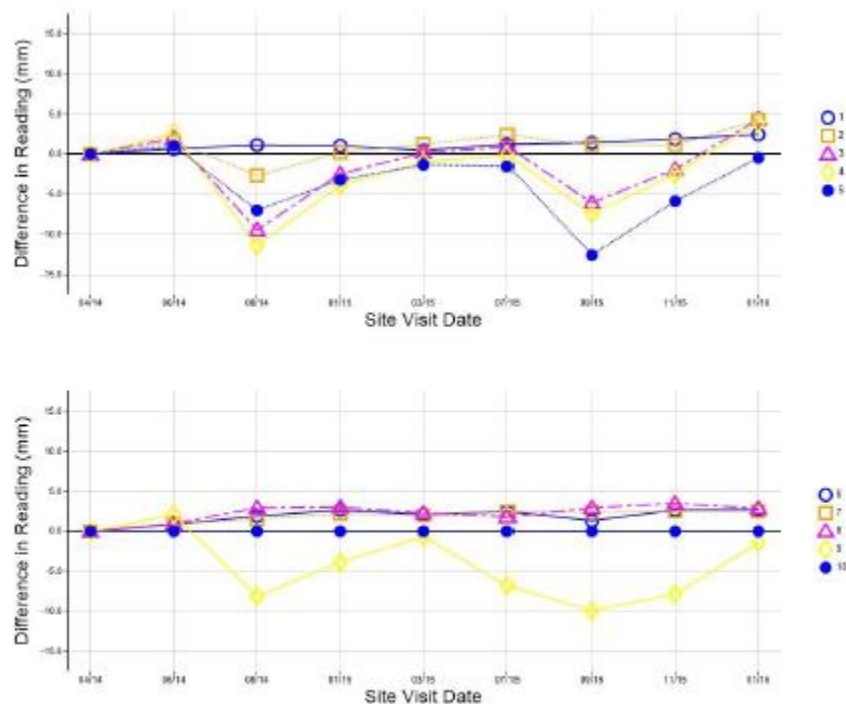
- 8.3. The monitoring results, which are presented in below, show that the property is affected by seasonal downward movement to the rear extension and also to the corner of the garage.

- 8.6. The monitoring shows the affected parts of the property moving down during the summer months when the trees are in leaf, demanding larger amounts of water and rainfall is lower and the net moisture content within the clay soil below the property decreases. Recovery or upward movement is then witnessed during the winter months when the tree loses leaf, demands less moisture and the rainfall events increase, allowing the soil to rehydrate to some degree and swell, causing upward movement and consequential closing of cracks within the property.

*Figure 7 – Level monitoring results indicating seasonal movement in areas of concern.*
