## Arboricultural Report

JINGLES HOTEL  
77 HORNDEAN ROAD  
EMSWORTH  
HAMPSHIRE  
PO10 7PU

SEPTEMBER 2015

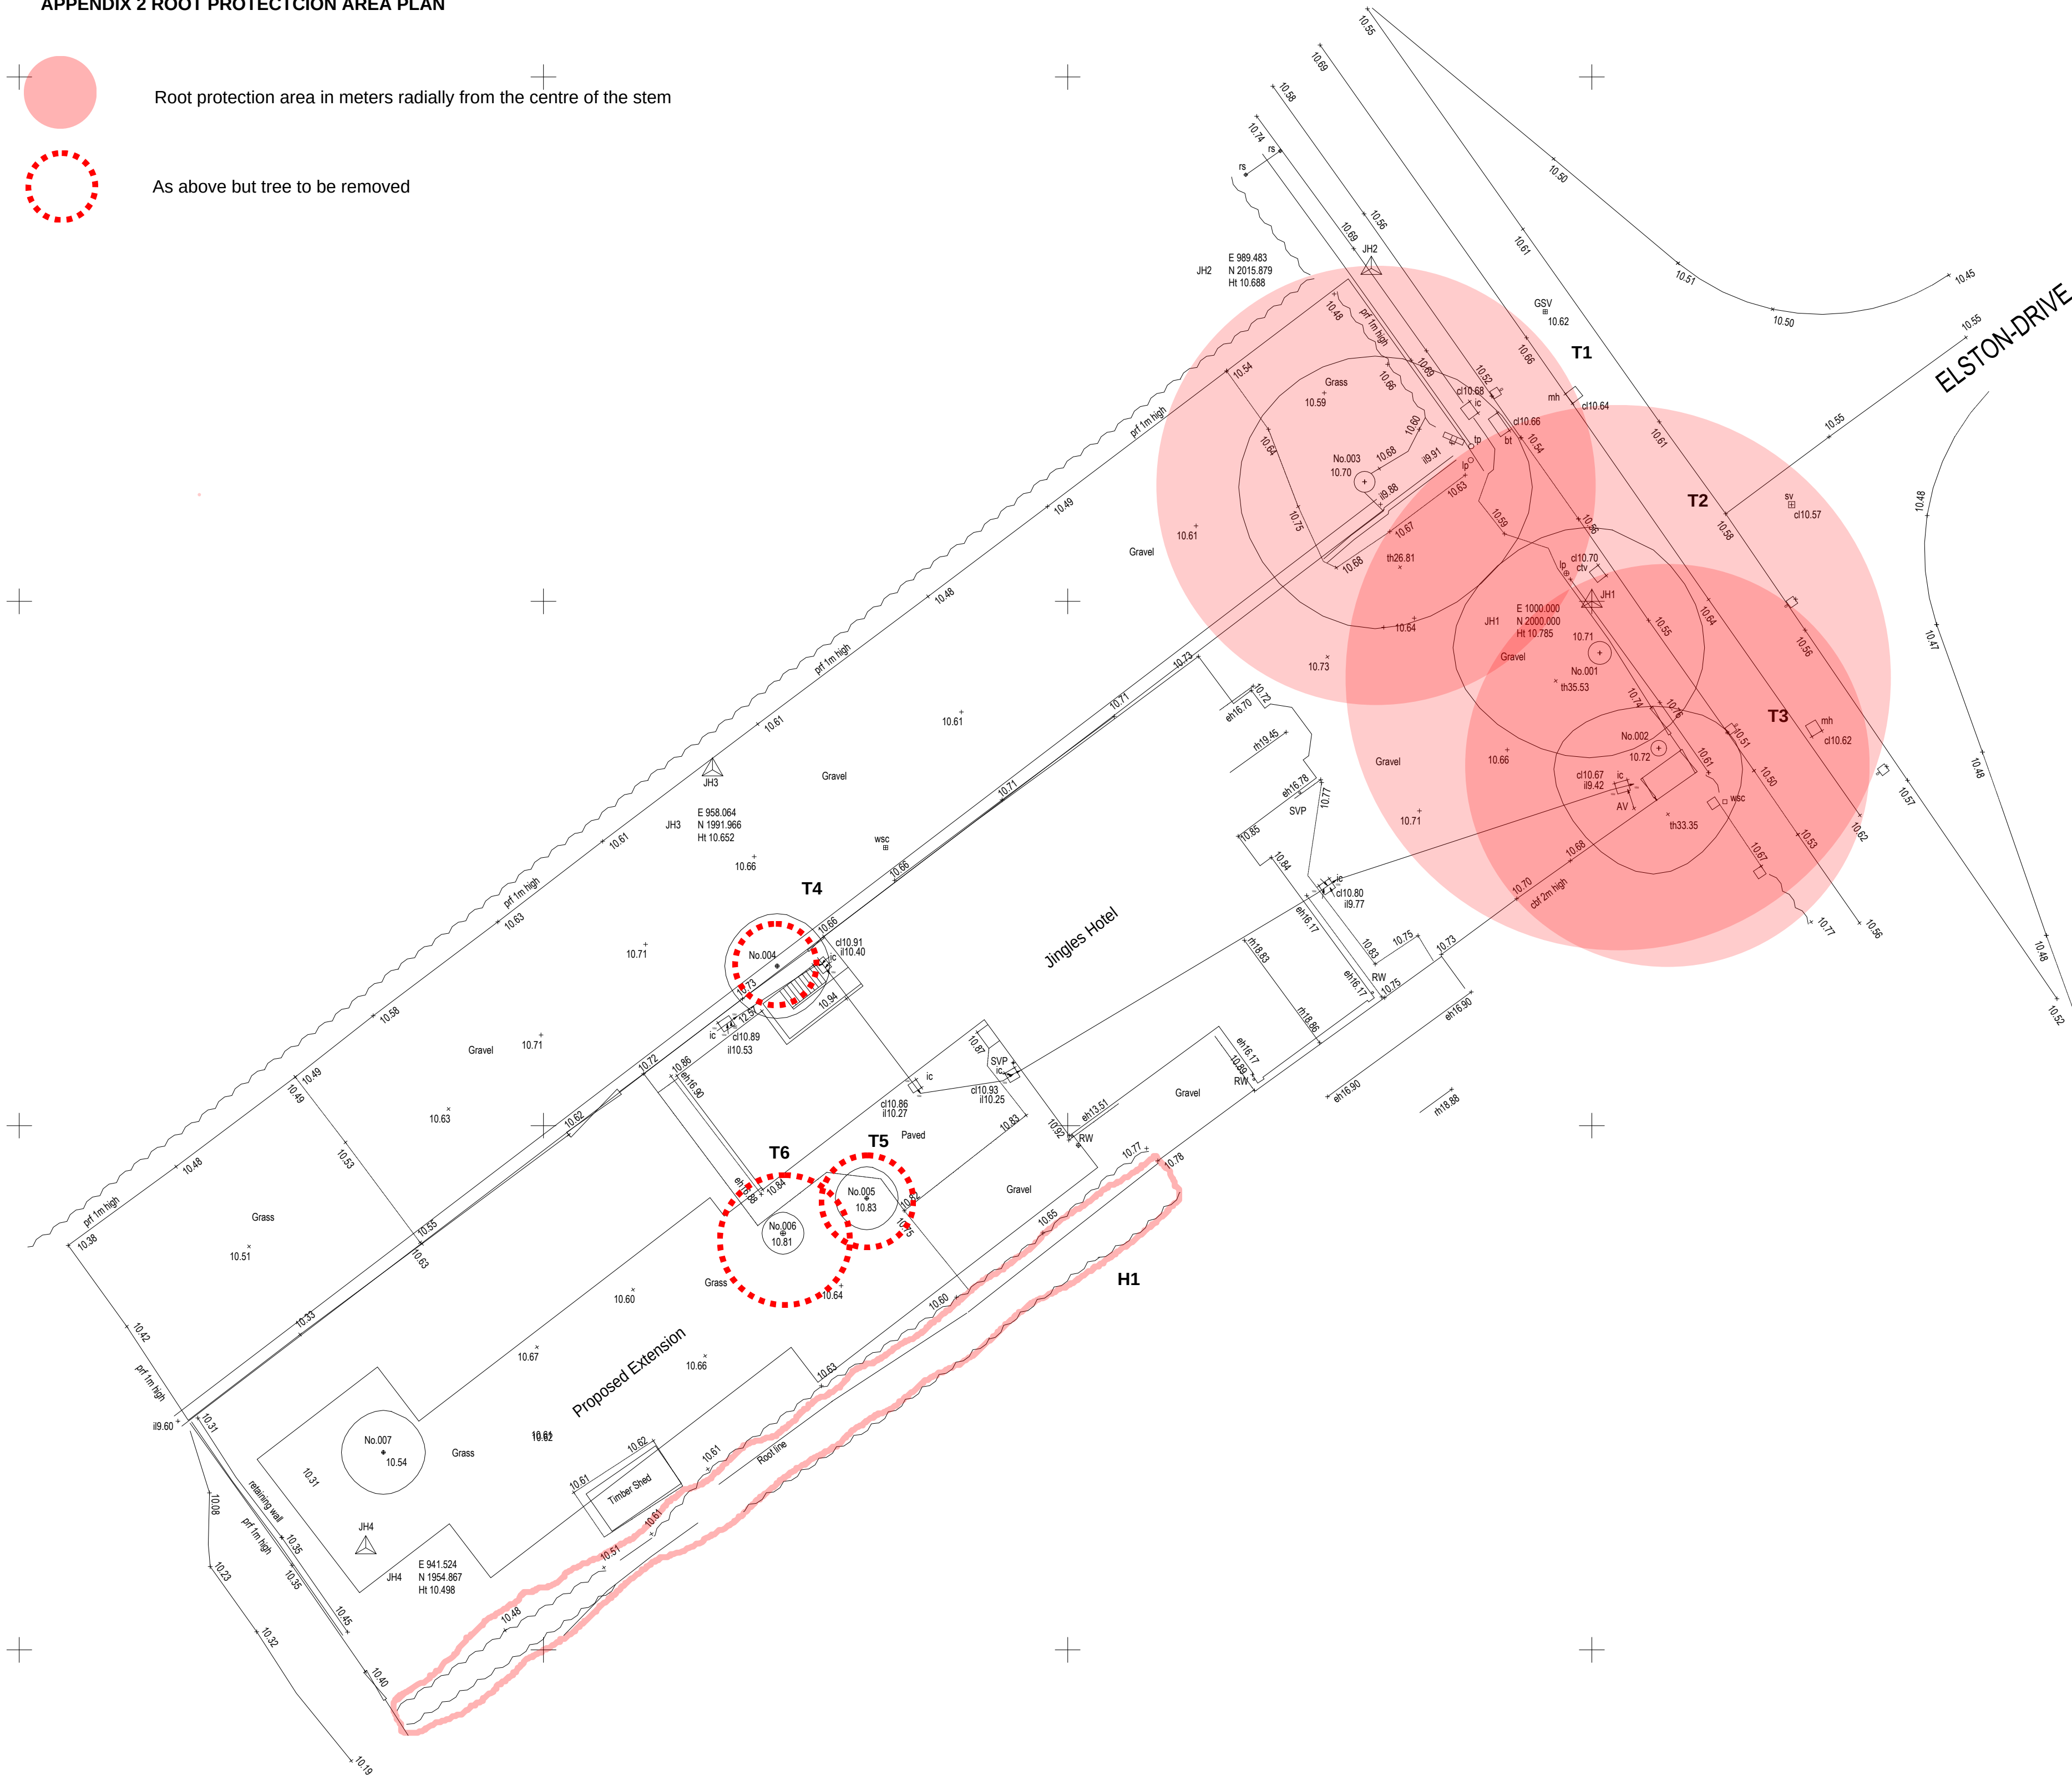
APPENDIX 2 ROOT PROTECTCION AREA PLAN

- Root protection area in meters radially from the centre of the stem
- As above but tree to be removed
