# Arboricultural Consultancy for Direct Line Insurance

| <b>Insured</b> | Mrs Elaine Potter | <b>Address</b> | 25 Galaxie Road, Waterloooville, Hampshire, PO8 9AT | | |
| <b>MT Ref</b> | LS/0710131219/JS-REV1 | <b>Consultant</b> | Jonnie Setterfield | <b>Contact No.</b> | 08702 416 180 |
| <b>Report Date</b> | 22/10/2013 Revised 04/03/2015 | | | | |

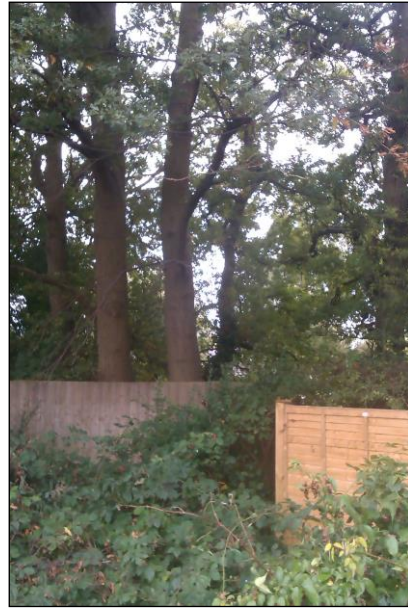
TG3 Oak

Our survey of the site identified T1 (Cypress), T3 (Ash) and TG3 (Oak); given their position relative to the damage it is our opinion that the roots identified emanate from these trees.

*Quercus spp* roots were noted to 3700mm within TP/BH2; these roots will also derive from the Oaks (TG3).

In assessing the potential drying influence of the vegetation on site TG3 (Oak) is considered the dominant feature and accordingly we have identified these trees as the principal cause of subsidence.

In order to mitigate the current damage and allow soils beneath the property to recover to a position such that an effective engineering repair solution can be implemented we recommended that TG3 (Oak) is removed.

| Tree No. | Species | Age Cat | Approx. Height (m) | Distance to Building (m) | Ownership | Action | Requirement |
|---|---|---|---|---|---|---|---|
| TG3 | Oak x3 | 3 | 19.6 | 6.4 | A - Third Party<br>22 Fairmead Walk<br>Hampshire<br>PO8 9AL | Remove | Remove. Remove regrowth annually due to translocation risk. |

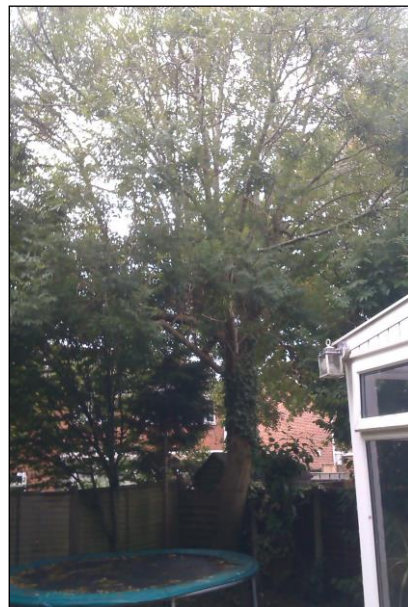
T3 Ash

Based on their size, known species characteristics and proximity we also consider that, prior to their removal, T1 (Cypress) and T3 (Ash) were also exerting a contributory influence with respect to the current damage, albeit in a secondary capacity to that of TG3 (Oak).

| Tree No. | Species | Age Cat | Approx. Height (m) | Distance to Building (m) | Ownership | Action | Requirement |
|---|---|---|---|---|---|---|---|
| T3 | Ash | 3 | 12.5 | 6.5 | C - Insured | Remove | Removed Feb 2014. |
