# GEOTECHNICAL

## for Subsidence Management Services

**24 Ramblers Way, Waterlooville, PO7 8RE**

Client: Subsidence Management Services  
Client Contact: Philippa Mann  
Client Ref: IFS-AVI-ROF-13-0044713  
Policy Holder: Mrs C Gradison  
Report Date: 20 November 2015  
Our Ref: C11143G11109

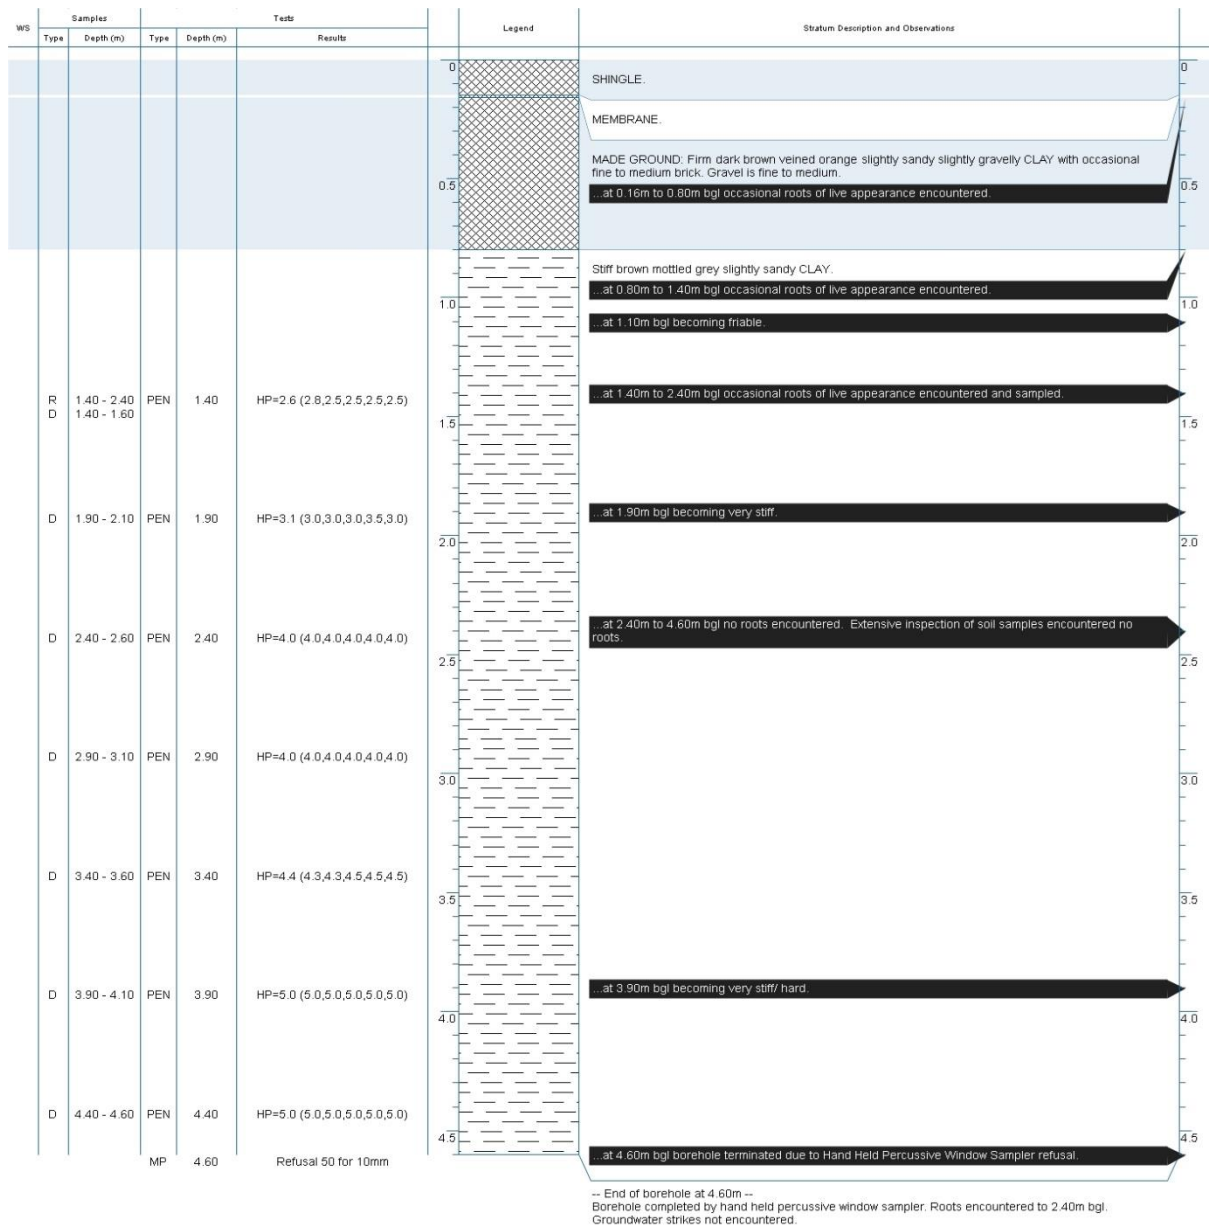
## BH5 Borehole Log

-- End of borehole at 4.60m --  
Borehole completed by hand held percussive window sampler. Roots encountered to 2.40m bgl.  
Groundwater strikes not encountered.
