24 March 2015

Your ref:  
Planning ref:  
Our ref: J13126/DB/c05

**RE: MANOR FARM SITE AND COPSEYS NURSERY SITE, HAVANT, HAMPSHIRE  
COMBINED REMEDIATION VALIDATION AND VERIFICATION REPORT**

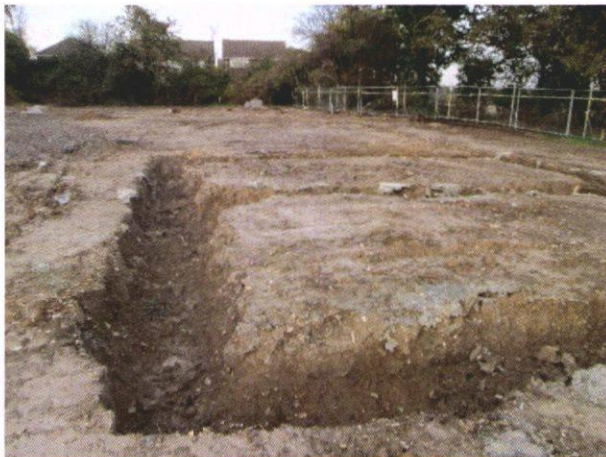
The location of the former above ground heating oil tank was inspected and no indications of any staining, residual odours or discoloration of the ground was noted such that a requirement for further work in this part of the site was not deemed necessary.

Photograph showing area of former above ground heating oil tank

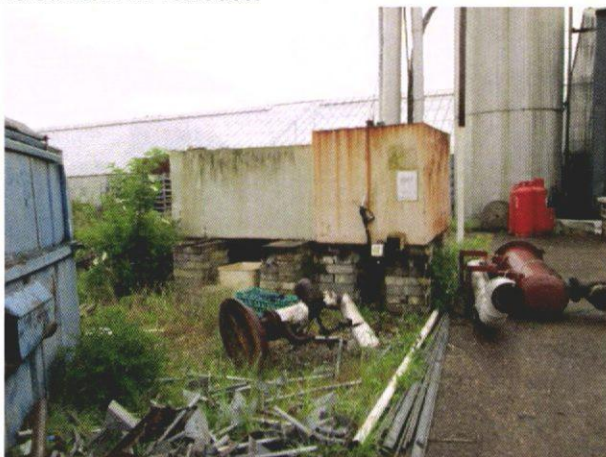
Localised oil spillage was identified as part of the site walk over survey in the area to the east of the main oil tanks, where a series of former single skin steel oil tanks were located. It is understood that the tanks in this area central eastern area may correspond with the former location of tanks identified on the historical mapping, although at the time of our investigation they were not actively used but appeared to contain oil residues.

Photograph showing some of the disused oil tanks located to the east of the main boiler house prior to demolition.

It is understood that at some point the oil residues or other inflammable substances caused a fire in this part of the site. Whilst it is likely that this would have combusted any of the oils present, it left a residue of ash and debris that required removal.

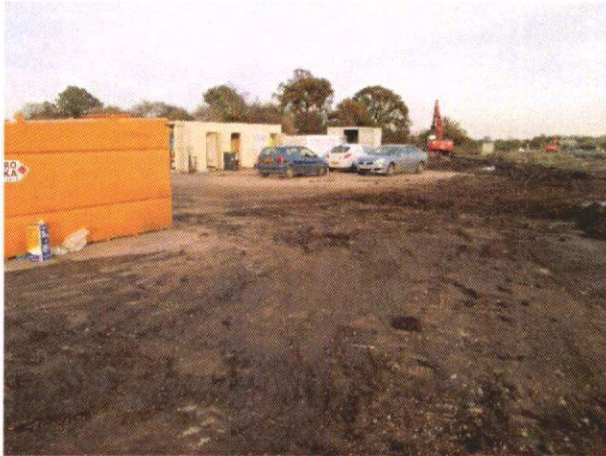
Following demolition and clearance of this part of the site, the ground level in this part of the site was reduced to remove any residues and the remaining soils inspected to confirm the absence of any staining, residual odours or discoloration of the ground was noted such that a requirement for further work in this part of the site was not deemed necessary.

Photographs showing the clearance of the area of waste oil spillage

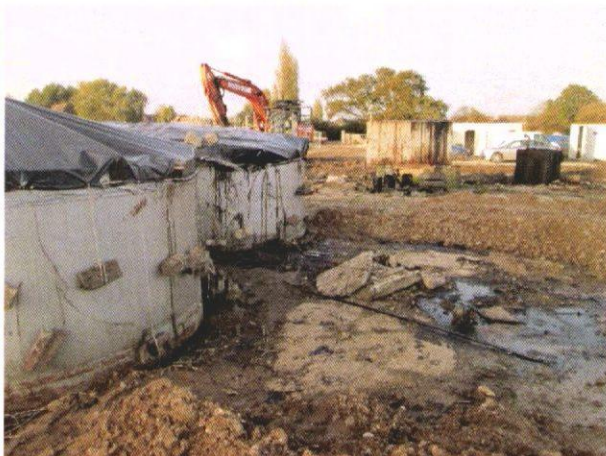
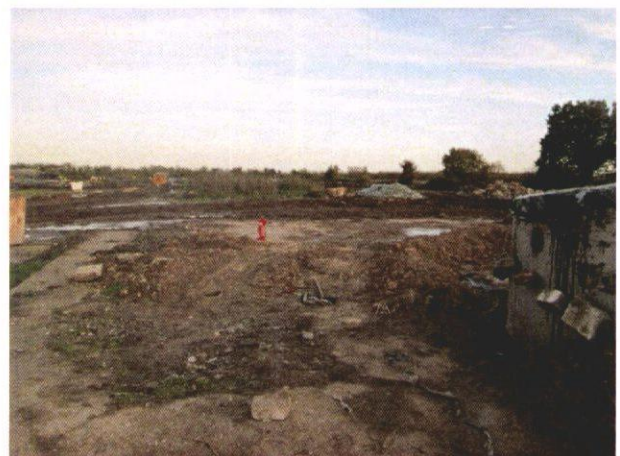
We subsequently attended site to carry out the removal of the floor slab under our inspection and supervision. The initial slab removal indicated the presence of potential asbestos containing materials incorporated into the base of the multi-layered concrete slab, although no indications of widespread hydrocarbon contamination was identified. The works were halted prior to the removal of the main base to the oil tanks as this was found to comprise a substantial concrete structure to ensure that the tanks remained stable.

Photographs showing oil tank base during the early stages of demolition

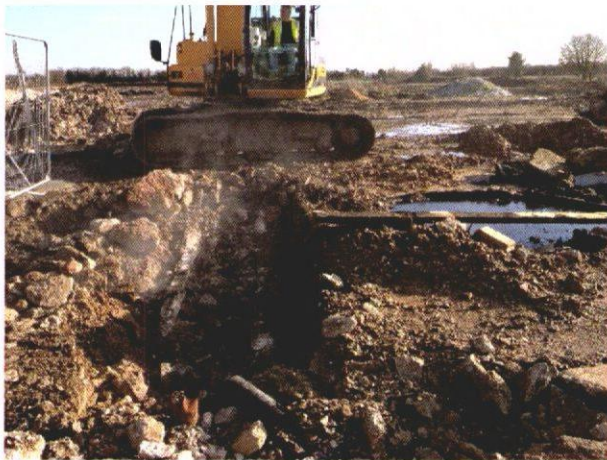
Photograph showing the removal of the base and short section of duct

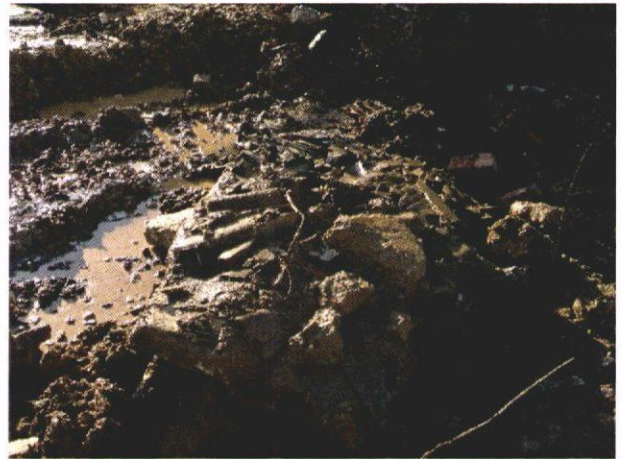
Photograph showing presence of asbestos containing materials within the concrete slab of the boiler house

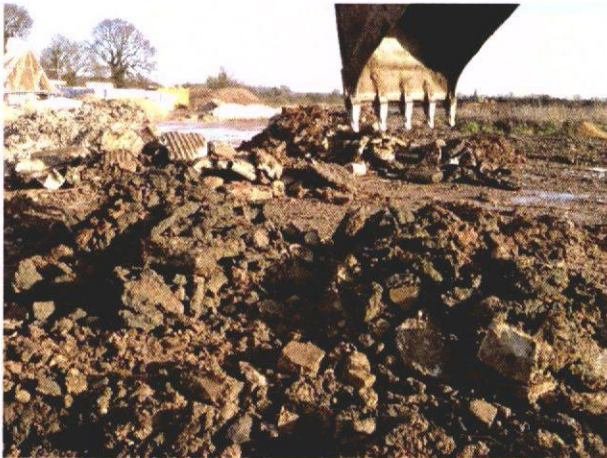
Photograph showing the waste materials from the excavation works

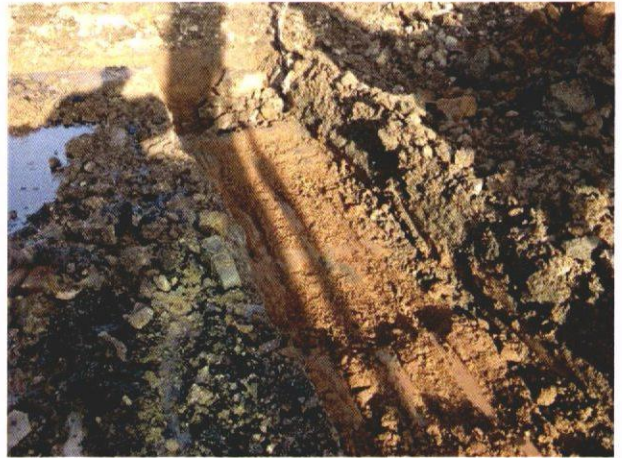
Photograph showing the eastern side of the tank base excavation

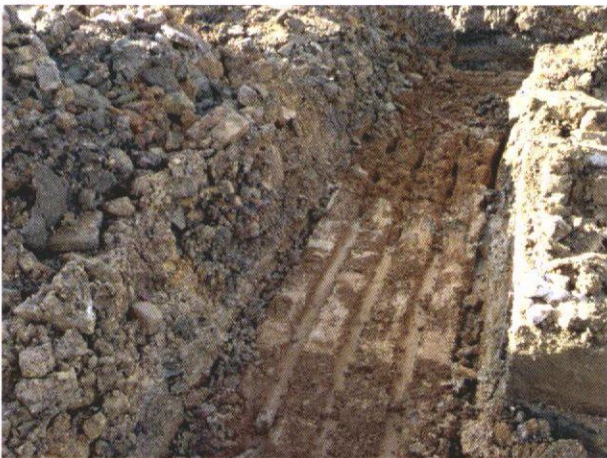
Photograph showing the southern side of the tank base  
- note the limited relic oil stained clay to 0.25m

Samples recovered from the sides and bases of the excavation to the oil tank area were submitted for laboratory analyses for the presence of hydrocarbons and asbestos fibres. The results of this work are enclosed and indicate that the soils that remain are clean and suitable for the proposed residential end use.

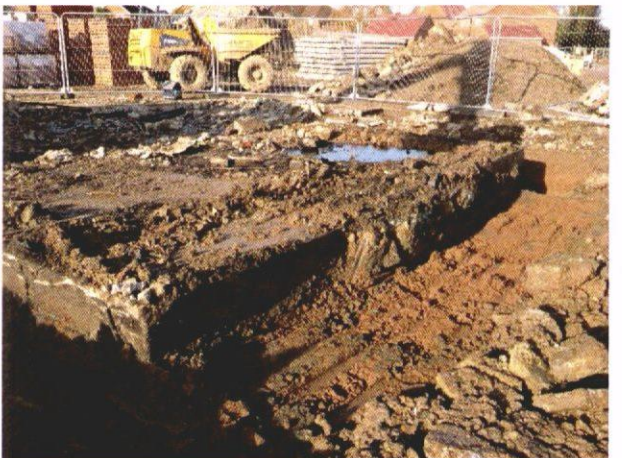
Photograph showing tank base prior to removal

The tank base was removed as part of the road and drainage construction works by others and it is understood that there was no indication of ground contamination under the slab, which is consistent with the findings of our works

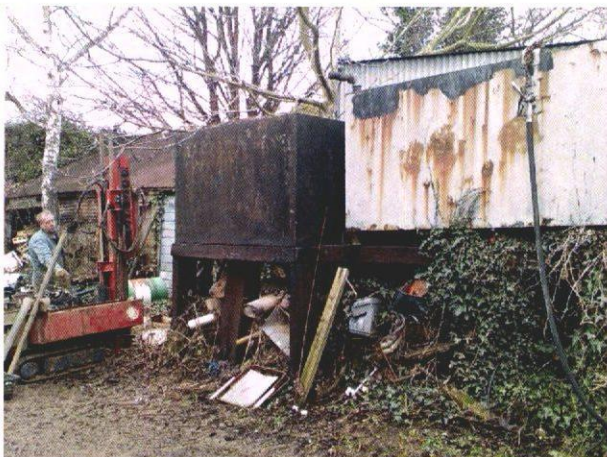
The southwestern part of the overall site comprises an historical farmyard complex where a pair of above ground oil tanks were identified in the original ground investigation.

Photograph showing the tanks -note the adjacent ground investigation borehole that encountered low level hydrocarbon contamination

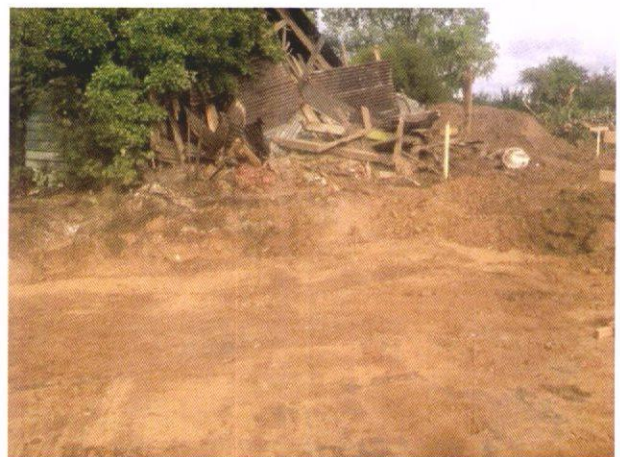
Photograph showing the former location of tank base excavation following removal

This inspection did not reveal any indications of staining, residual odours or discoloration of the ground was noted such that a requirement for further work in this part of the site was not deemed necessary.
