| SURVEY OF TREES AT HAYLING BILLY PUB, 117 ELM GROVE, HAYLING ISLAND | | | | | | | | | | | | | | | | | | | | | | |

PROJECT:  
Hayling Billy Pub, 117 Elm Grove,  
Hayling Island

TITLE:  
Tree Protection Plan

DRAWING NUMBER:  
9030/02 Rev C

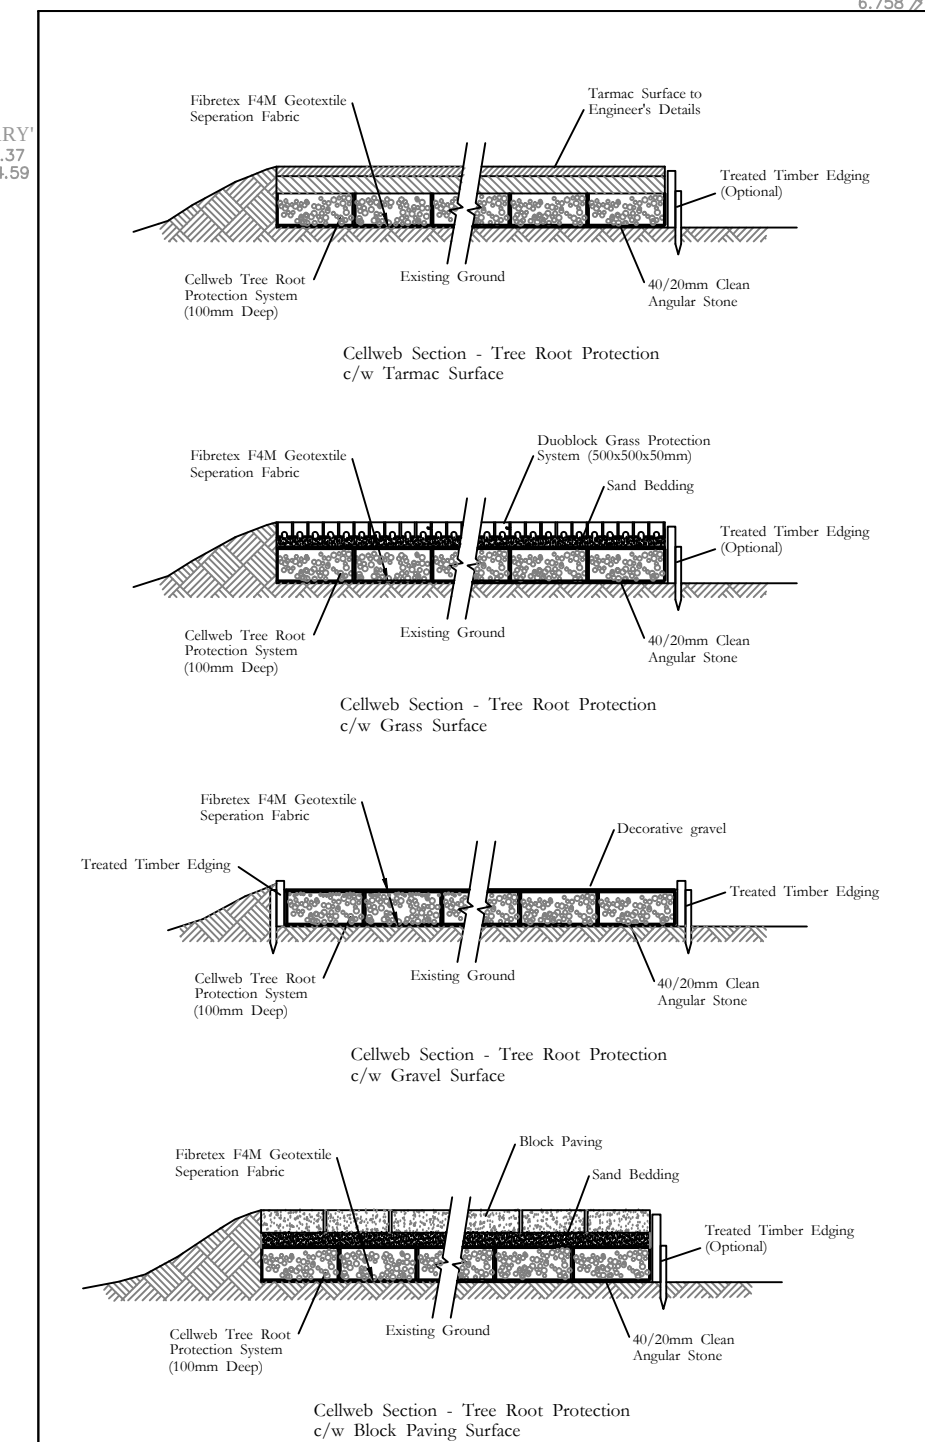
Any roots encountered whilst creating this cut back to be cut cleanly in a single plane

Hand excavation for new foundation where within root protection area

Piling for foundation to be supervised by arboriculturist

New proposed hard surface created without excavating in to soil below existing hard surface. Existing kerbs retained within root protection areas.
