### Inspections

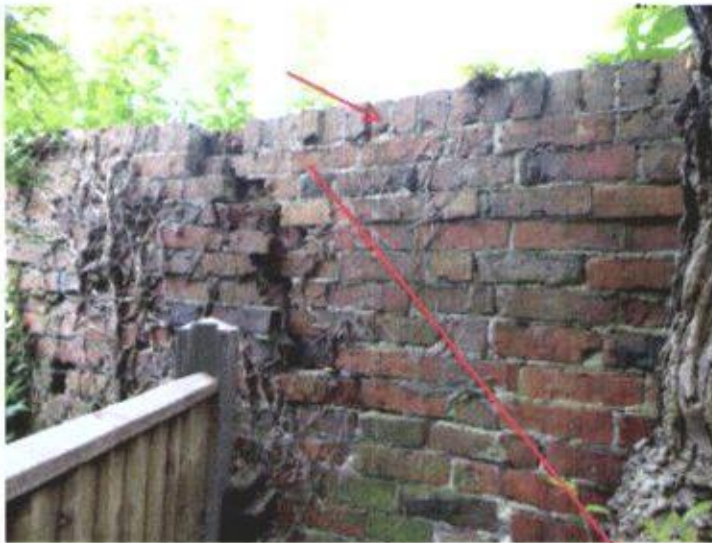
Left hand corner behind tree – wall has been pushed over 70mm at top

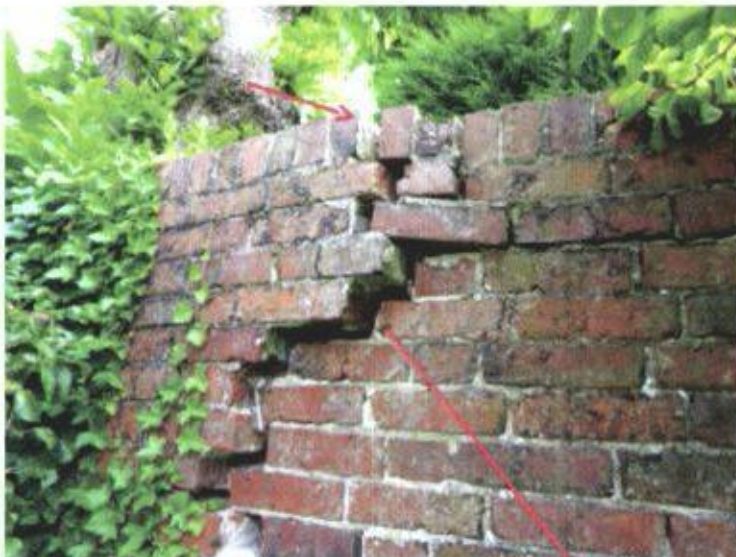
View from neighbours side – Wall leans 70mm at top – wall is unsafe

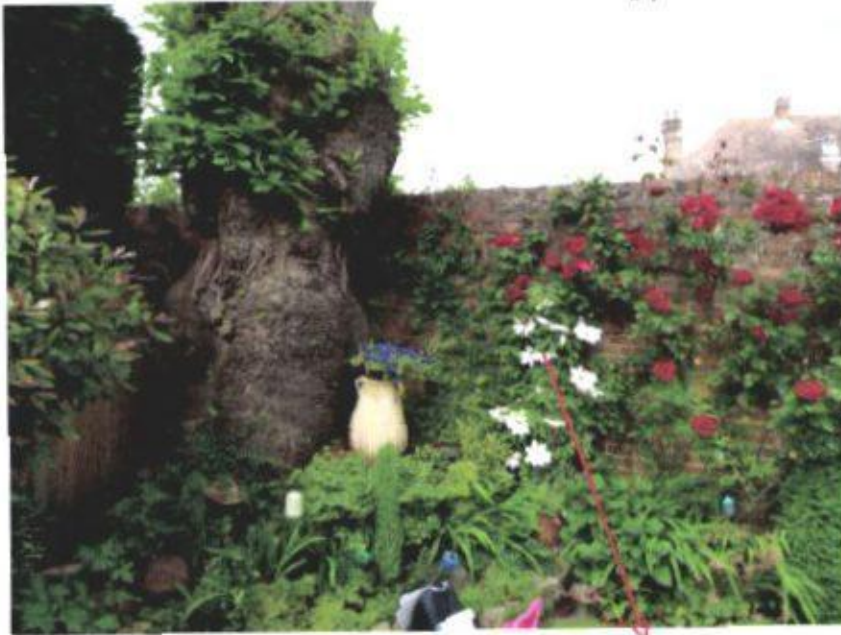
View from our side showing wide trunk at base and full height vertical crack to right of tree (see sketch view A appended separately)

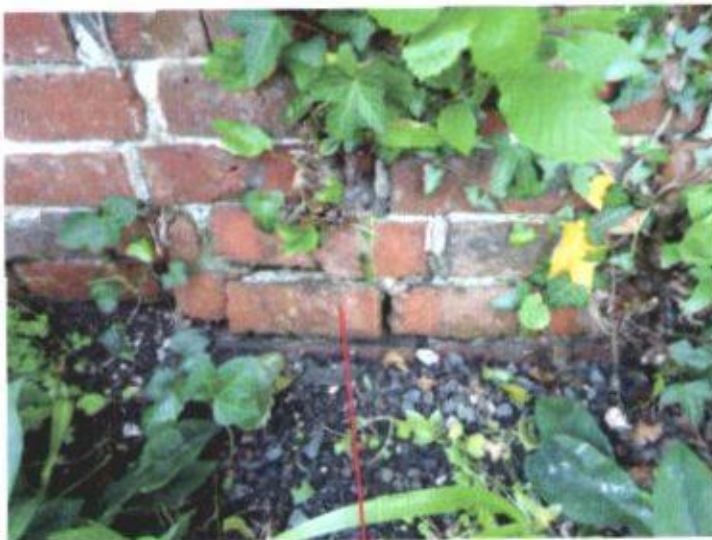
Damage to base of wall (neighbours side)

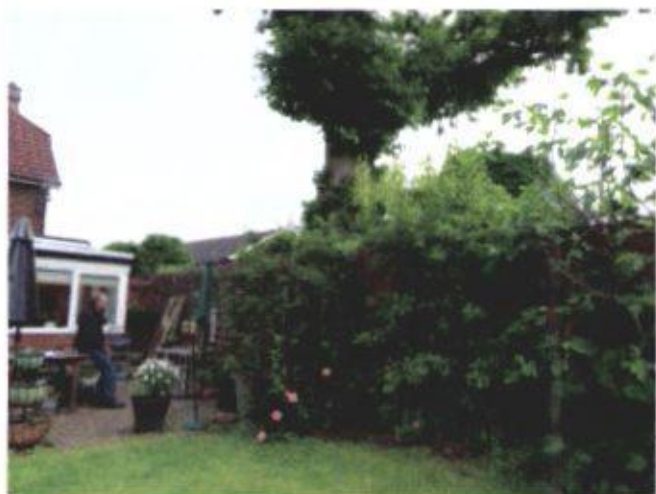
General view on neighbours side – shows tree is in close proximity to neighbours house & rear conservatory (tree is 3.5m from corner of conservatory)

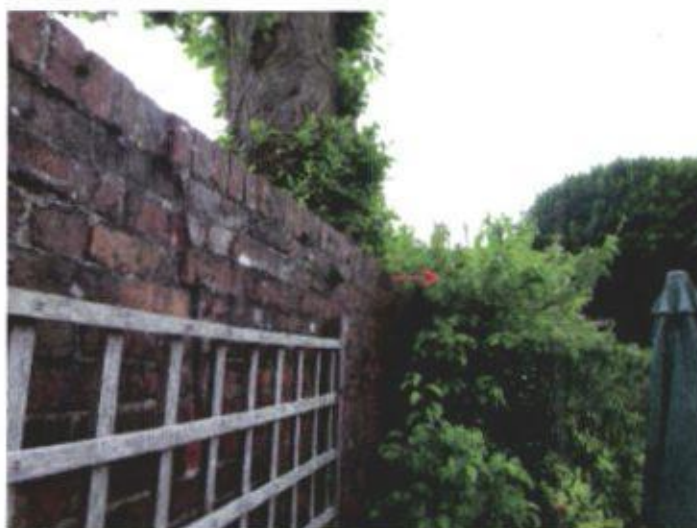
View along wall on neighbours side – shows wall leaning 70mm at top
