# Arboricultural Appraisal Report

## Subsidence Damage Investigation at:

12 Linda Grove  
Waterlooville  
Hants  
PO8 8UX

| REPORT DATE: | 14 January 2015 |

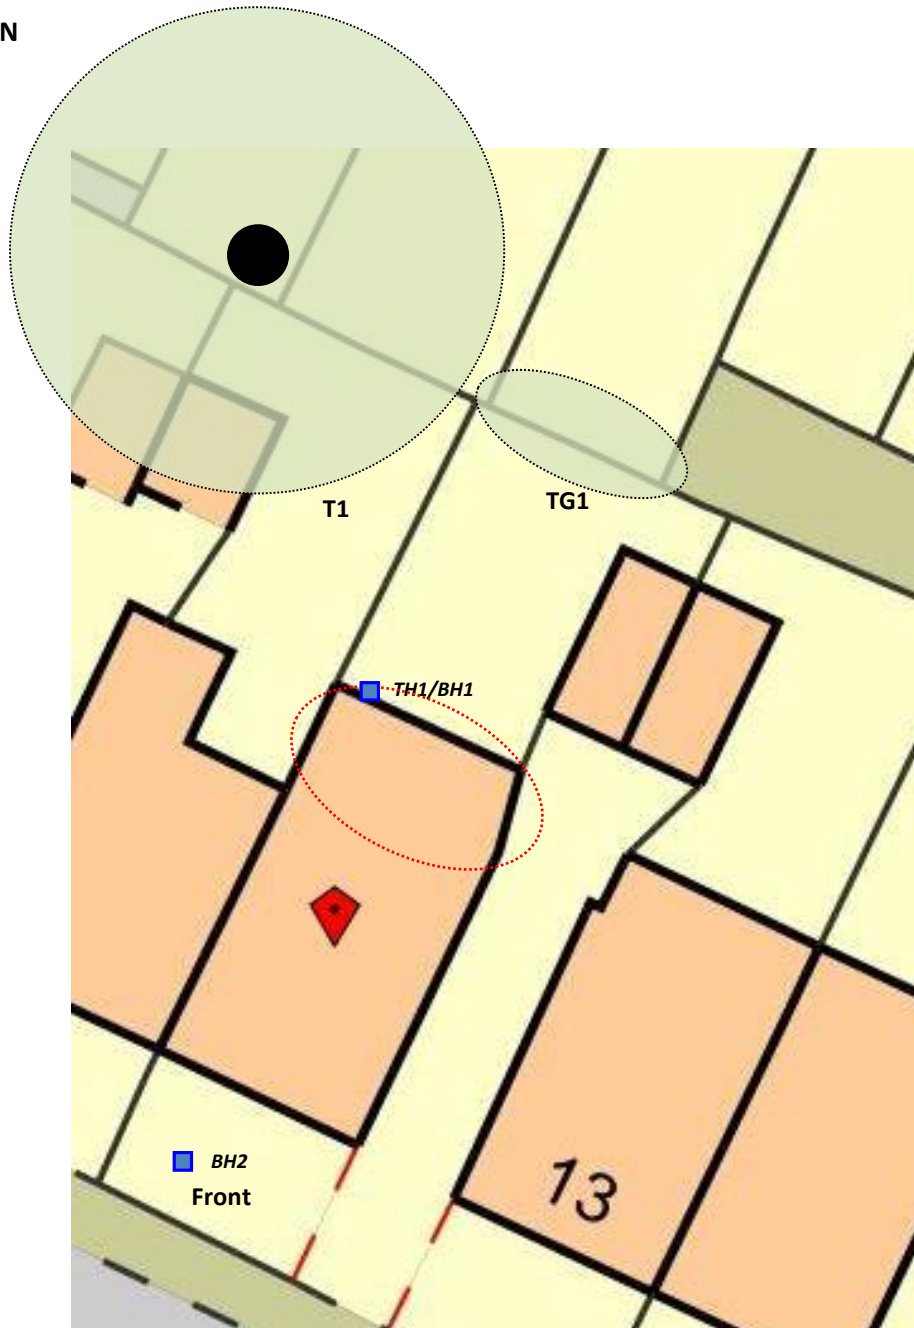
## SITE PLAN

Approximate areas of damage

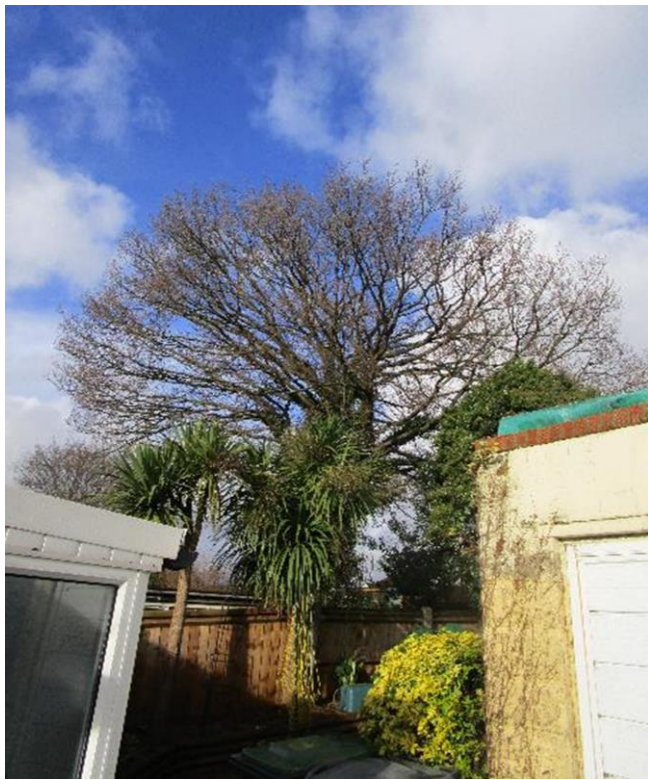
View of T1

Roots were observed to 590mm bgl in trial pit 1 and recovered samples have been positively identified (using anatomical analysis) as Quercus (Oak). Roots were also observed in borehole 1 to 3000mm bgl which have been identified as probably Quercus the origin of which will be T1 confirming the influence of this vegetation on the soils below the foundations.

Based on the technical reports currently available, engineering opinion and our own site assessment we conclude the damage is consistent with shrinkage of the clay subsoil related to moisture abstraction by vegetation. Having considered the available information, it is our opinion that T1 is the material cause of the current subsidence damage. If an arboricultural solution is to be implemented to mitigate the current damage and allow the soils beneath the property to recover to a position such that an effective repair solution can be implemented we recommend that T1 is removed.

| Tree No. | Species | Ht (m) | Dia (cm) | Crown Spread (m) | Dist. to building (m) | Age Classification | Ownership |
|---|---|---|---|---|---|---|---|
| T1 | Oak | 18* | 75* | 16* | 11.5 | Older than property | 3 <sup>rd</sup> Party:- 27b Durley Avenue |

| Tree No. | Species | Ht (m) | Dia (cm) | Crown Spread (m) | Dist. to building (m) | Age Classification | Ownership |
|---|---|---|---|---|---|---|---|
| Recommendation | | Remove and treat stump to inhibit regrowth | | | | | |

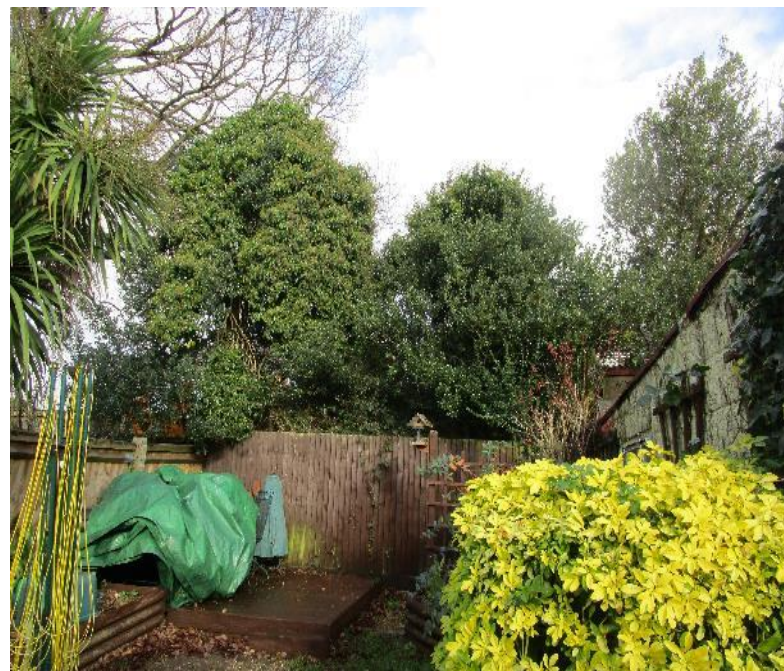
View of TG1

| Tree No. | Species | Ht (m) | Dia (cm) | Crown Spread (m) | Dist. to building (m) | Age Classification | Ownership |
|---|---|---|---|---|---|---|---|
| TG1 | Holly | 8 | 20* | 4 | 9 | Younger than property | 3 <sup>rd</sup> Party:- 25 Durley Avenue |

| Tree No. | Species | Ht (m) | Dia (cm) | Crown Spread (m) | Dist. to building (m) | Age Classification | Ownership |
|---|---|---|---|---|---|---|---|
| Recommendation | | Do not allow to exceed current dimensions | | | | | |
