**RESIDENTIAL DEVELOPMENT  
MANOR FARM & COPSEYS NURSERY  
DENVILLES  
HAVANT  
HAMPSHIRE**

**SUDS INSPECTION REPORT**

**BARRATT DAVID WILSON HOMES SOUTHAMPTON**

**25<sup>TH</sup> FEBRURAY 2016**

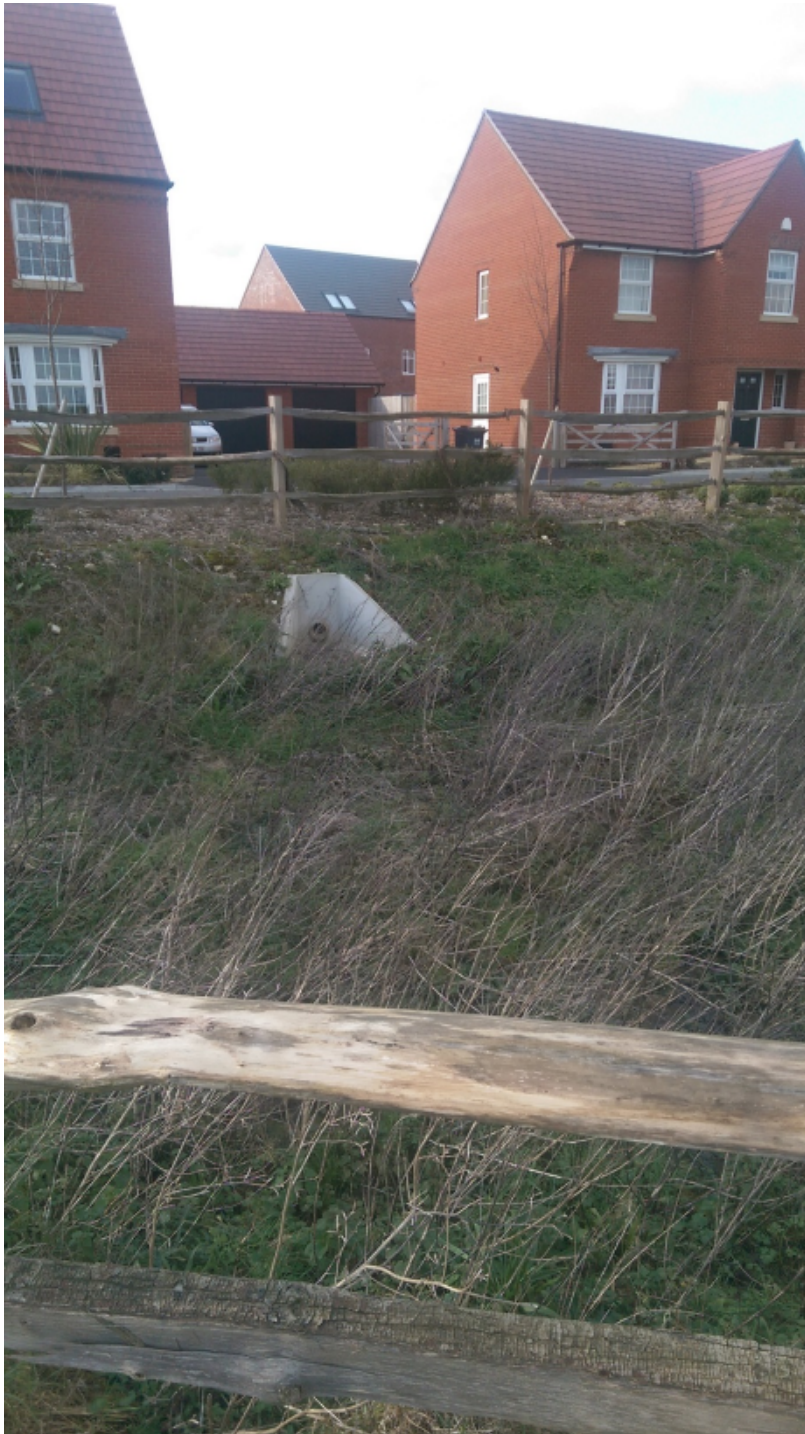
- 2.1 The associated inlet headwalls and high level overflows from the road sub-base for Attenuation pond No.1 (Manor Farm southernmost) has been constructed in accordance with the approved design.  
The required safety measures to pond No.1 including fencing and lifebuoy are provided (Image 1 & 2).
- 2.2 Evidence of impermeable membrane used in pond (image 3).
- 2.3 The outfall headwall, flow control chamber and the downstream outfall pipe to the Nore Farm Stream has been constructed (image 5).
- 2.4 Link headwall between ponds (image 4)

**Image No.1** – Overflow from permeable carriageway with protection fencing

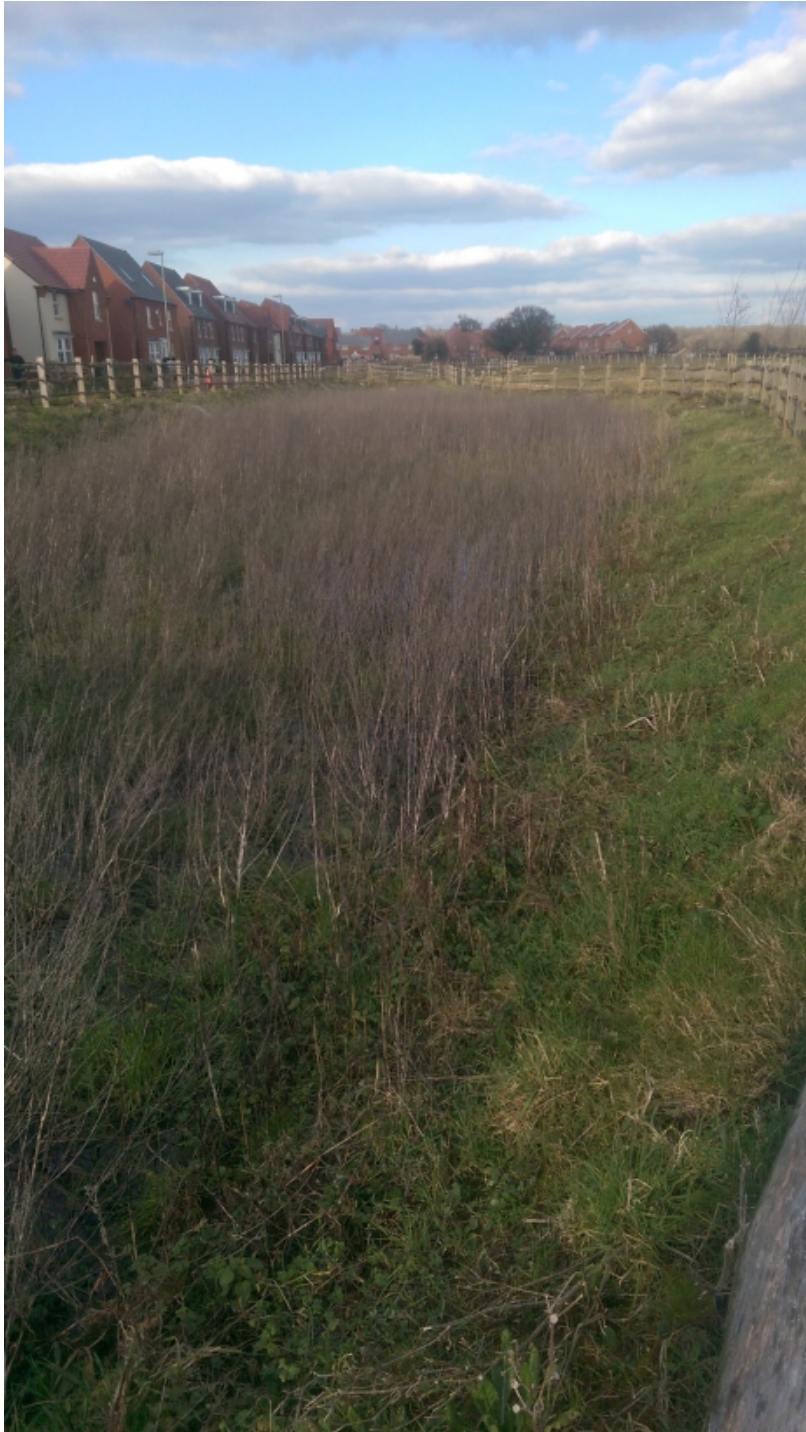
**Image No.2** – Pond with protection fencing and Lifebuoy

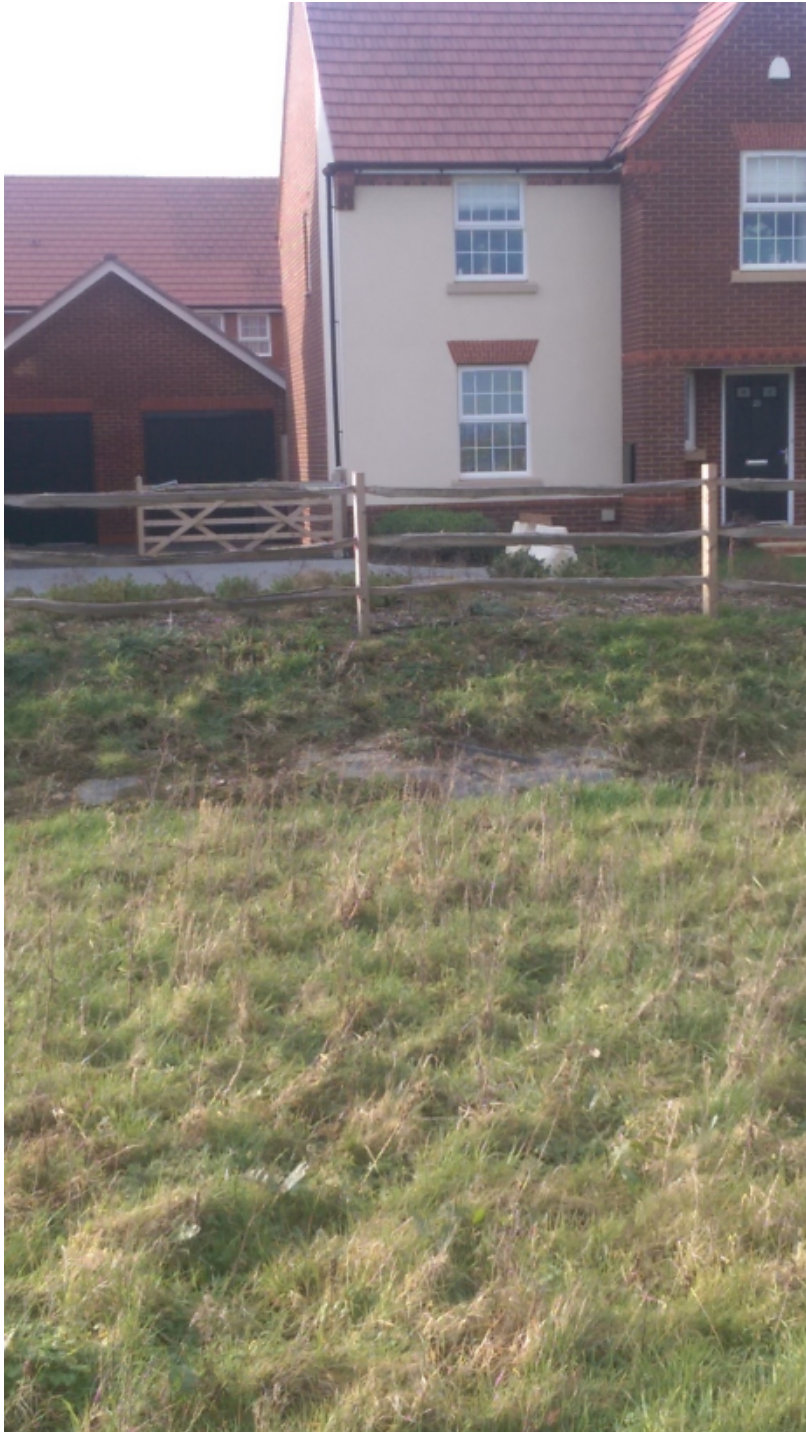
**Image No.3** – Pond liner evident on embankment

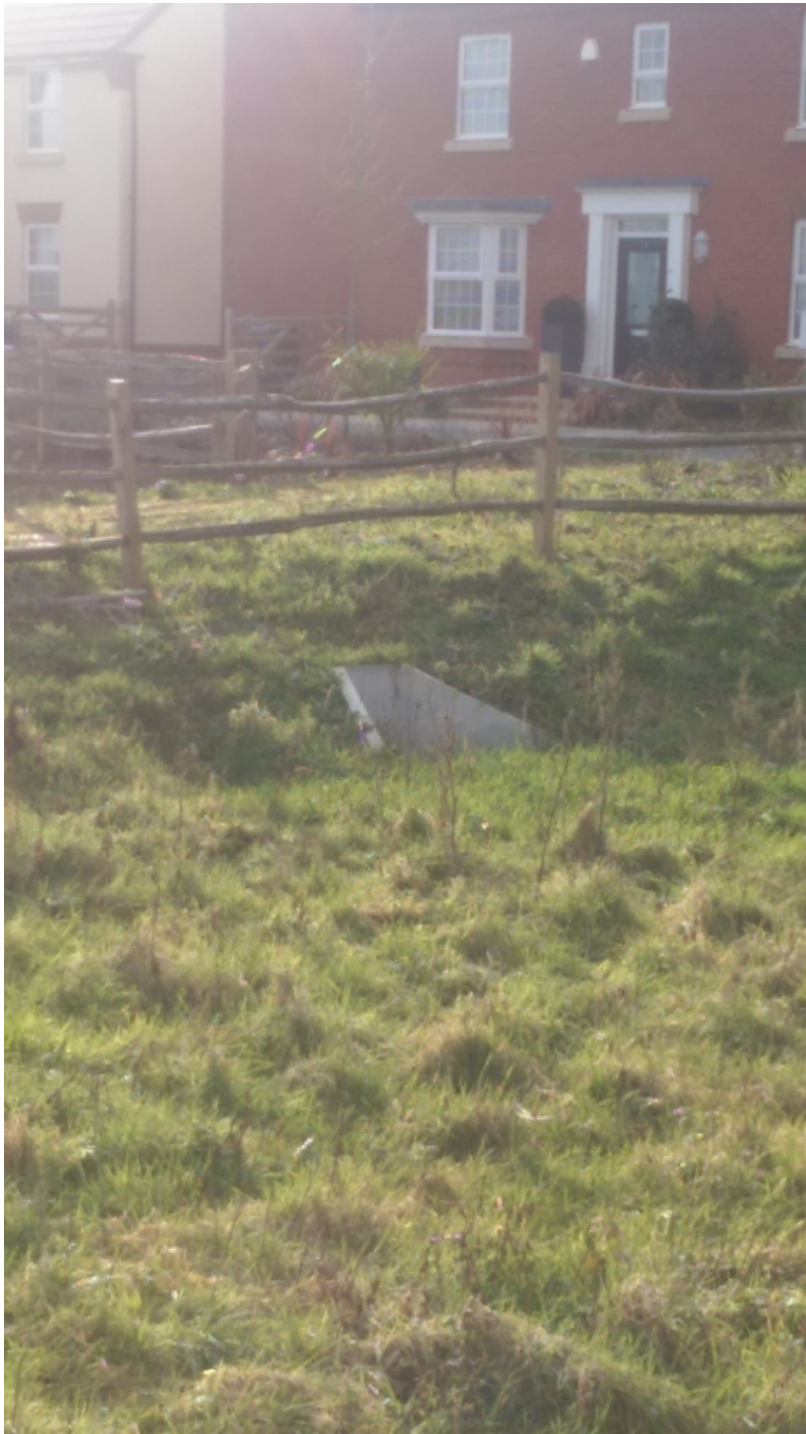
**Image No.4** – Headwall link between ponds with protection fencing

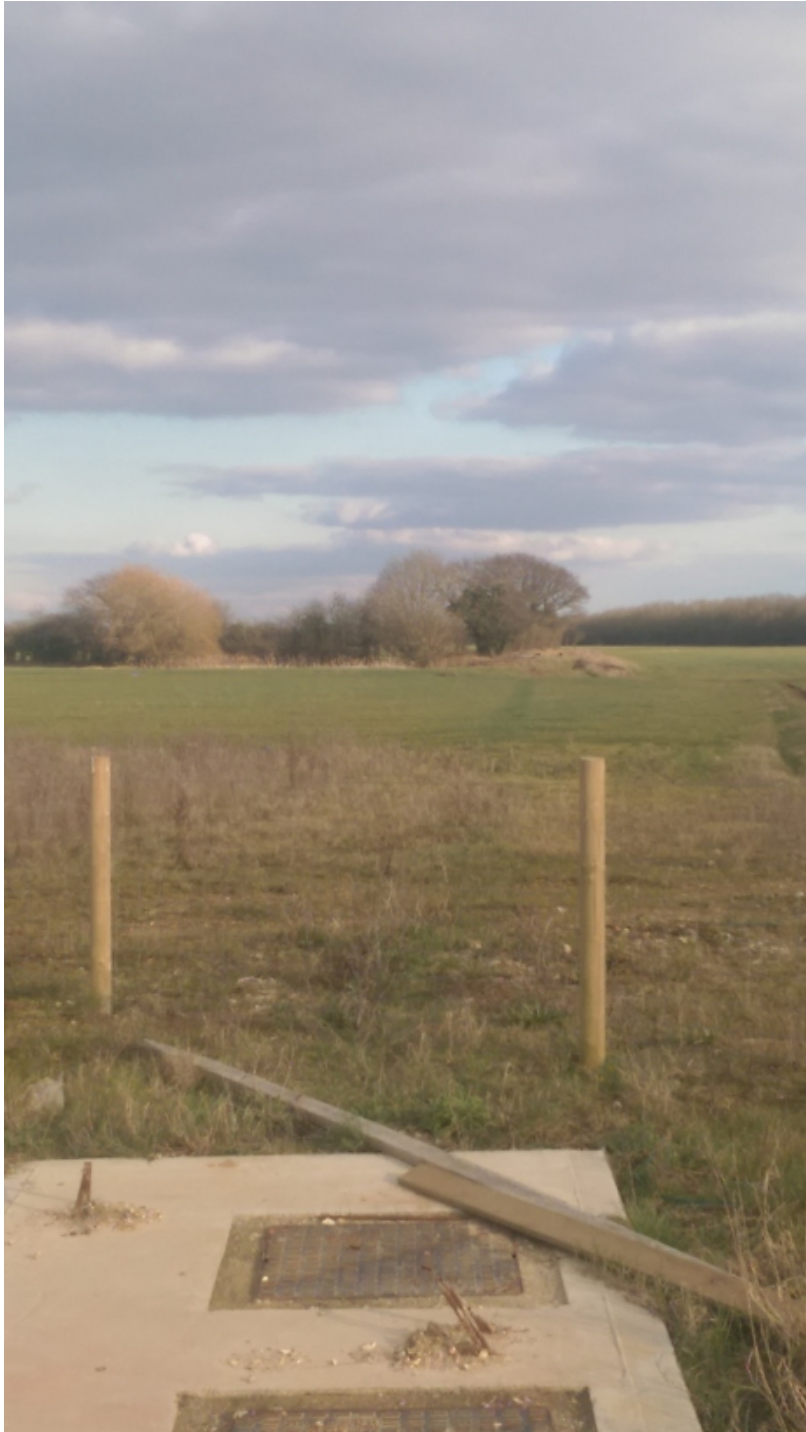
**Image No.5** – Control structure and route of outfall to existing pond

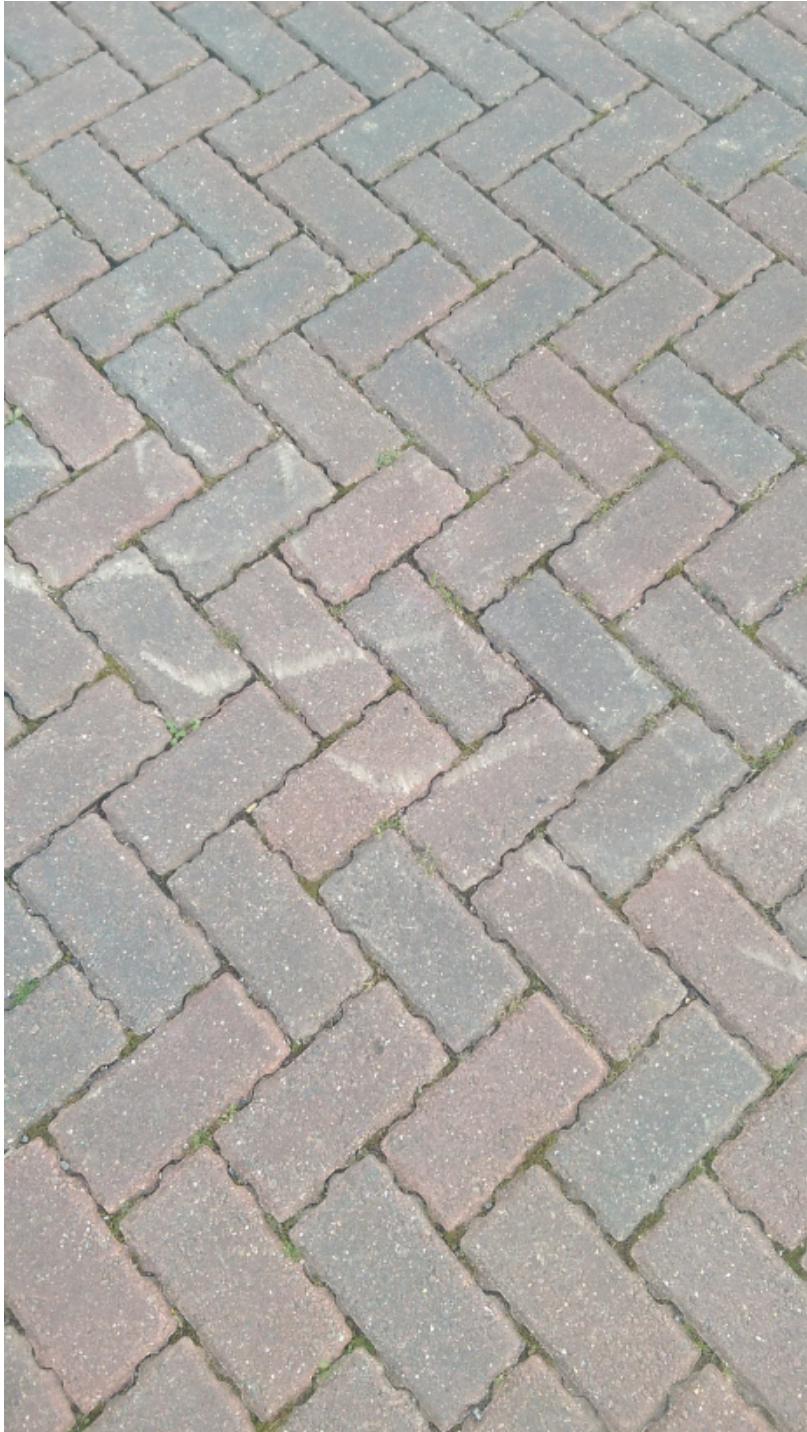
**Image No.6** – Permeable paving with moss in joints

Maintenance of the permeable paving is required ie removal of detritus from the block joints by vacuum sweeping. This will improve performance and longevity of the system

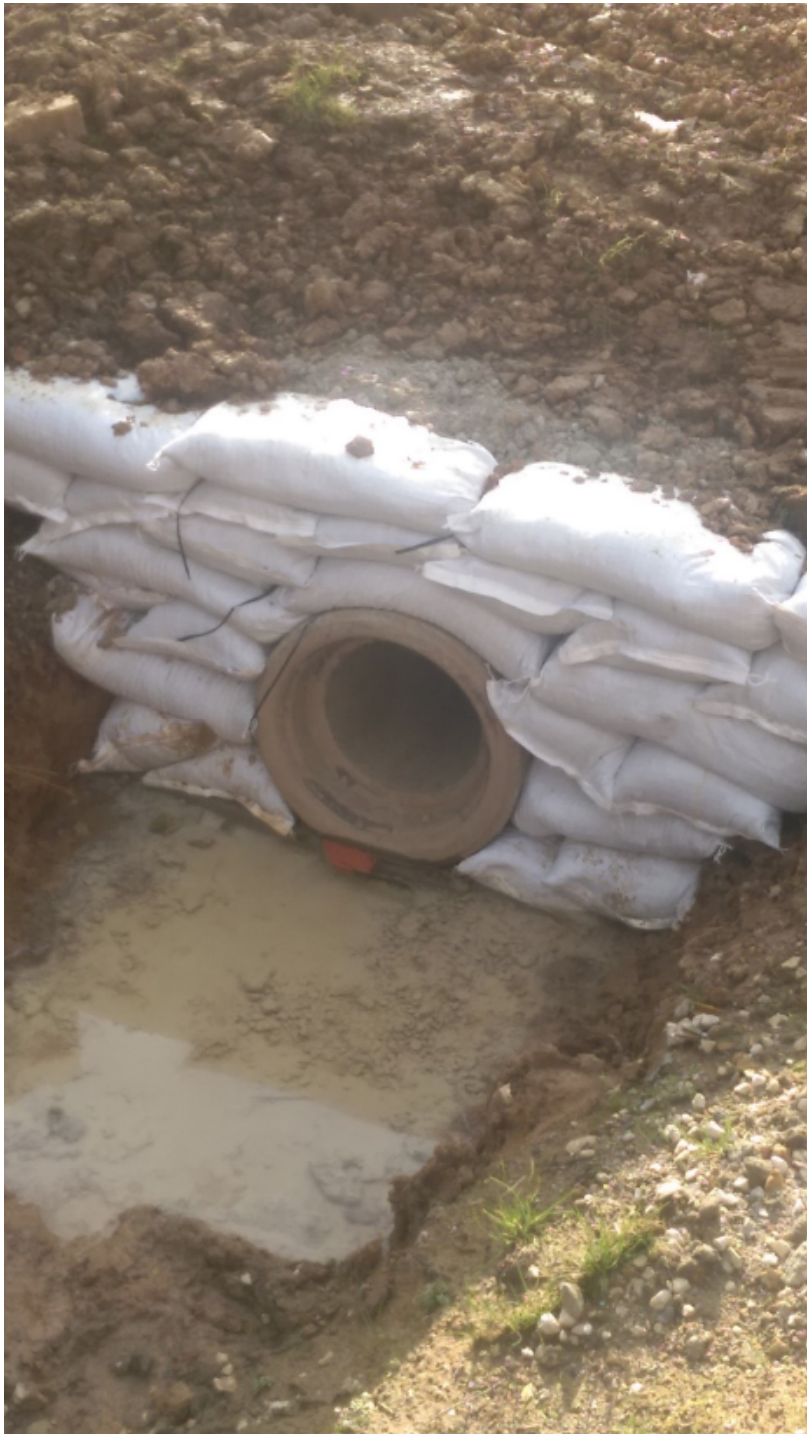
- 3.1 The perforated piped land drainage system for Manor Farm is now fully constructed along the western boundary of the site and the connection to the attenuation ponds has also been installed via a standard pipe outfalling into chamber LD1 (refer to previous SUD's report for details)
- 3.2 Land drainage outfall for Copsesy Nursery (image 7).

**Image No.7-** Copsey Nursery land drainage outfall

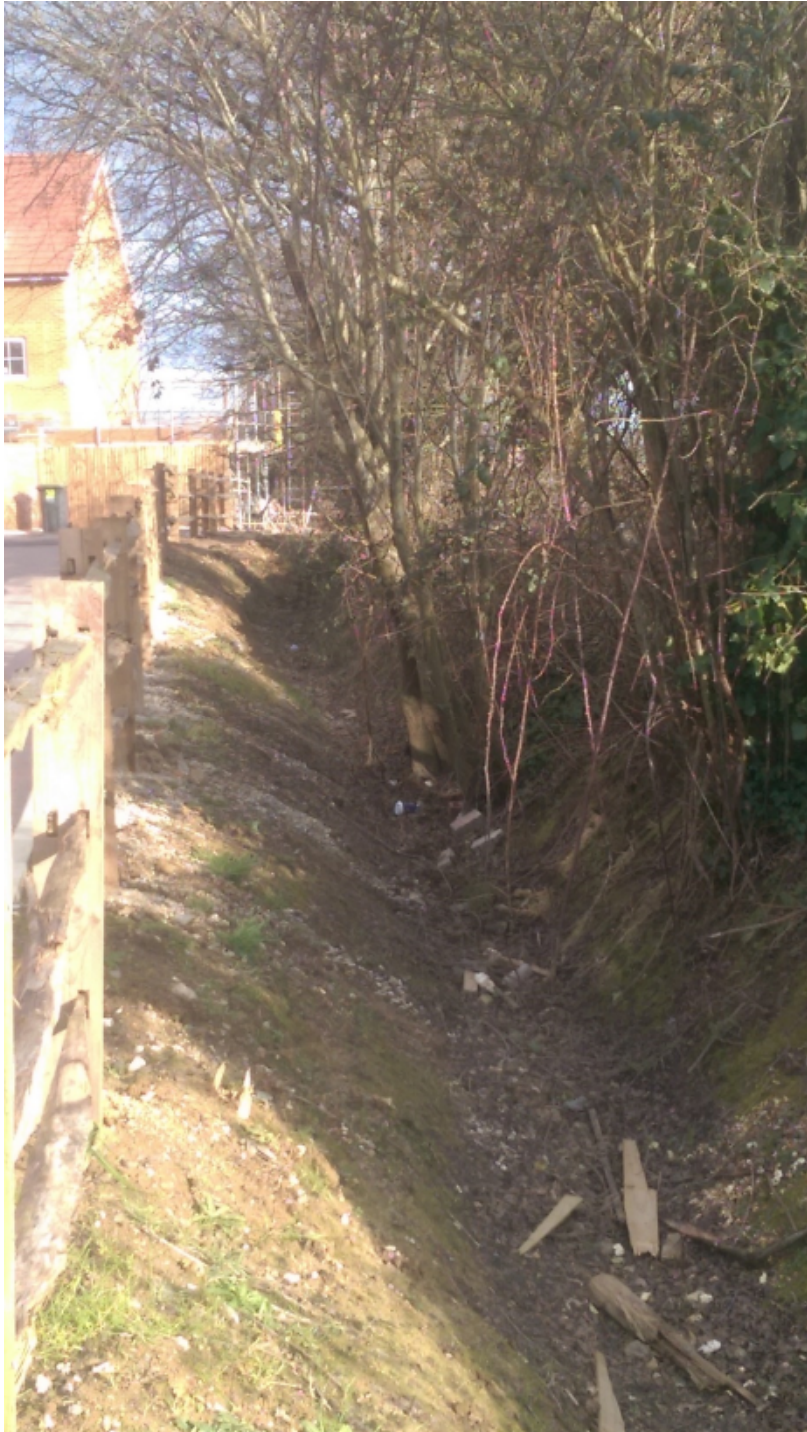
**Image No.8** – Ditch between Manor Farm and Copsey Nursery cleaned out

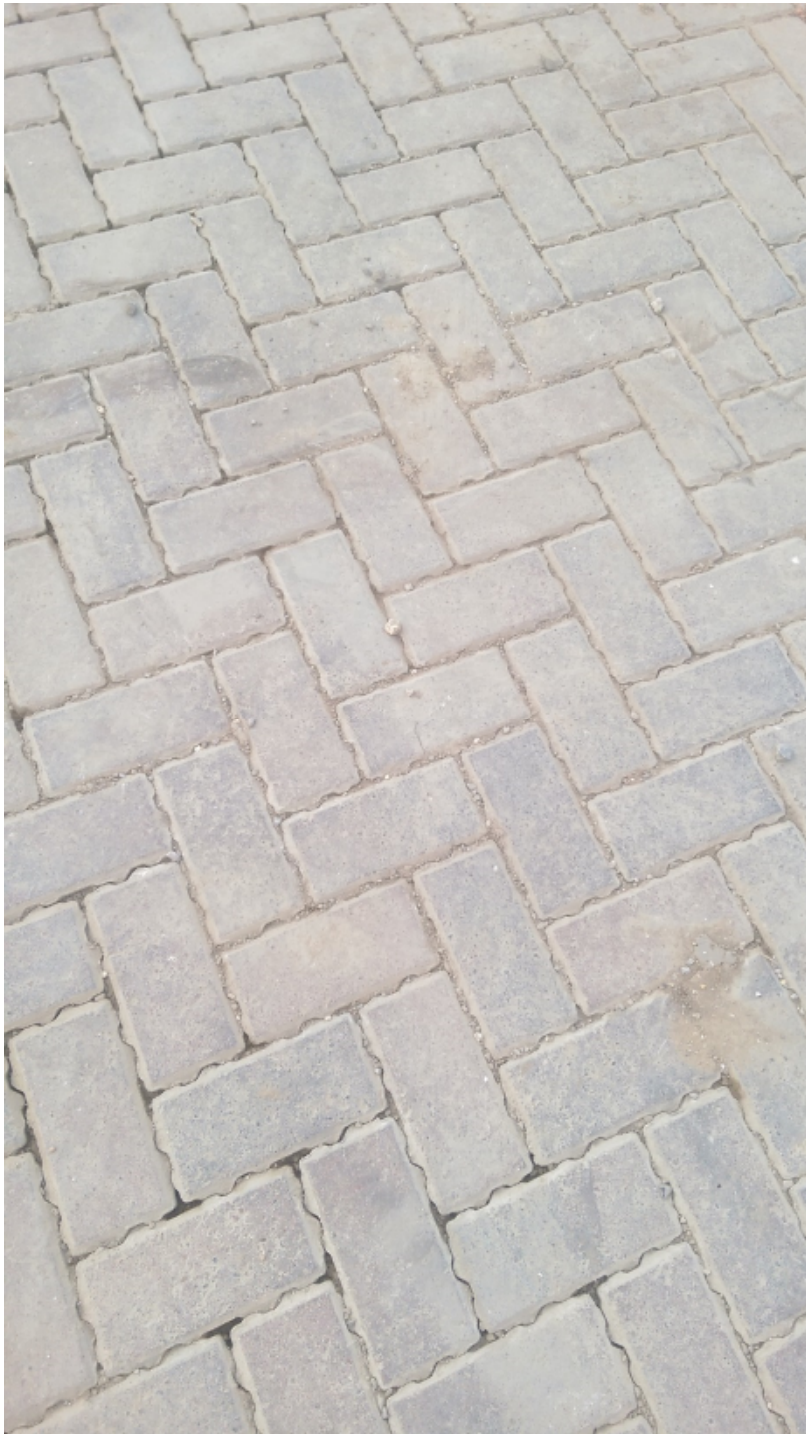
**Image No.8** – Permeable paving in Manor Farm with evidence of joints infilled with mud

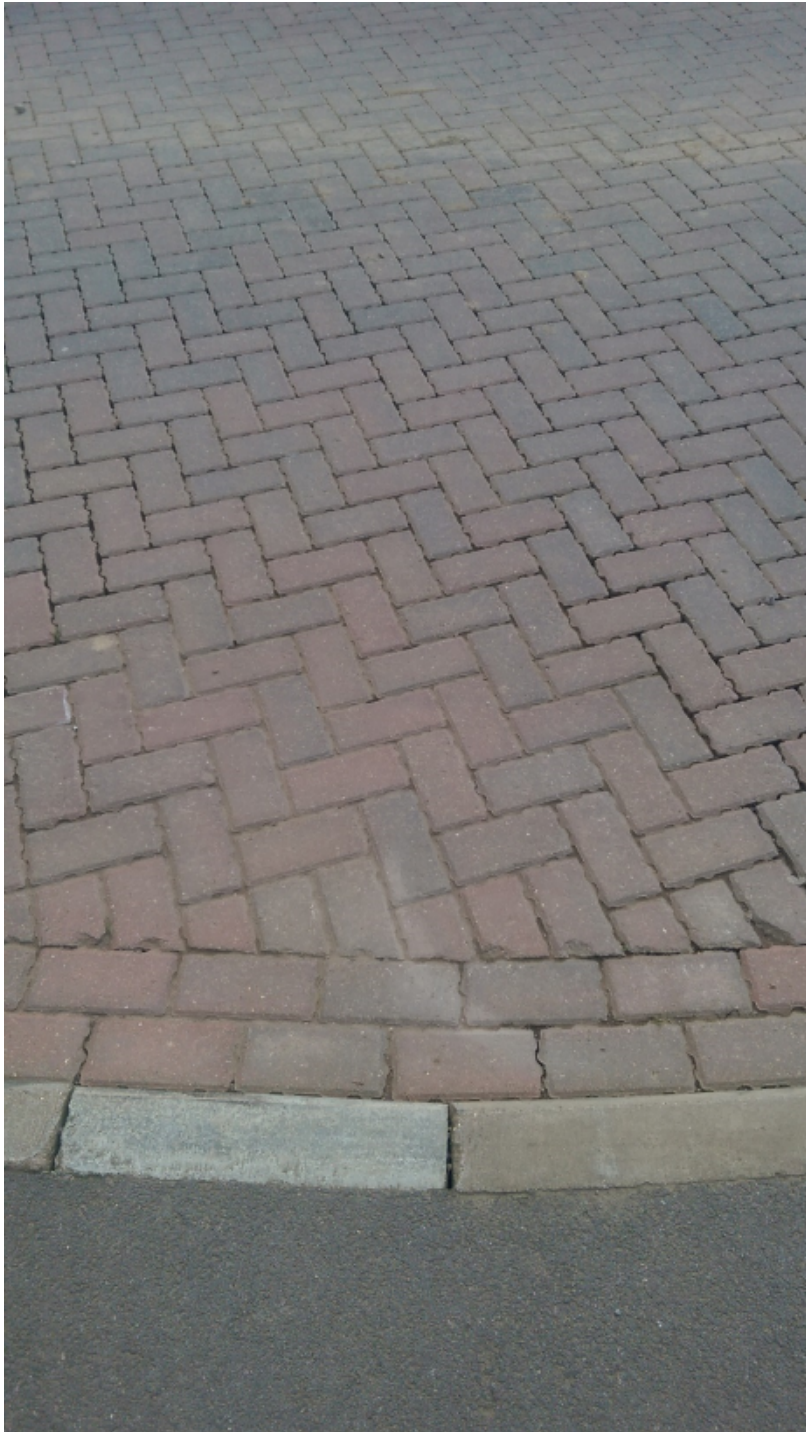
**Image No.9** – Permeable paving in Copsey Nursery with evidence of ponding due to infilled joints

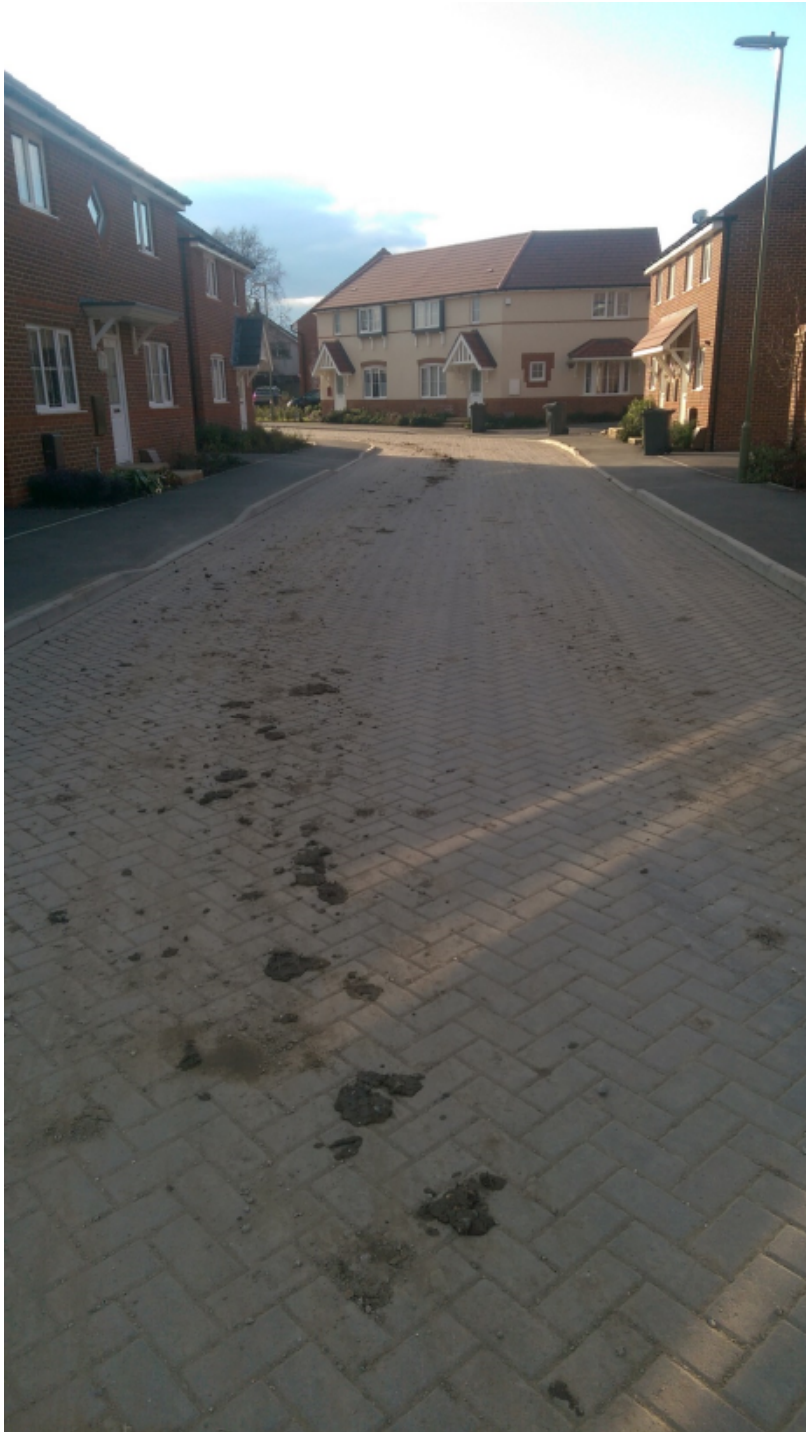
**Image No.10** – Permeable paving on Copsey Nursery being used by construction traffic causing blockage of the joints
