Address: Harbour View, Marine Walk, Hayling Island, Hampshire

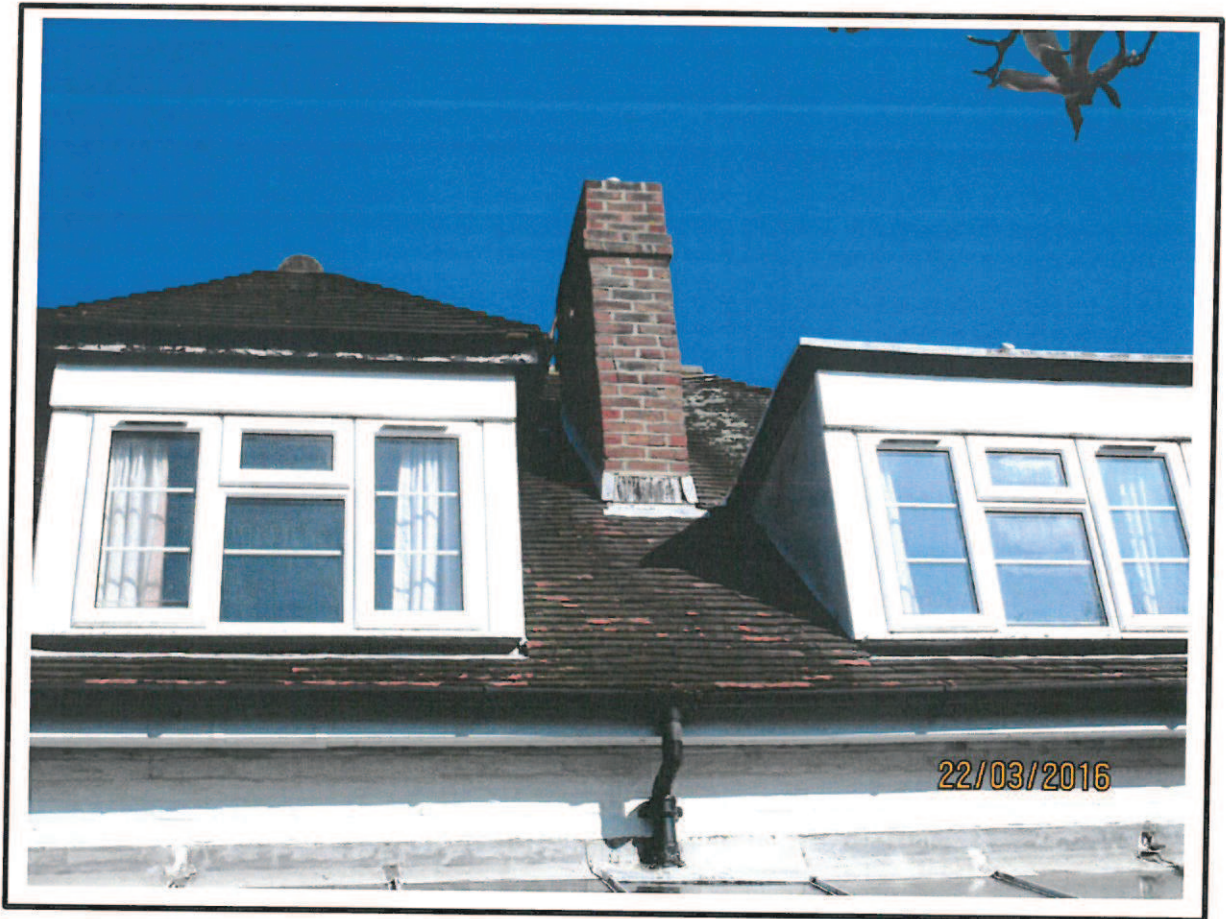
Chimney and delaminating tiles

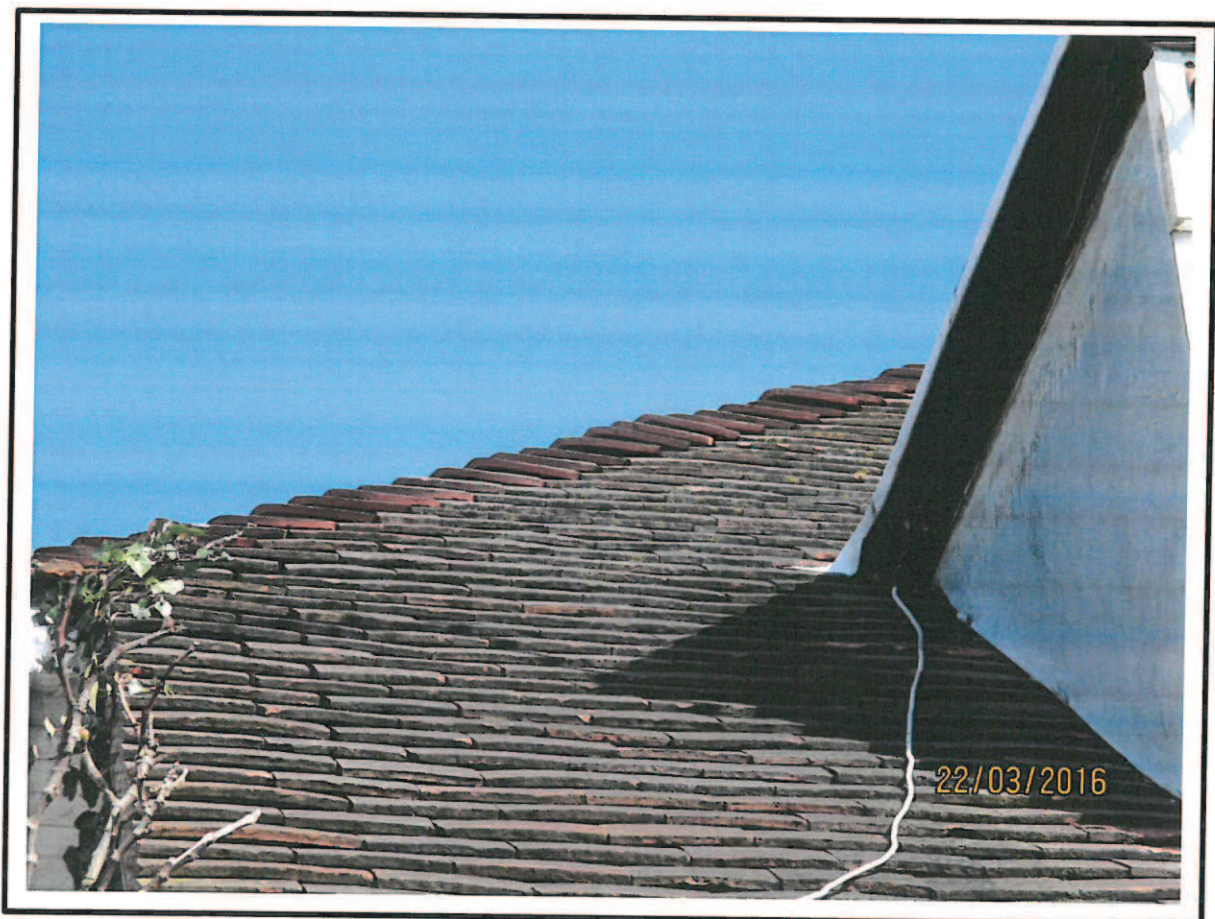
Bonnet hip tiles standing proud

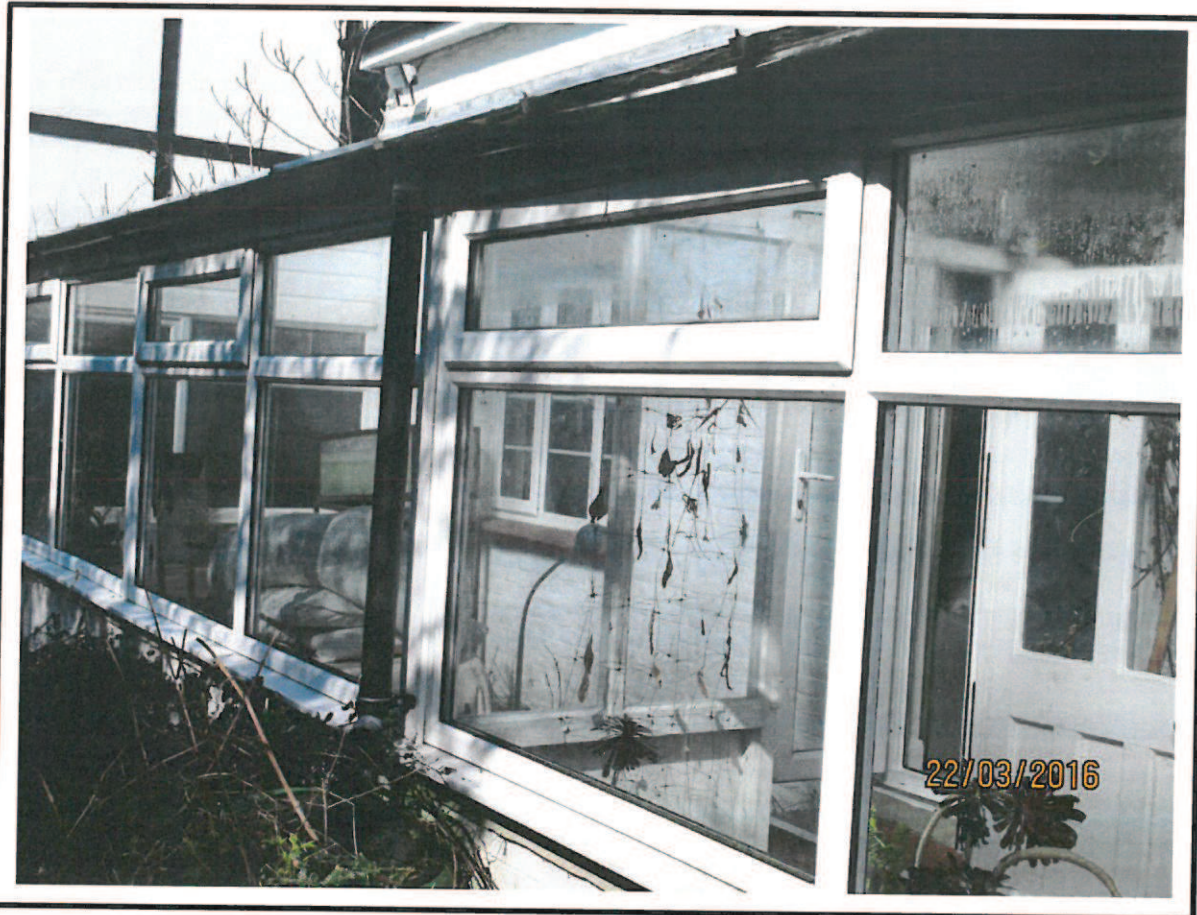
Distorted gutter to rear conservatory

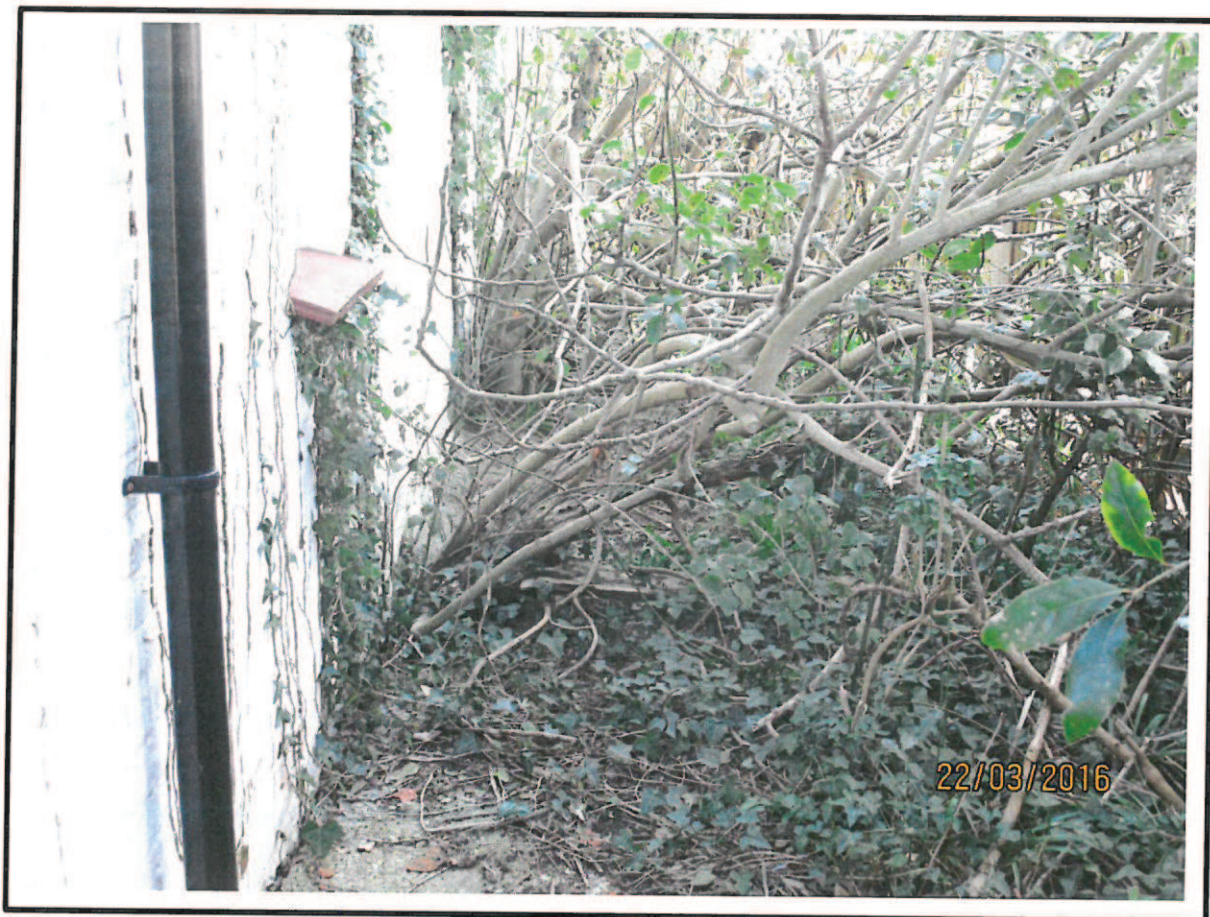
Saplings adjoining exterior wall

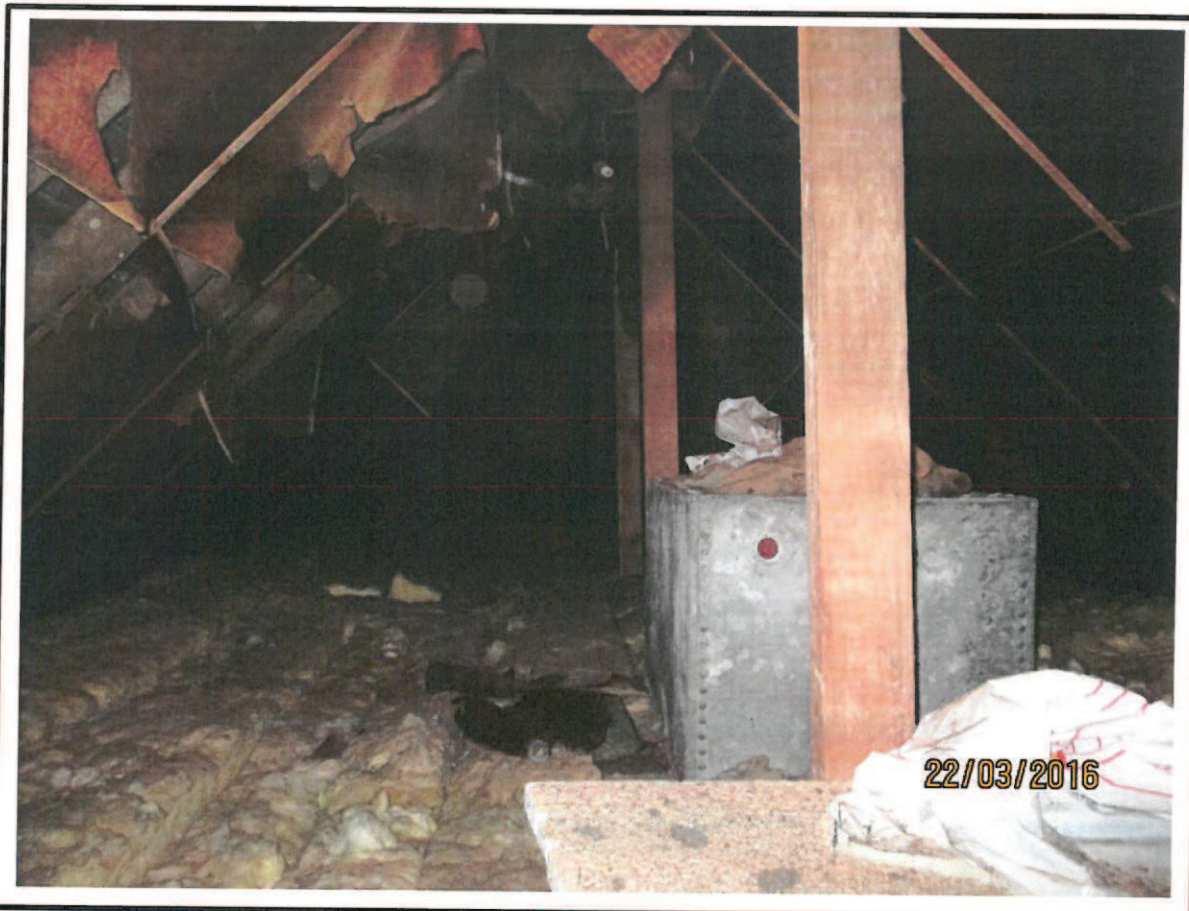
Roof void and redundant tank

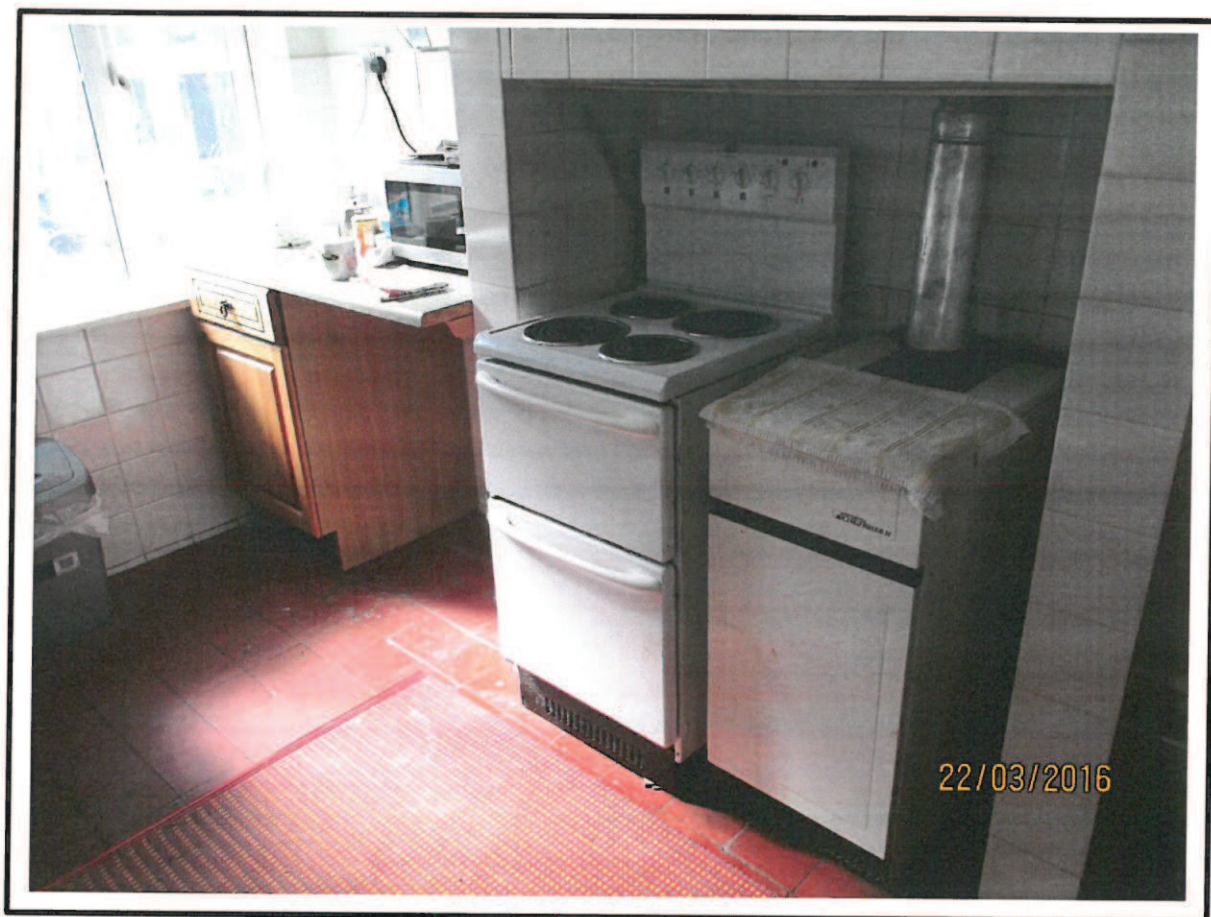
Boiler in chimney recess

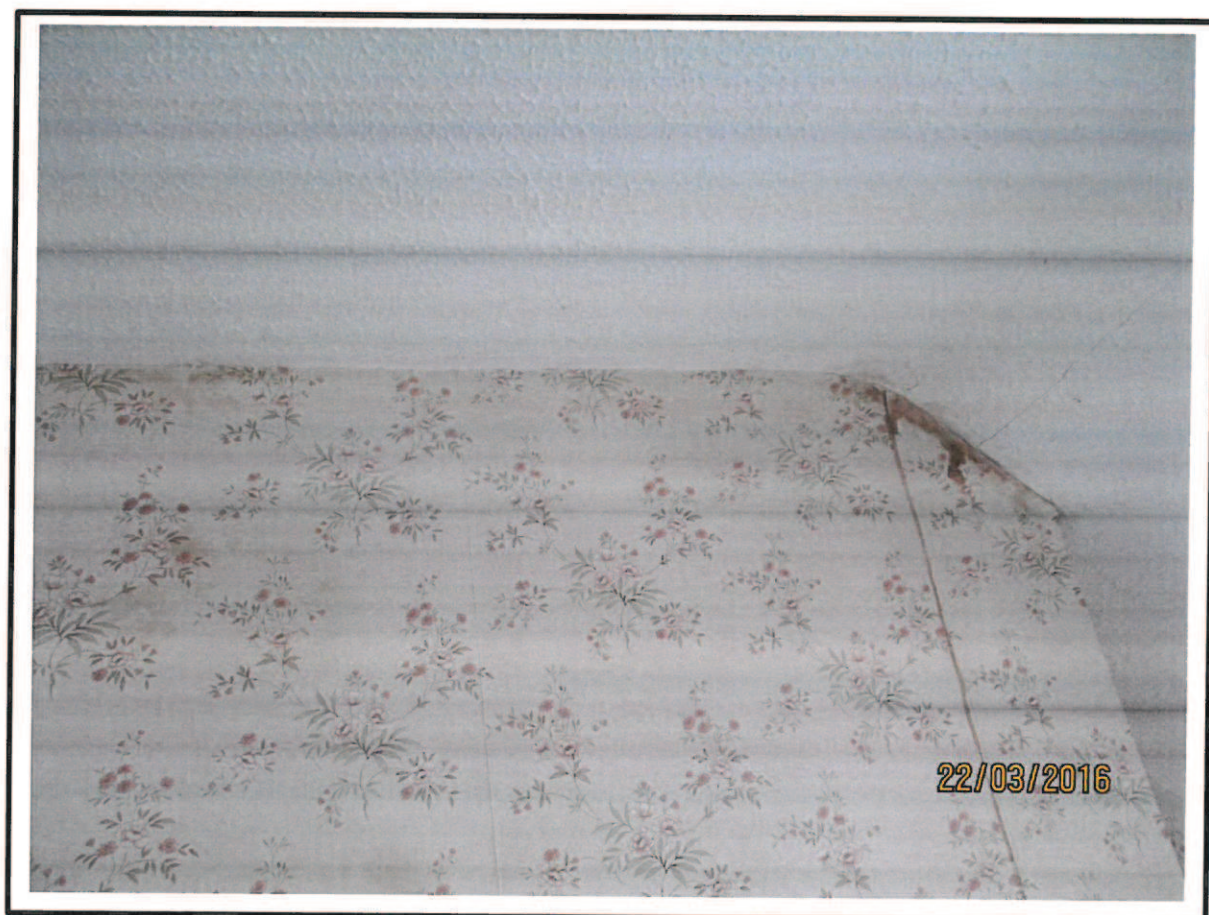
Staining to chimney breast

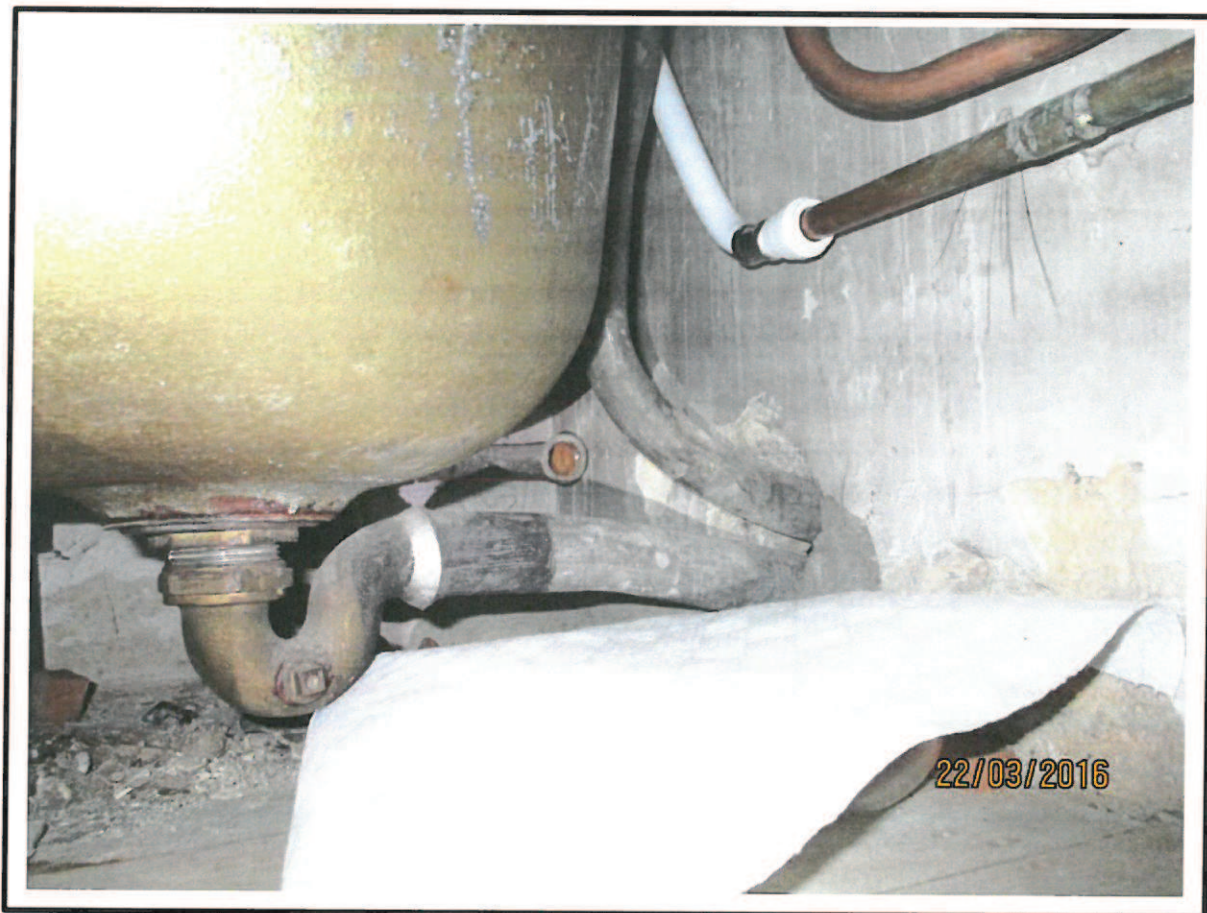
Lead wastes to bath
