September 2015

**A BS 5837 Tree Survey Report, Tree Constraints Plan,  
Arboricultural Impact Assessment and Tree Protection Plan  
for**

**Whittington Designer Homes Ltd  
at**

**11, Bound Lane, South Hayling**

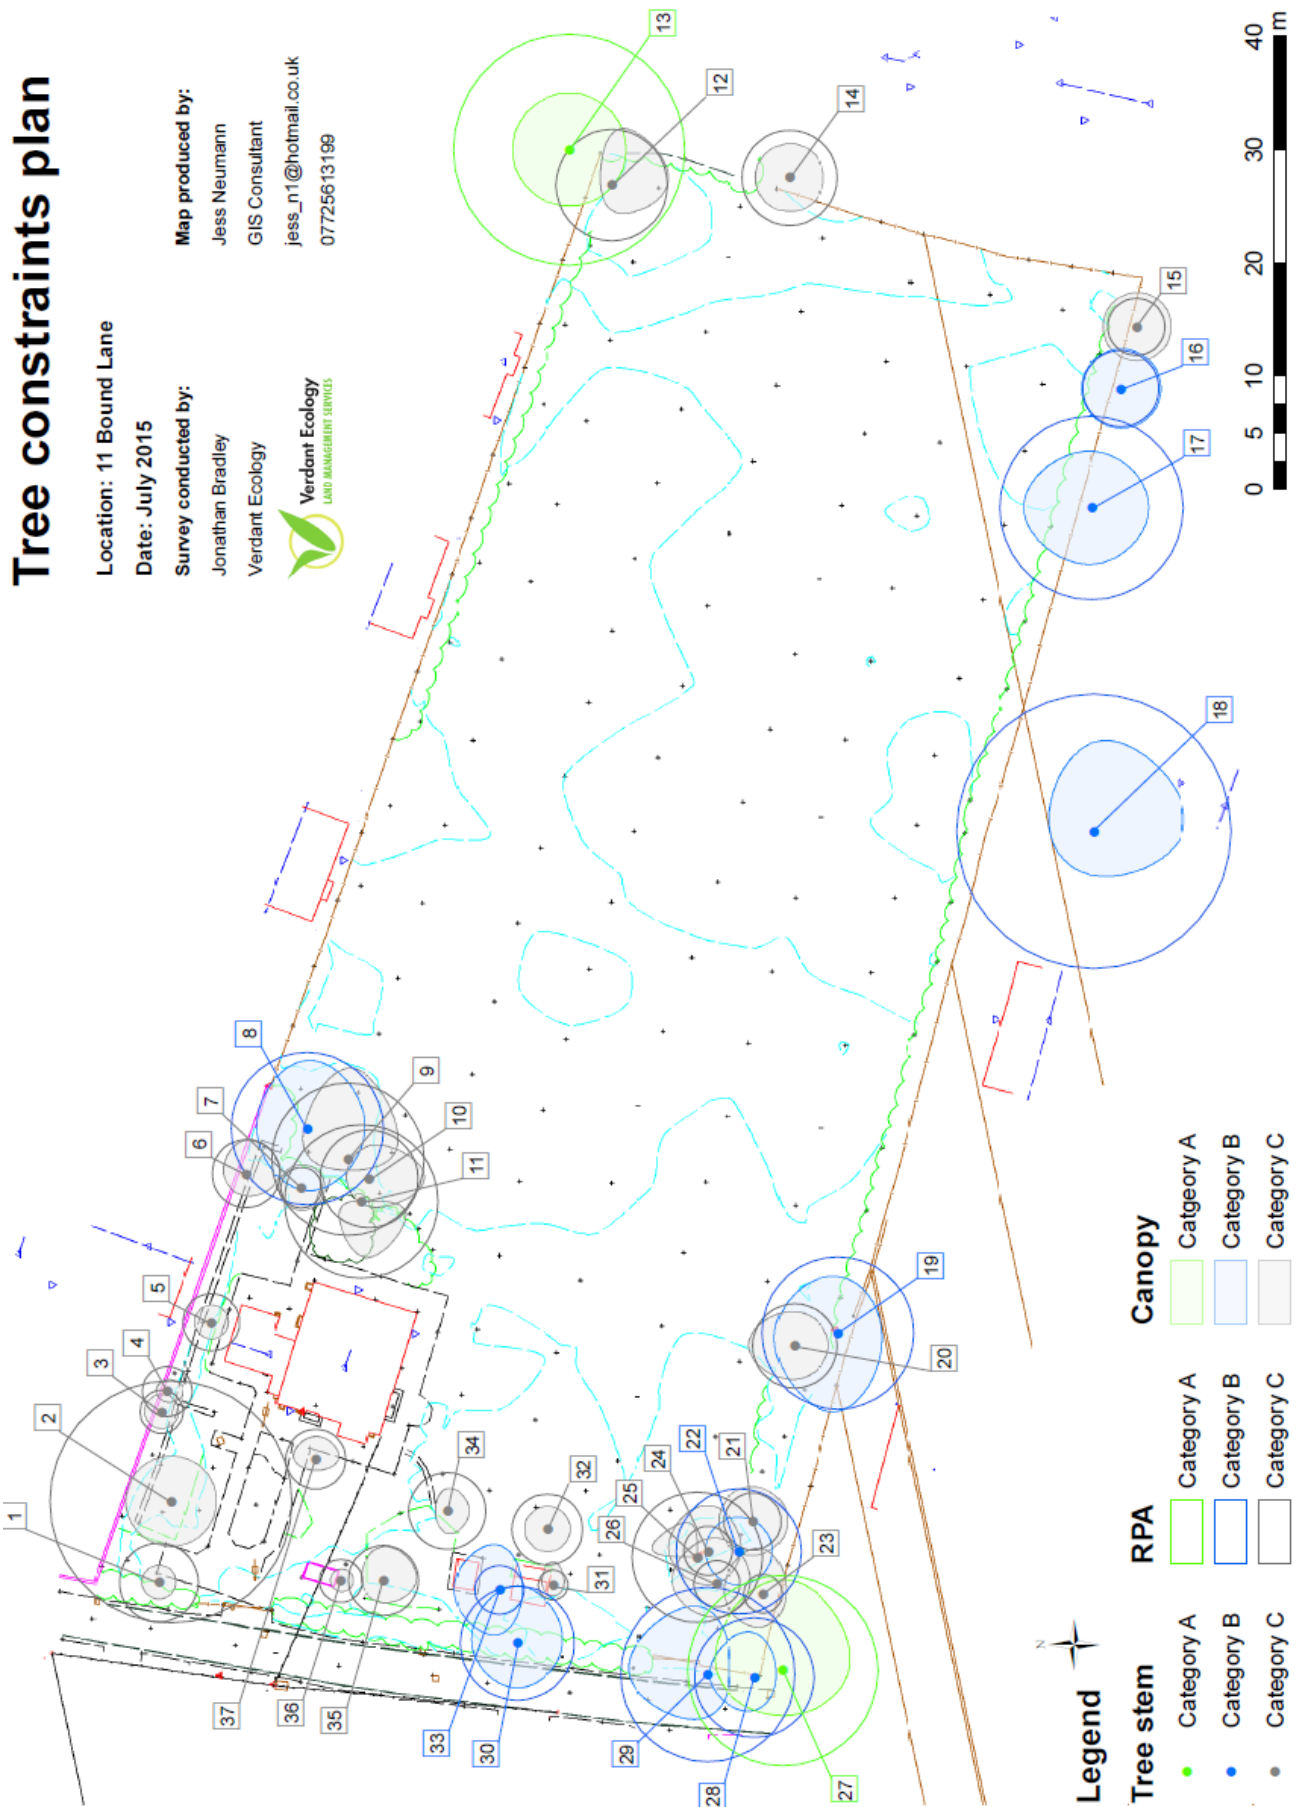
## 8.2 Appendix 2. Tree Constraints Plan

The TCP in Appendix 2 shows the locations of trees on/near the site, their BS5837 category, their canopy extents and RPA. RPA have not been offset/adjusted.

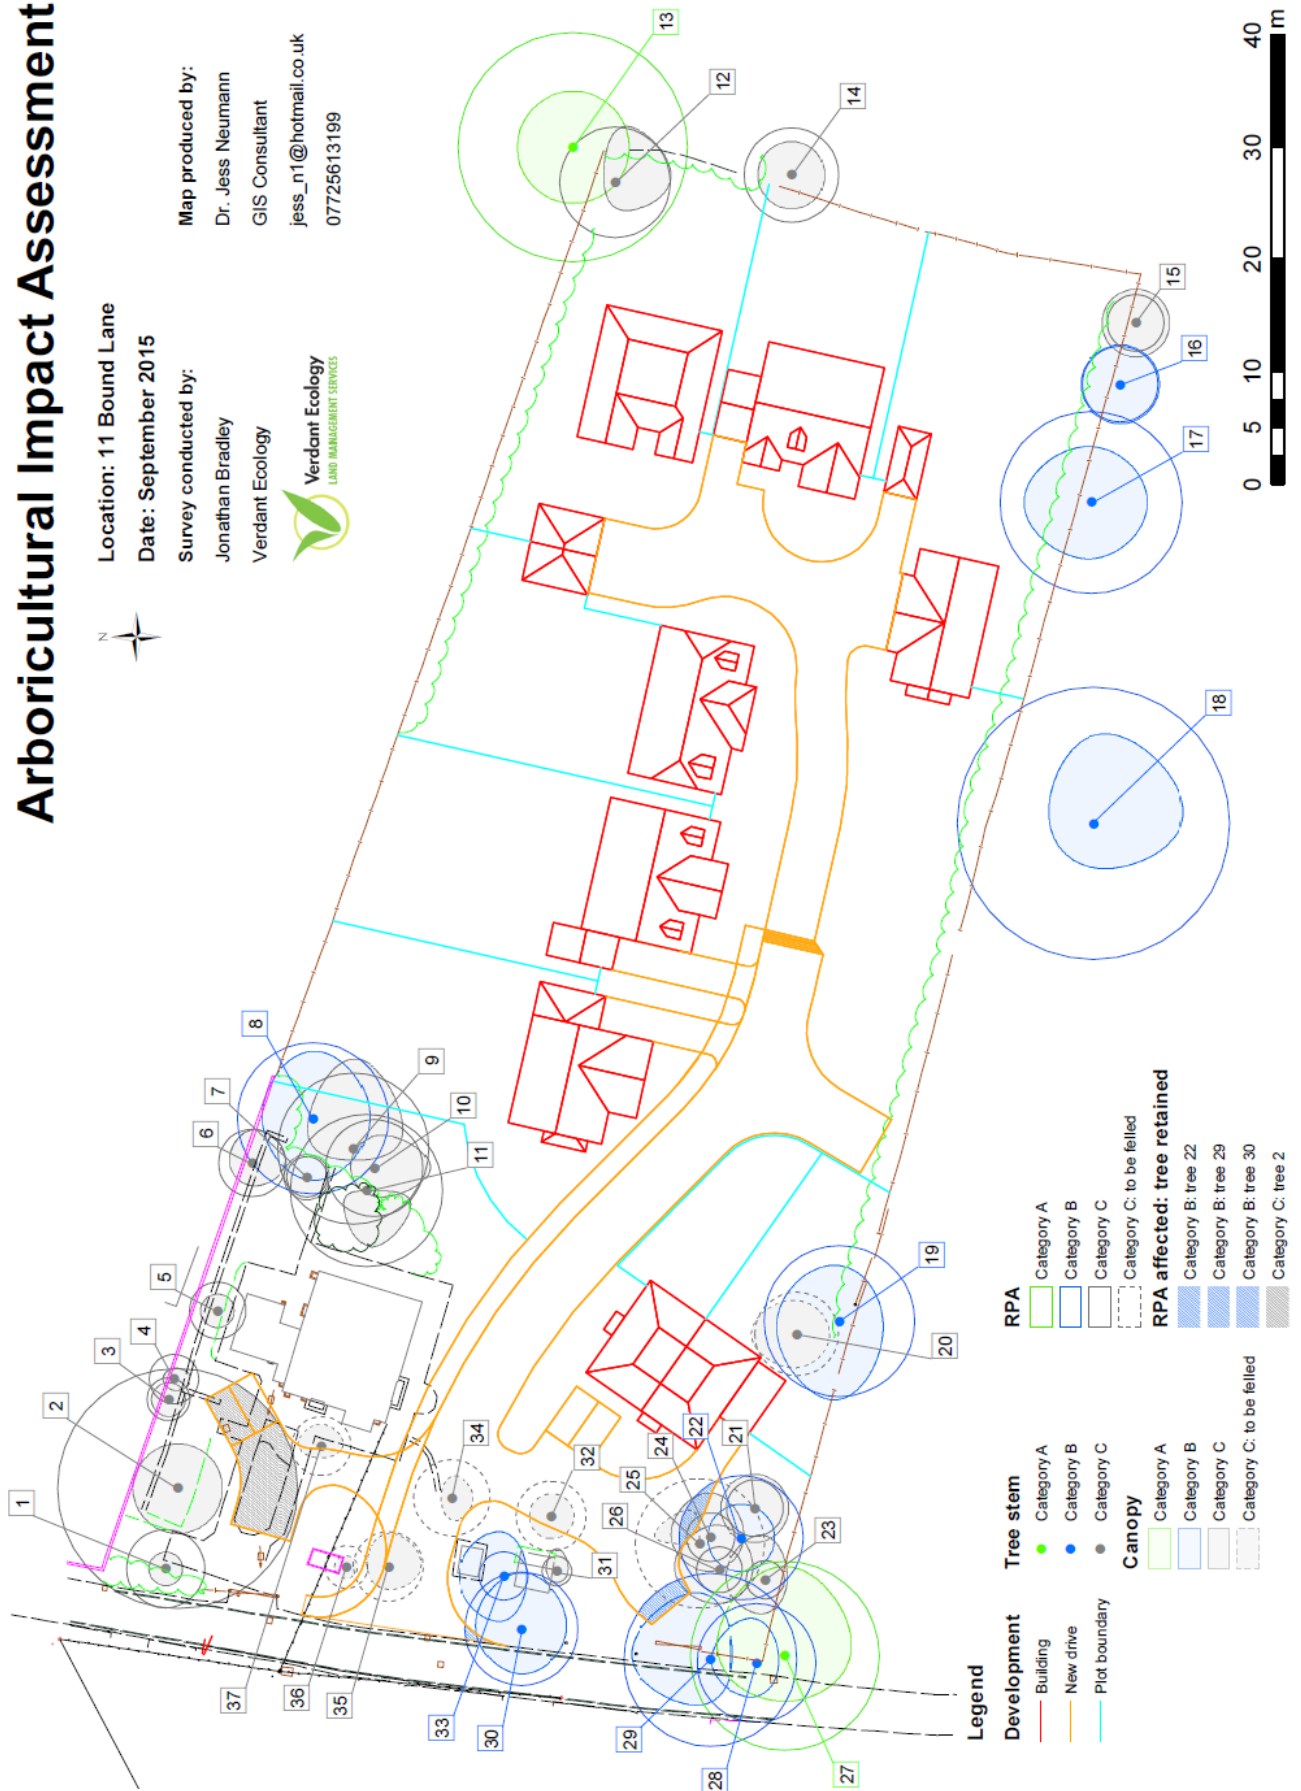
### 8.3 Appendix 3. Arboricultural Impact Assessment Plan

Trees numbered 20, 25, 32, 34, 35, 36, 37 will be felled. These are all C-categorised. Of these tree 25 was considered to have Medium BRP so needs to be included in the bat surveys proposed by the baseline ecology survey.

Trees numbered 2, 22, 29, 30 will have activity within their RPA.

- 2 is a C-categorised tree (because it has been heavily managed) but is a frontage tree, visible from the street so it is intended for retention. This will be affected by the removal of existing paving slabs and the creation of a driveway in the RPA. The RPA could feasibly be reduced because it has been so heavily managed but this has not been done (nor should it be) because a large portion of the RPA is off site (and thus beyond 'control').
- 22, 29 and 30 are all B-categorised. I understand that 29 and 30 have a Tree Preservation order in place.
