Our Ref: J1221/R01c

11 August 2015

**RE : 2 Pine Grove Havant - Specific Structural Inspection Report - Rear garden wall adjacent tree**

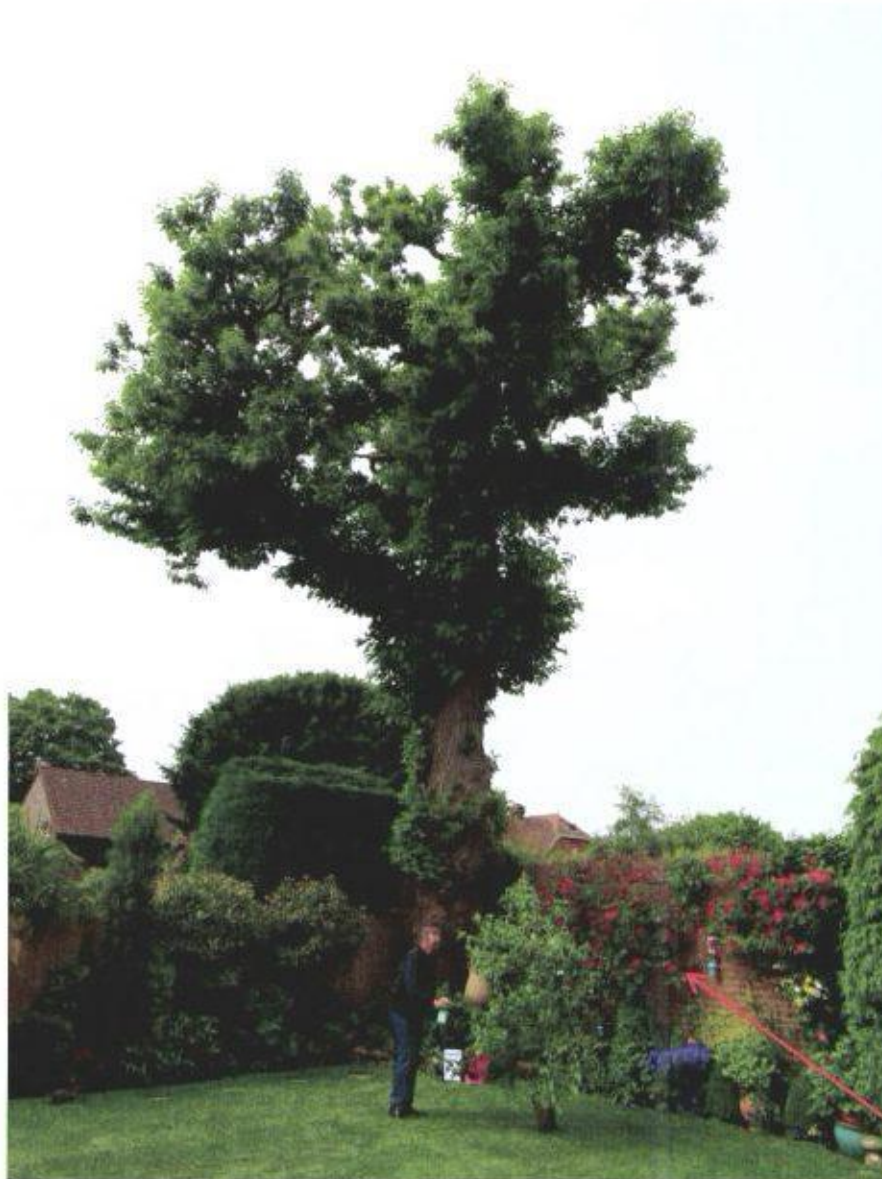
Typical view on rear viewing from house showing mature Sweet Chestnut with garden wall behind

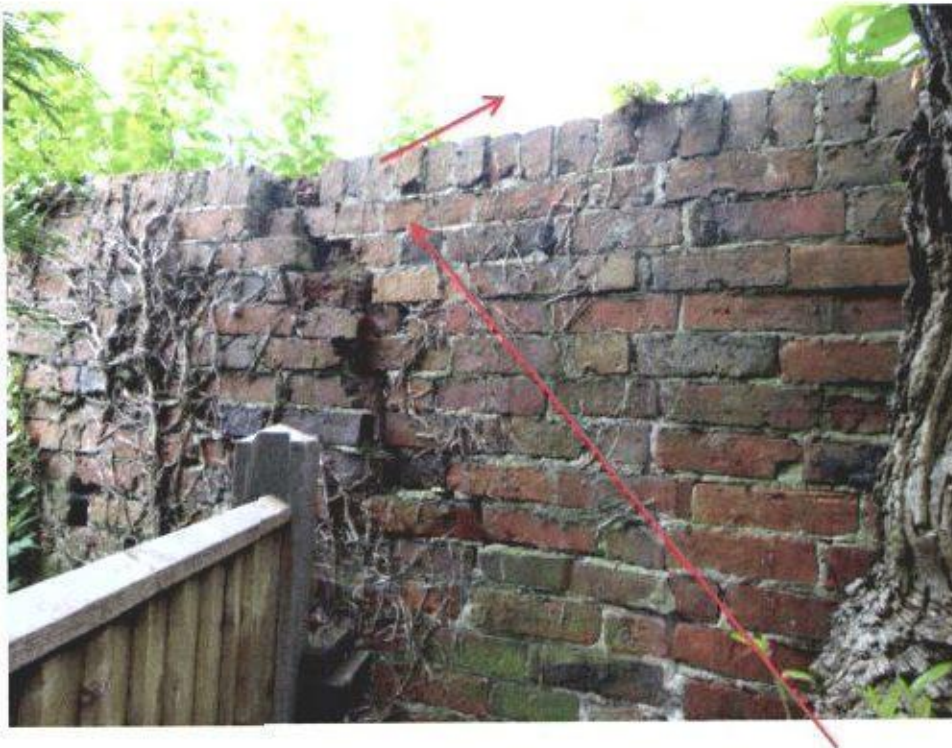
Left hand corner behind tree – wall has been pushed over 70mm at top

- The section of wall in question has been physically pushed over/damaged by the tree's growth, and in our opinion is now unsafe, and the areas with most damage/movement should be demolished locally without delay to make the wall safe. Remove the minimum necessary to make safe.

- The trunk of the tree is currently encroaching within the zone of the wall. As shown in the above photographs the wall locally is damaged severely, leaning 70mm at the top - hence this damaged/leaning section of wall needs to be demolished - we recommend this is done without further delay to make the wall safe.

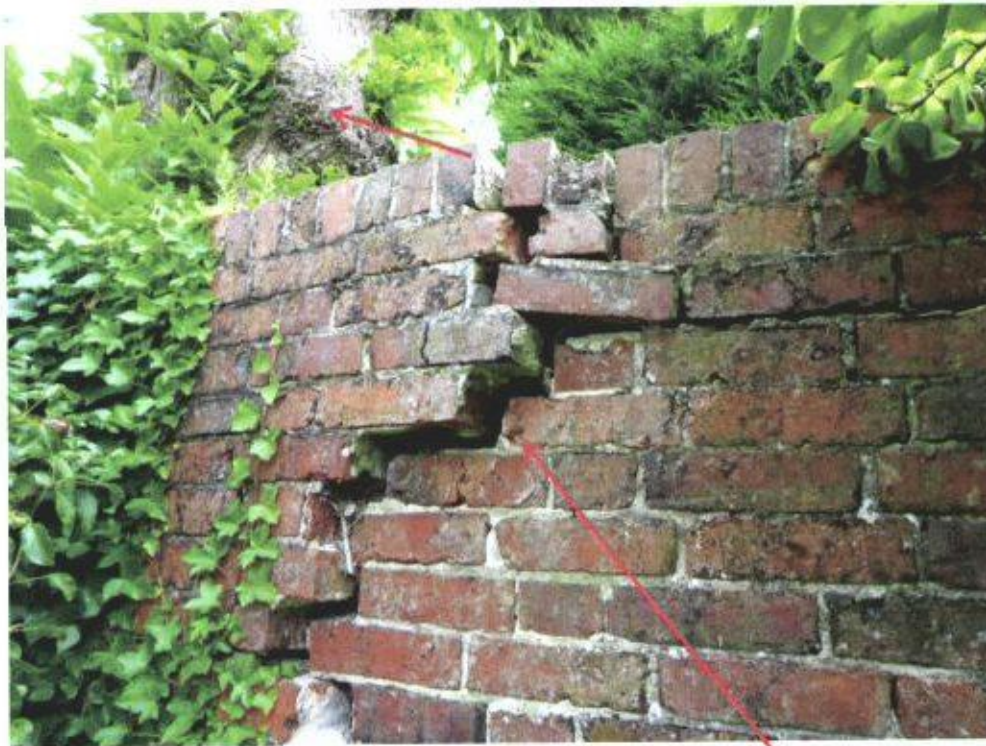
View from neighbours side – Wall leans 70mm at top – wall is unsafe

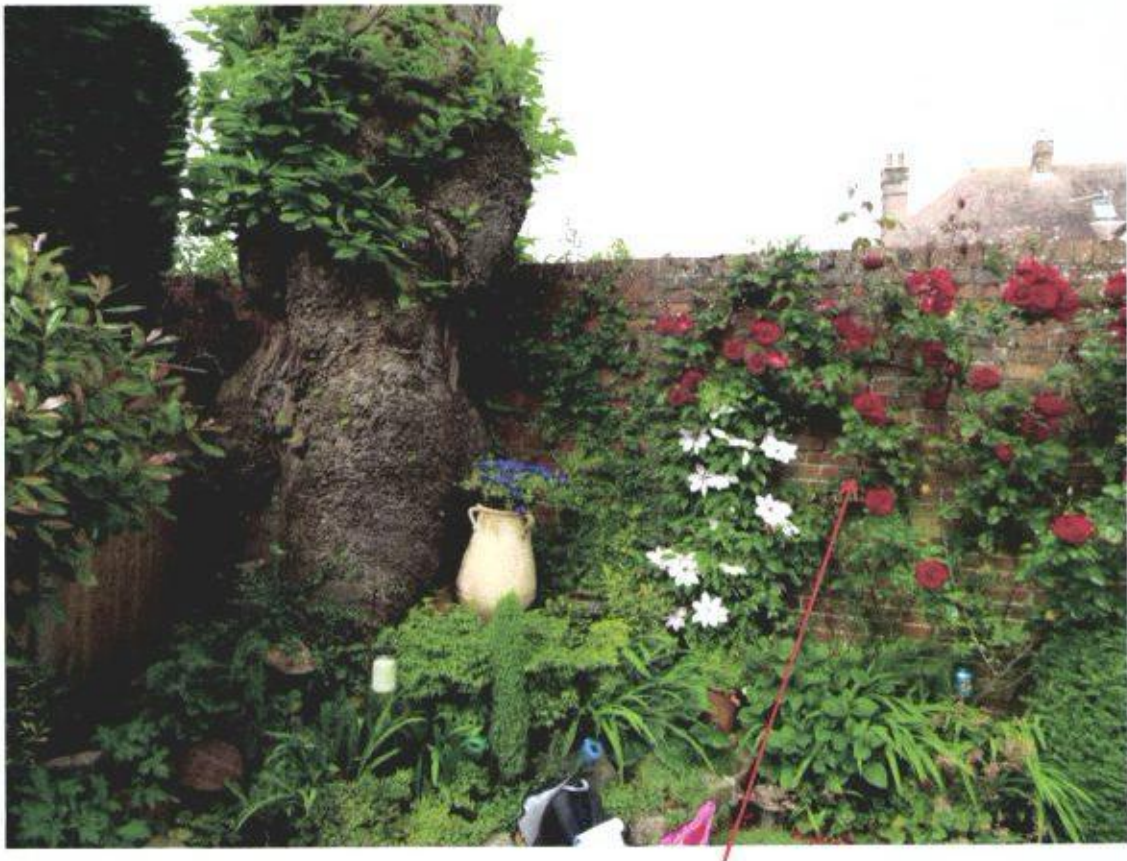
View from our side showing wide trunk at base and full height vertical crack to right of tree (see sketch view A appended seperately)

- We recommend the wall is also rebuilt at the location of the full height vertical crack with new brickwork fully bonded in locally to make the wall good - use a lime based mortar NHL 3.5 prebagged mix, to match the existing wall. (A cement based mortar could be used but runs the risk of slight cracking at junctions with the existing etc and would probably not match aesthetically, all to be discussed/reviewed by bricklayer/builder on site). Existing bricks to be reused where possible etc.

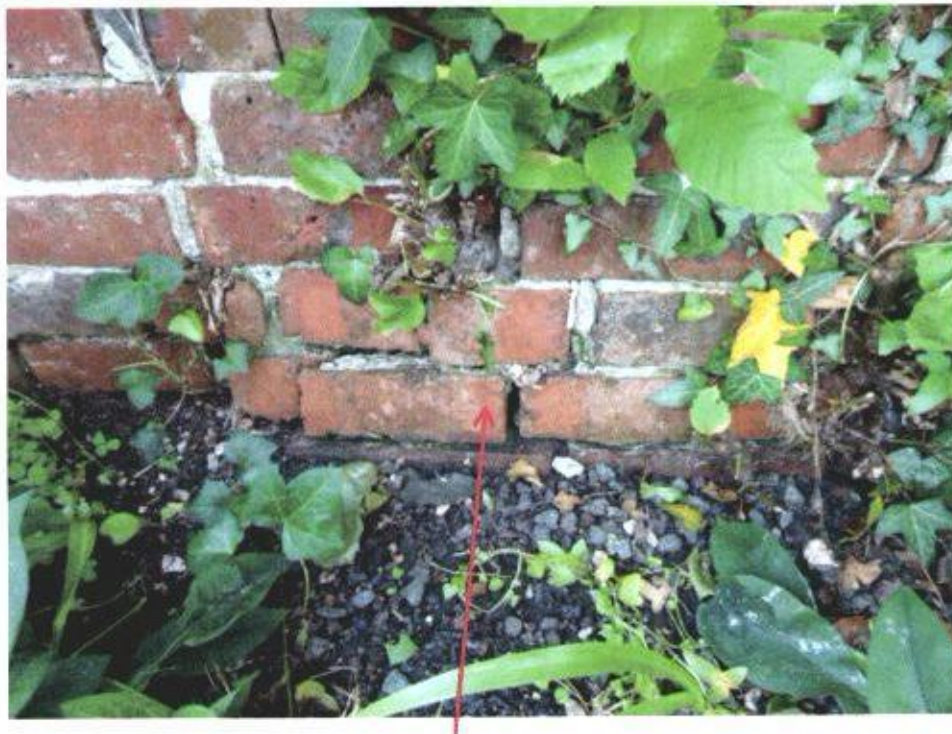
Damage to base of wall (neighbours side)

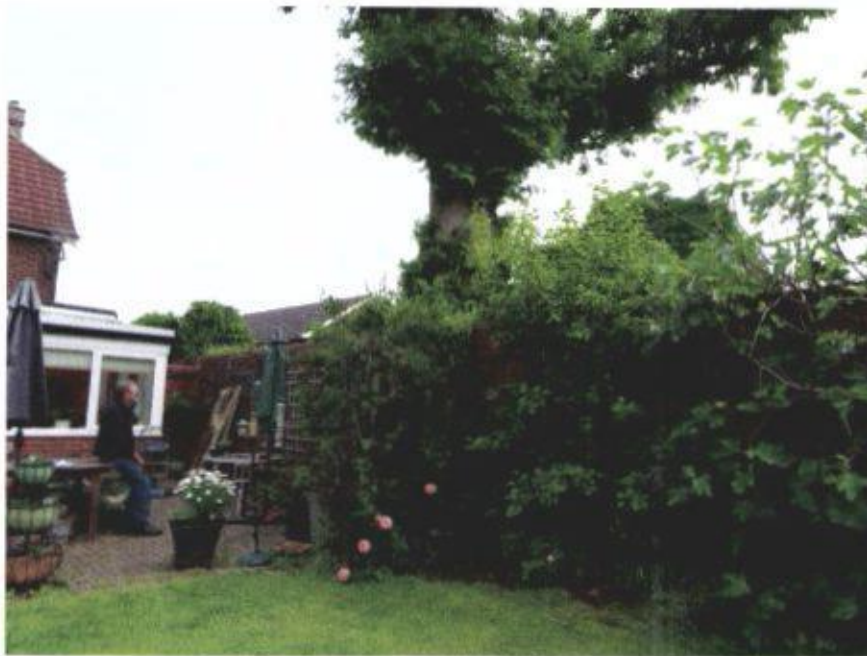
General view on neighbours side – shows tree is in close proximity to neighbours house & rear conservatory (tree is 3.5m from corner of conservatory)

- The Sweet Chestnut tree has a TPO on it (TPO No 1617). By removal of the tree (assuming clay soils) there would be a potential risk of ground heave on the neighbours property in such close proximity to the tree (3.5 metres away to the corner of the neighbours conservatory). (if the decision is taken to remove the tree, we cannot be held liable for any damage to any property that may result)

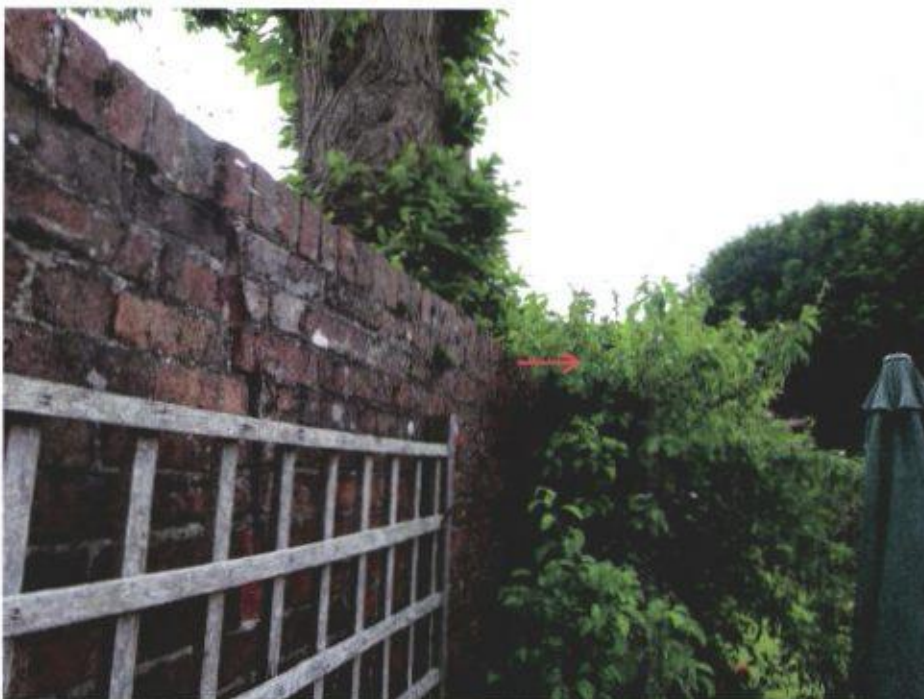
View along wall on neighbours side – shows wall leaning 70mm at top
