## **Picus Sonic Tomographic Test Report**

**Westfield Oaks Westfield Avenue Hayling Island**

### **T1 English Oak**

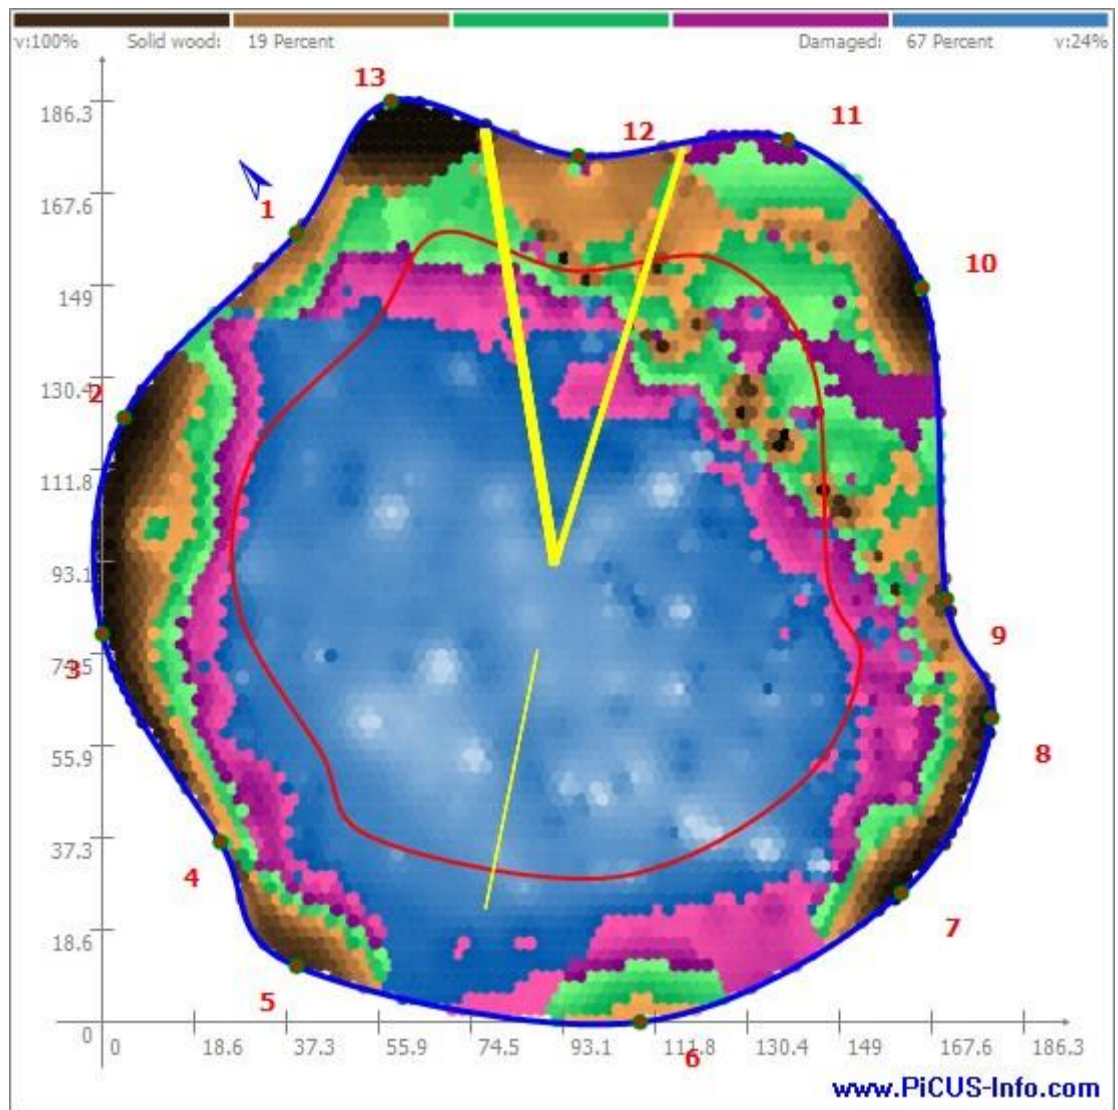
**Test @ level: 30cms ground level** approximately from ground level. Test point 1 at north orientation.

The measuring point readings give evidence low sound velocities results across the area of test.

**Recommendation:** This specimen shows signs of altered timber in the area of test.

**Recommend 'crown retrenchment' remedial treatment by selective crown reduction overall of 3m to 4m. Future maintenance requires the crown to be maintained at this reduced volume on a three year cycle, to relieve stress from the decayed areas. Monitor on a regular basis for future structural changes.**
