**Infront-Innovation**  
**ENGINEERING REPORT**

Infront Innovation Reference: IFS-AVI-ROF-13-0044763

Address of Property: 10, Linda Grove, Waterlooville, Hampshire, PO8 8UX

Date of Report: 27 March 2015

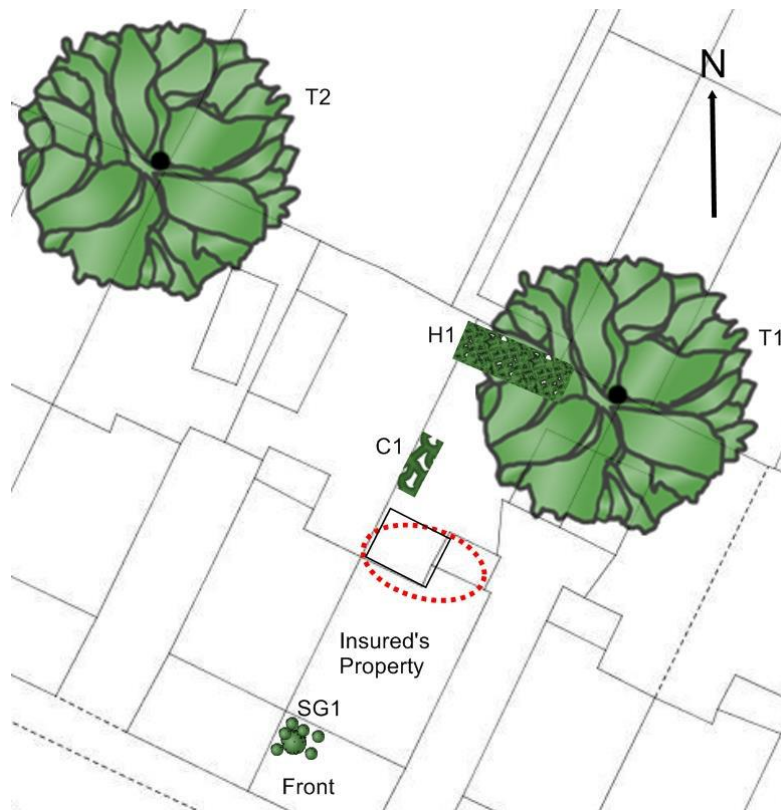
Figure 1 – Sketch taken from Marshall Thompson Group survey showing location of the principal vegetation in relation to Property

Marshall Thompson subsequently recommended removal of the Oak tree (reference T1) at the rear of the property. Additionally, it was recommended in the same report of December 2013, that further tree management works should be undertaken to the nearby trees as a precautionary measure.

The borehole in TH1 was extended to a depth of 5m and root activity was recorded to a depth of 1.8m below ground level. Root samples retrieved on site from below foundation to a depth of 1.8m below ground level have been identified as *Quercus (Oak)*.
- 5.2. The only Oak tree near the area of damage to the property and therefore the tree whose roots are present below the foundations within TH1 is that denoted on the Marshall Thompson site plan above.

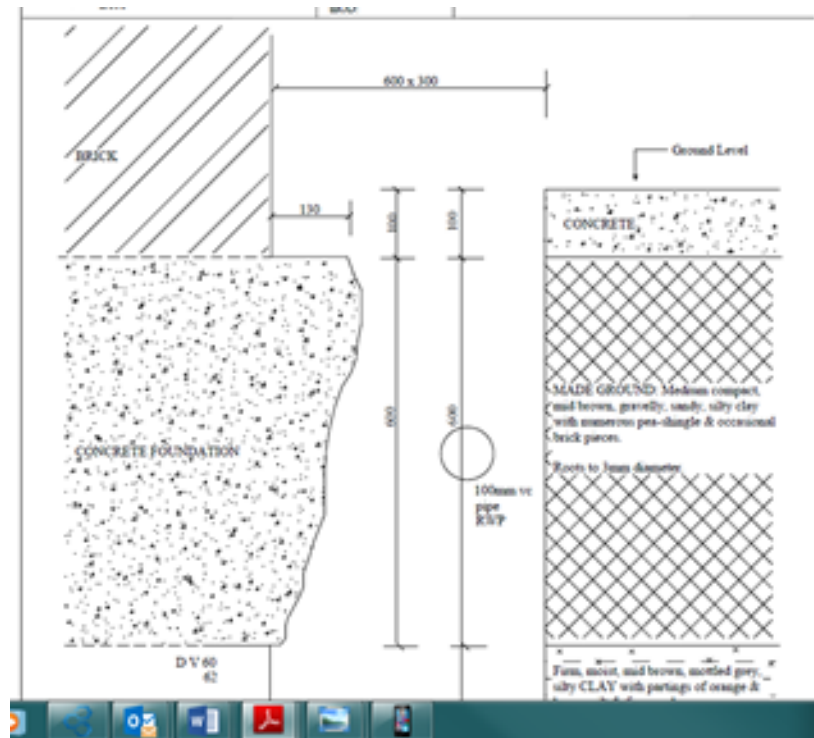
- 3.3. Site investigations were carried out in September 2013 by CET Property Assurance from which it was concluded that the property had been affected by clay shrinkage subsidence. The site investigations confirmed that the underside of the foundations was found at 700mm below ground level and the soils at the underside were found to be a Firm, moist, mid brown mottled grey silty clay (fig 2 below)

Fig 2. Foundation detail and soil description

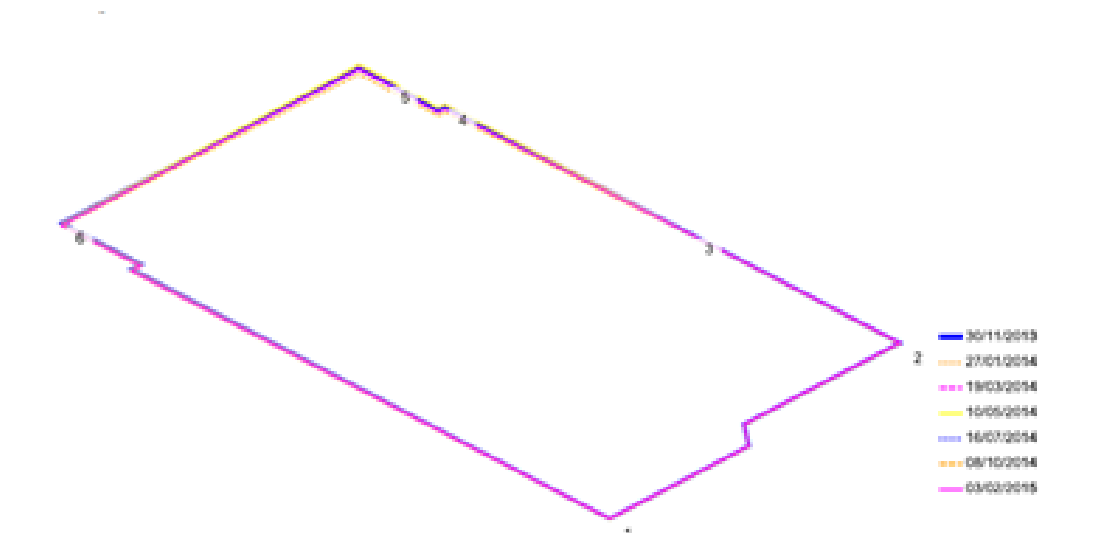
- 8.2. Level monitoring was set up in November 2013 and readings have been taken at approximately 8 week intervals. The monitoring locations which are presented in *Figure 5* below, show that the property is affected by seasonal downward movement to the rear right corner with the maximum degree of seasonal downward movement occurring between points 4 and 6 on the rear right corner. The left hand elevation shows minimal movement which would be anticipated in a property founded upon clay and unaffected by subsidence and the rear right hand corner which is closest to the oak tree which is consistent with anticipated trends in clay shrinkage cases. The monitoring shows the affected parts of the property moving down during the summer months when the tree is in leaf, demanding larger amounts of water and rainfall is lower and the net moisture content within the clay soil below the property decreases. Recovery or upward movement is then witnessed during the winter months when the tree loses leaf, demands less moisture and the rainfall events increase, allowing the soil to rehydrate to some degree and swell, causing upward movement and consequential closing of cracks within the property.

- 8.3. The level monitoring program to date clearly indicates downward movement through June to October 2014 with recovery becoming evident with the onset of the wetter winter months. This demonstrates that the identified offending trees are the cause.

- 8.4. While climate alone can cause some small changes in the surface soil (to a depth of 500 mm or so), the foundations of the house, being some 700mm below ground level are beyond this zone and seasonal movements of the scale shown in *Figure 5* are indicative of root-induced shrinkage associated with a large tree.

Figure 5 – Monitoring location positions
