September 2015

**A BS 5837 Tree Survey Report, Tree Constraints Plan,  
Arboricultural Impact Assessment and Tree Protection Plan  
for**

**Whittington Designer Homes Ltd  
at**

**11, Bound Lane, South Hayling**

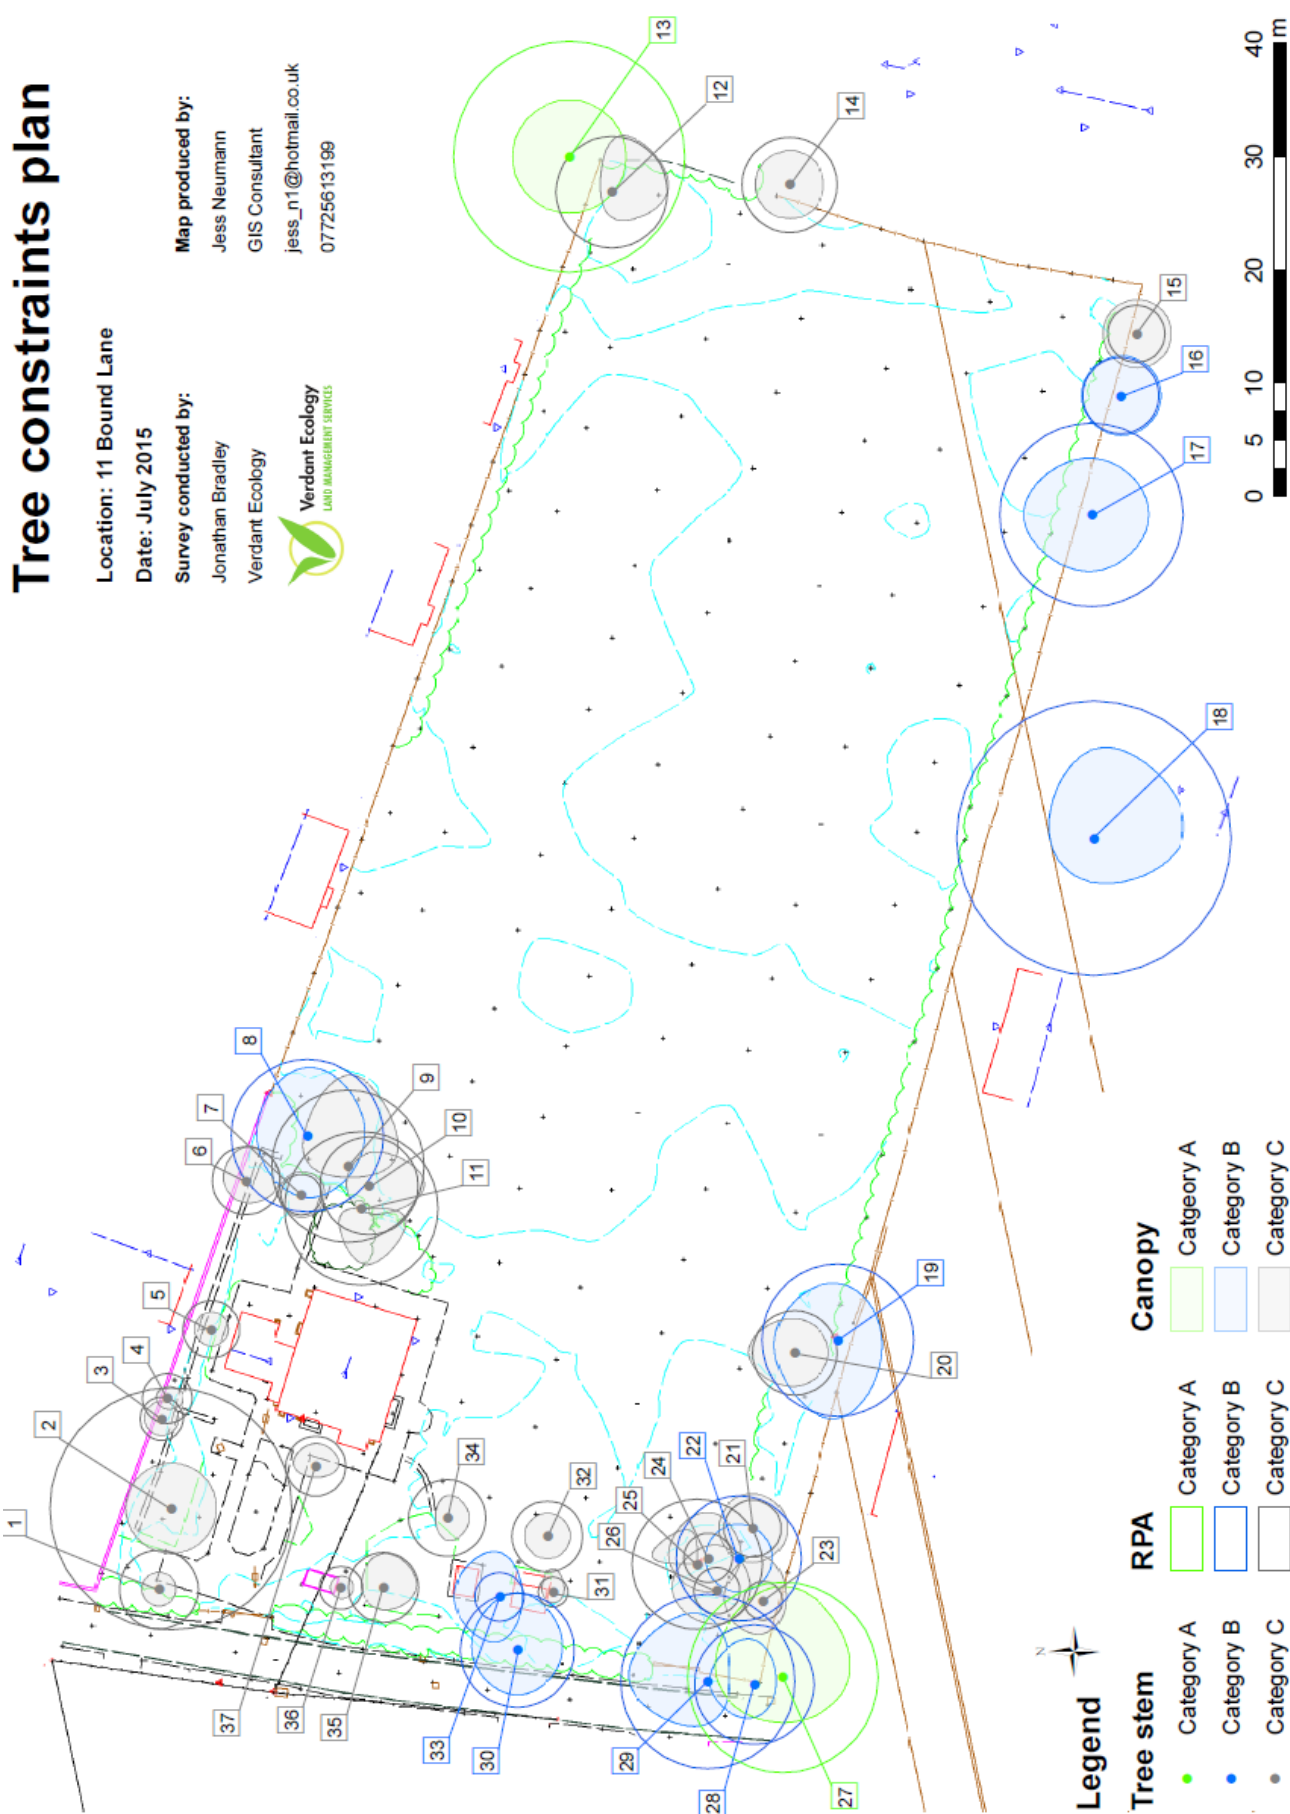
## 8.2 Appendix 2. Tree Constraints Plan

The TCP in Appendix 2 shows the locations of trees on/near the site, their BS5837 category, their canopy extents and RPA. RPA have not been offset/adjusted.

I understand that trees 28, 29 and 30 are the subjects of a Tree Preservation Order.
