# Arboricultural Consultancy for HBOS

## 1. Case Details

| Insured | Mrs C Watson | Address | 31 Hollybank Road, Emsworth, West Sussex, PO10 7UE |

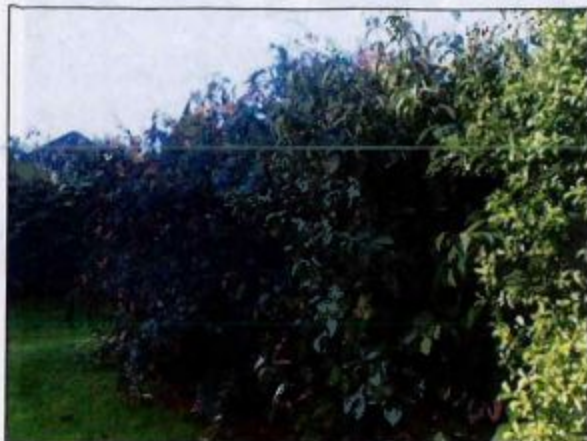
SG1 Mixed

Whilst there is currently no positive root identification to implicate SG1 (Mixed Species Group), T2 (Oak) and TG1 (Oak) in the current damage, our assessment on site considers that the footings of the subject property fall within the anticipated rooting zone of this vegetation.

In order to mitigate the current damage and allow soils beneath the property to recover to a position such that an effective engineering repair solution can be implemented we recommended that T2 (Oak) and TG1 (Oak) are removed. Shrubs within 4m of the rear conservatory within SG1 should be removed to eliminate them as a causal factor.

| Tree No. | Species | Age Cat | Approx. Height (m) | Distance to Building (m) | Ownership | Action | Requirement |
|---|---|---|---|---|---|---|---|
| SG1 | Mixed species shrubs including; Dogwood, Acer | 1 | 2.6 | 3.4 | C - Insured | Maintain as detailed | Remove to ensure 4m clearance to the rear conservatory. Do not allow remainder to exceed current dimensions. |

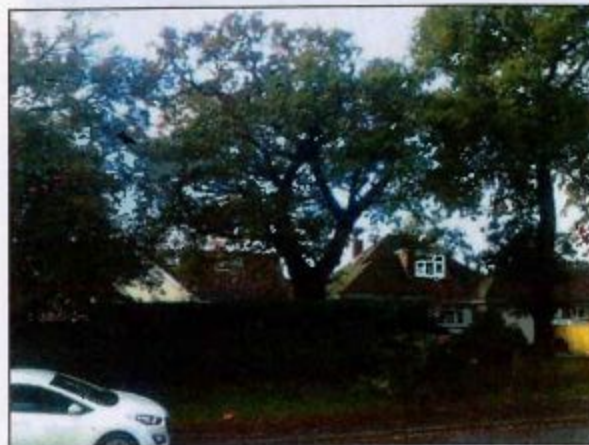
T2 Oak

In assessing the potential drying influence of the vegetation on site, T2 (Oak) and TG1 (Oak) are considered the dominant feature and accordingly we have identified them as the principal cause of subsidence.

| Tree No. | Species | Age Cat | Approx. Height (m) | Distance to Building (m) | Ownership | Action | Requirement |
|---|---|---|---|---|---|---|---|
| T2 | Oak | 3 | 10 | 13.8 | C - Insured | Remove | Remove subject to heave assessment. |
