RE: Application for Removal of TPO Ref- pp-04080976

# Arboricultural Consultancy for HBOS

| <b>Insured</b> | Mrs C Watson | <b>Address</b> | 31 Hollybank Road, Emsworth, West Sussex, PO10 7UE | | |

Client: Lloyds Banking Group  
Client Contact: David Elliot  
Claim Number: 101431391  
Policy Holder: Mrs C Watson  
Report Date: 3 December 2013  
Our Ref: C2811S9805

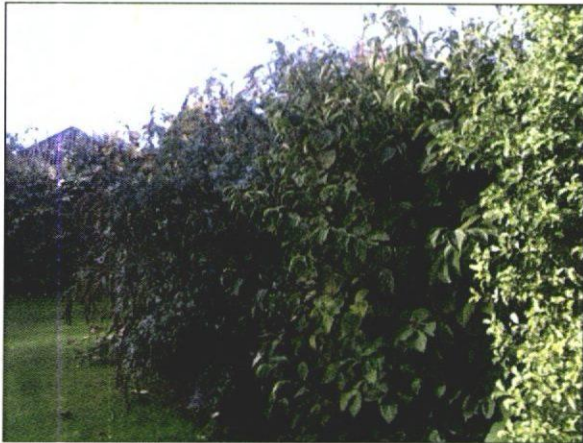
SG1 Mixed

| Tree No. | Species | Age Cat | Approx. Height (m) | Distance to Building (m) | Ownership | Action | Requirement |
|---|---|---|---|---|---|---|---|
| SG1 | Mixed species shrubs including; Dogwood, Acer | 1 | 2.6 | 3.4 | C - Insured | Maintain as detailed | Remove to ensure 4m clearance to the rear conservatory. Do not allow remainder to exceed current dimensions. |

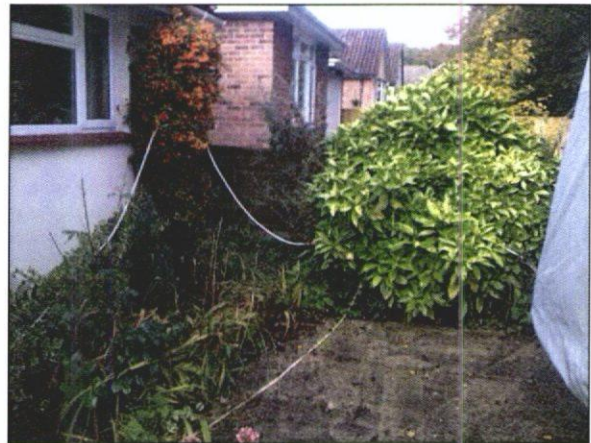
SG2 Mixed

| Tree No. | Species | Age Cat | Approx. Height (m) | Distance to Building (m) | Ownership | Action | Requirement |
|---|---|---|---|---|---|---|---|
| SG2 | Mixed species shrubs Group including; Laurel and Pyracantha. | 1 | 2.3 | 3.4 | C - Insured | Action to avoid future risk | Do not allow to exceed current dimensions. |

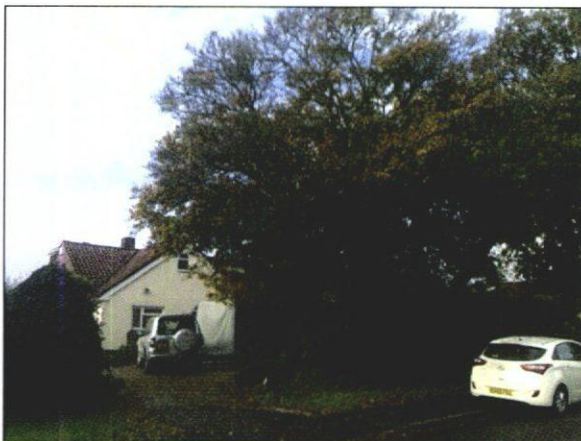
T1 Field Maple

| Tree No. | Species | Age Cat | Approx. Height (m) | Distance to Building (m) | Ownership | Action | Requirement |
|---|---|---|---|---|---|---|---|
| T1 | Maple (Field) | 3 | 10.5 | 16.5 | E - Boundary Veg (ownership to be confirmed) | Action to avoid future risk | Remove and treat stump to inhibit regrowth subject to heave assessment. |

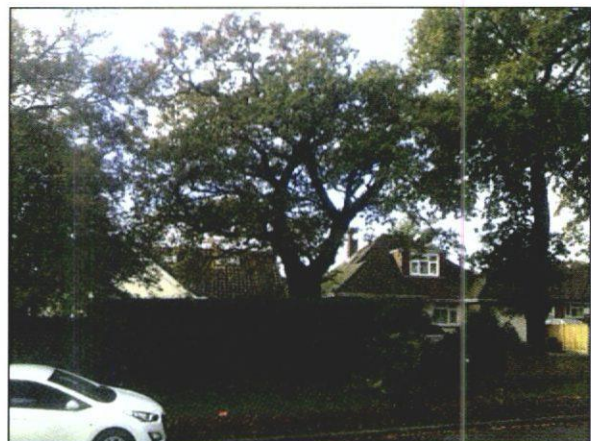
T2 Oak

Whilst there is currently no positive root identification to implicate SG1 (Mixed Species Group), T2 (Oak) and TG1 (Oak) in the current damage, our assessment on site considers that the footings of the subject property fall within the anticipated rooting zone of this vegetation.

| Tree No. | Species | Age Cat | Approx. Height (m) | Distance to Building (m) | Ownership | Action | Requirement |
|---|---|---|---|---|---|---|---|
| T2 | Oak | 3 | 10 | 13.8 | C - Insured | Remove | Remove subject to heave assessment. |

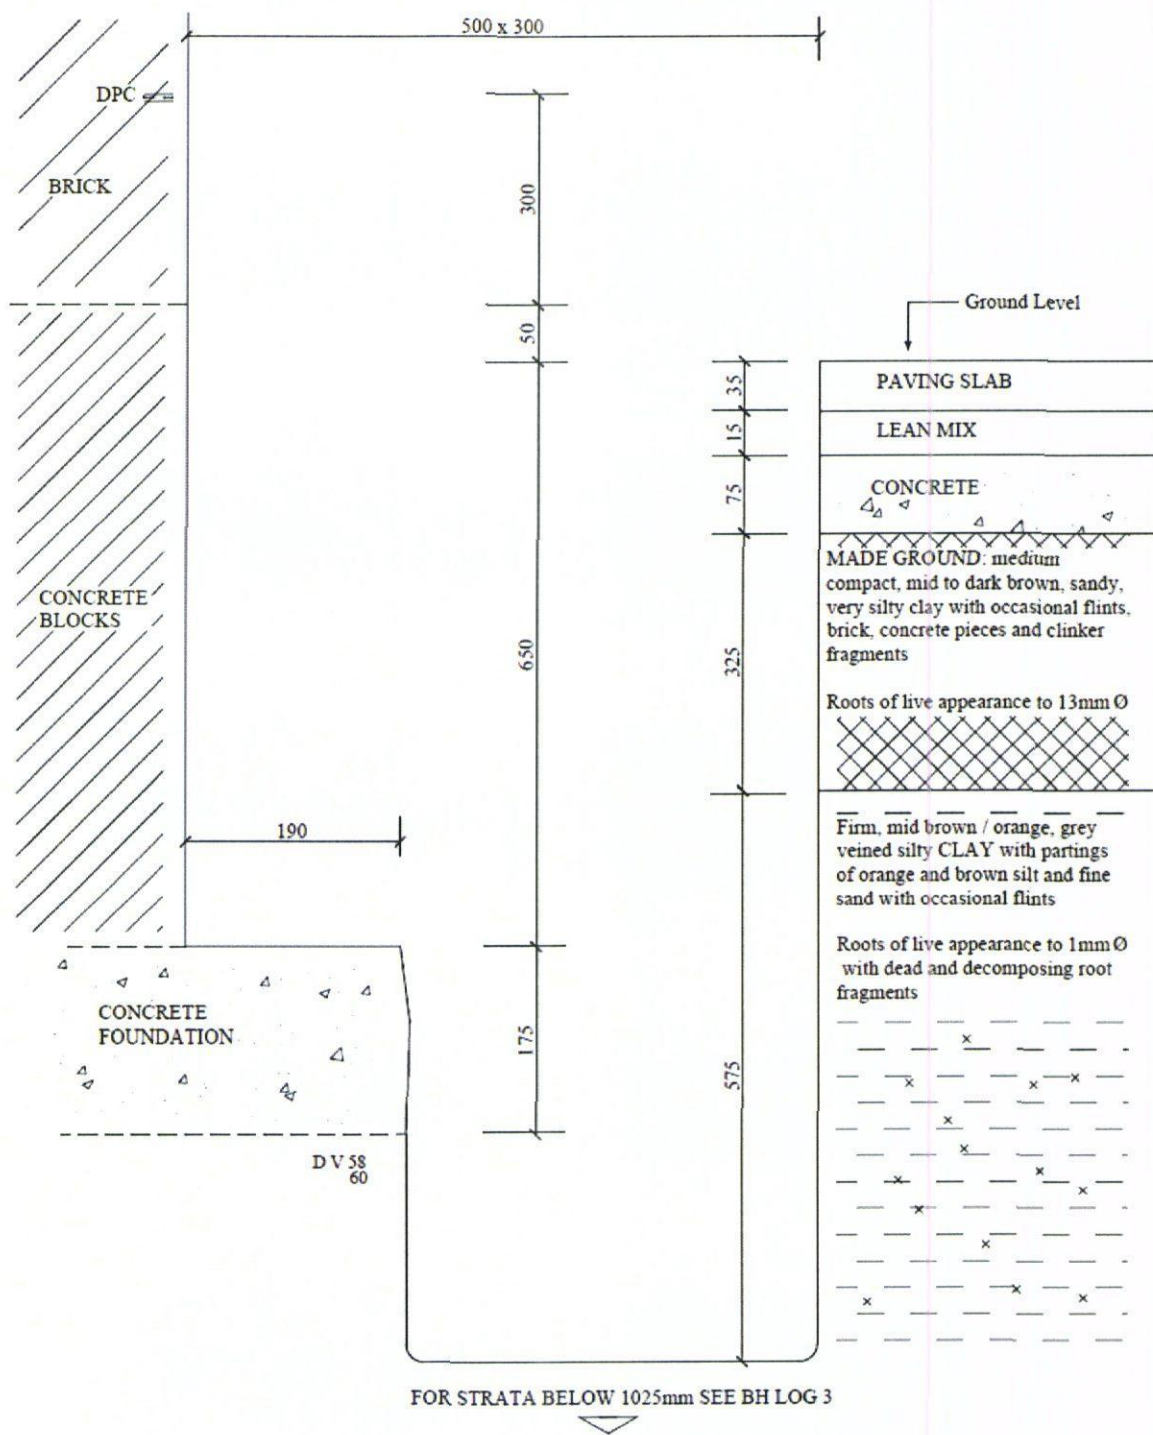
## TP/BH3 Foundation Detail

Remarks: Limited working space

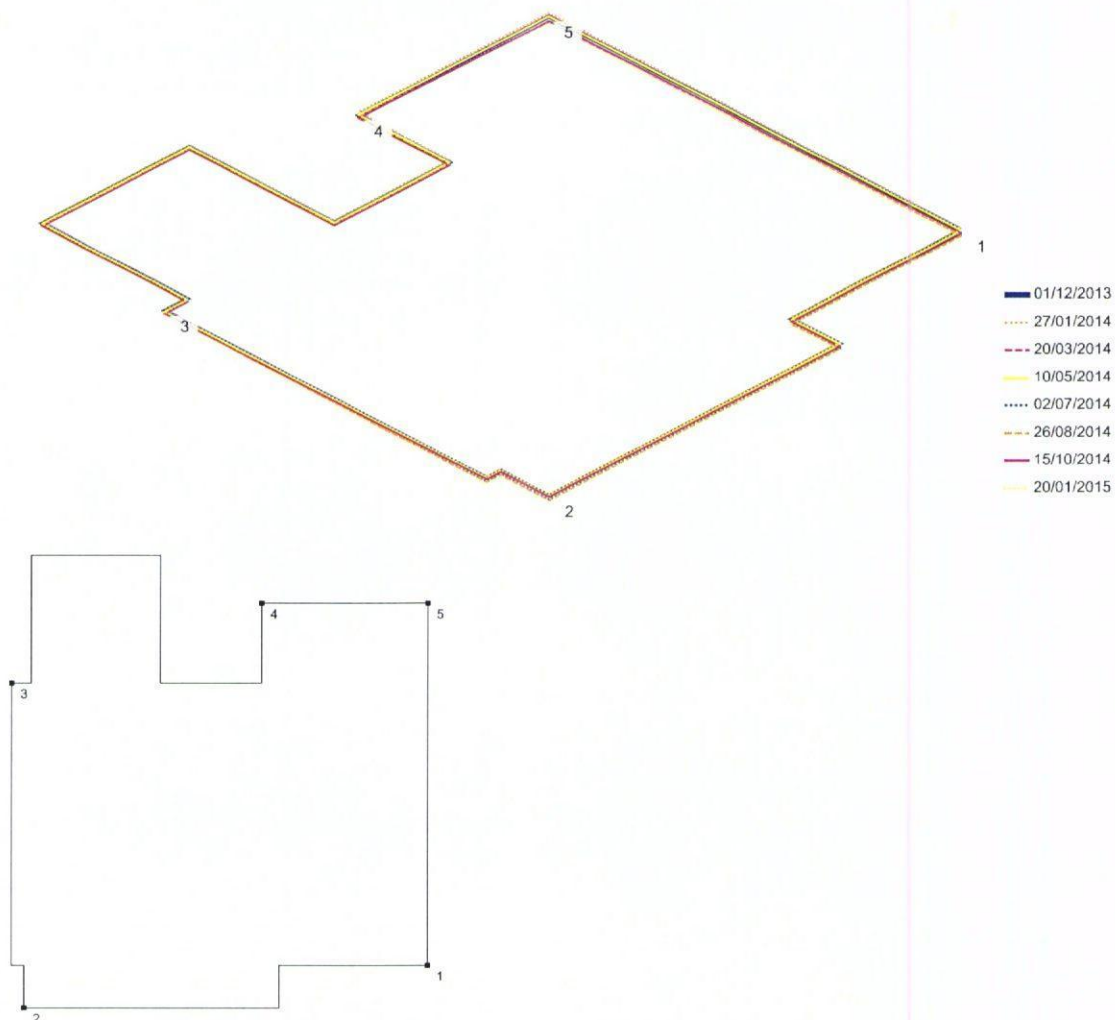
## Level Monitoring Displacement Map

The following image shows an isometric representation of the movement of the property, based on the Level Monitoring Stations that were installed.
