# LEVEL MONITORING

## for Subsidence Management Services

**10 Linda Grove, Waterlooville, Hampshire, PO8 8UX**

| Our Ref: | M1320 |

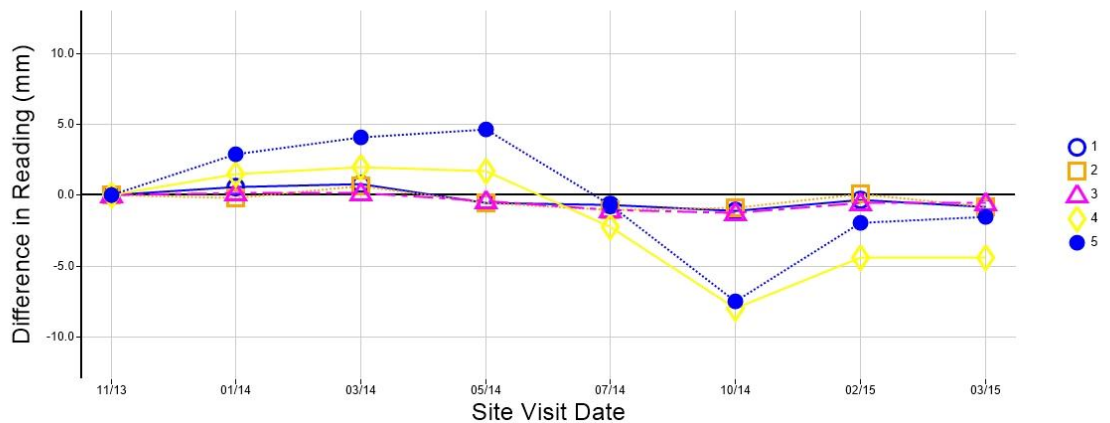
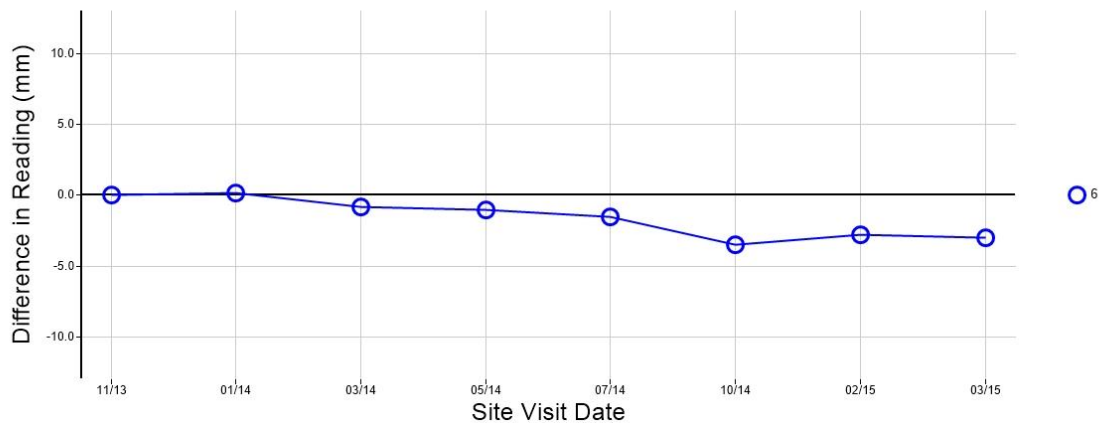
The following graphs display the progressive movement that each Level Monitoring Station recorded at each separate site visit date to give an overall look at how much the property is moving.

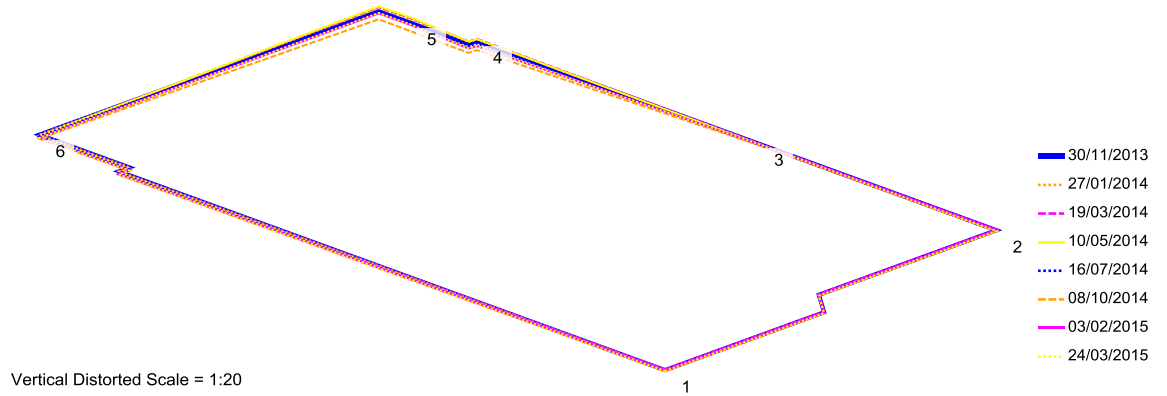
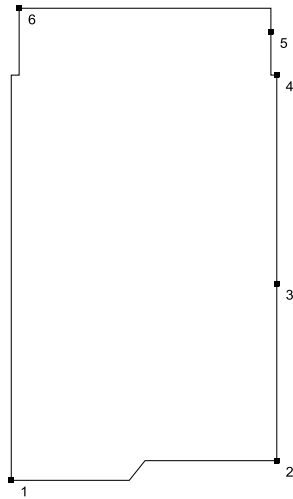
The following image shows an isometric representation of the movement of the property, based on the Level Monitoring Stations that were installed.
