# Arboricultural Assessment Report

## Preliminary Report on Trees

| | <b>Risk Address:</b> | 1 Swans Walk, Salterns Lane, Hayling Island,<br>Hants, PO11 9TX |
| <b>Refs:</b> | <b>OCA Ref:</b> | 54748 |

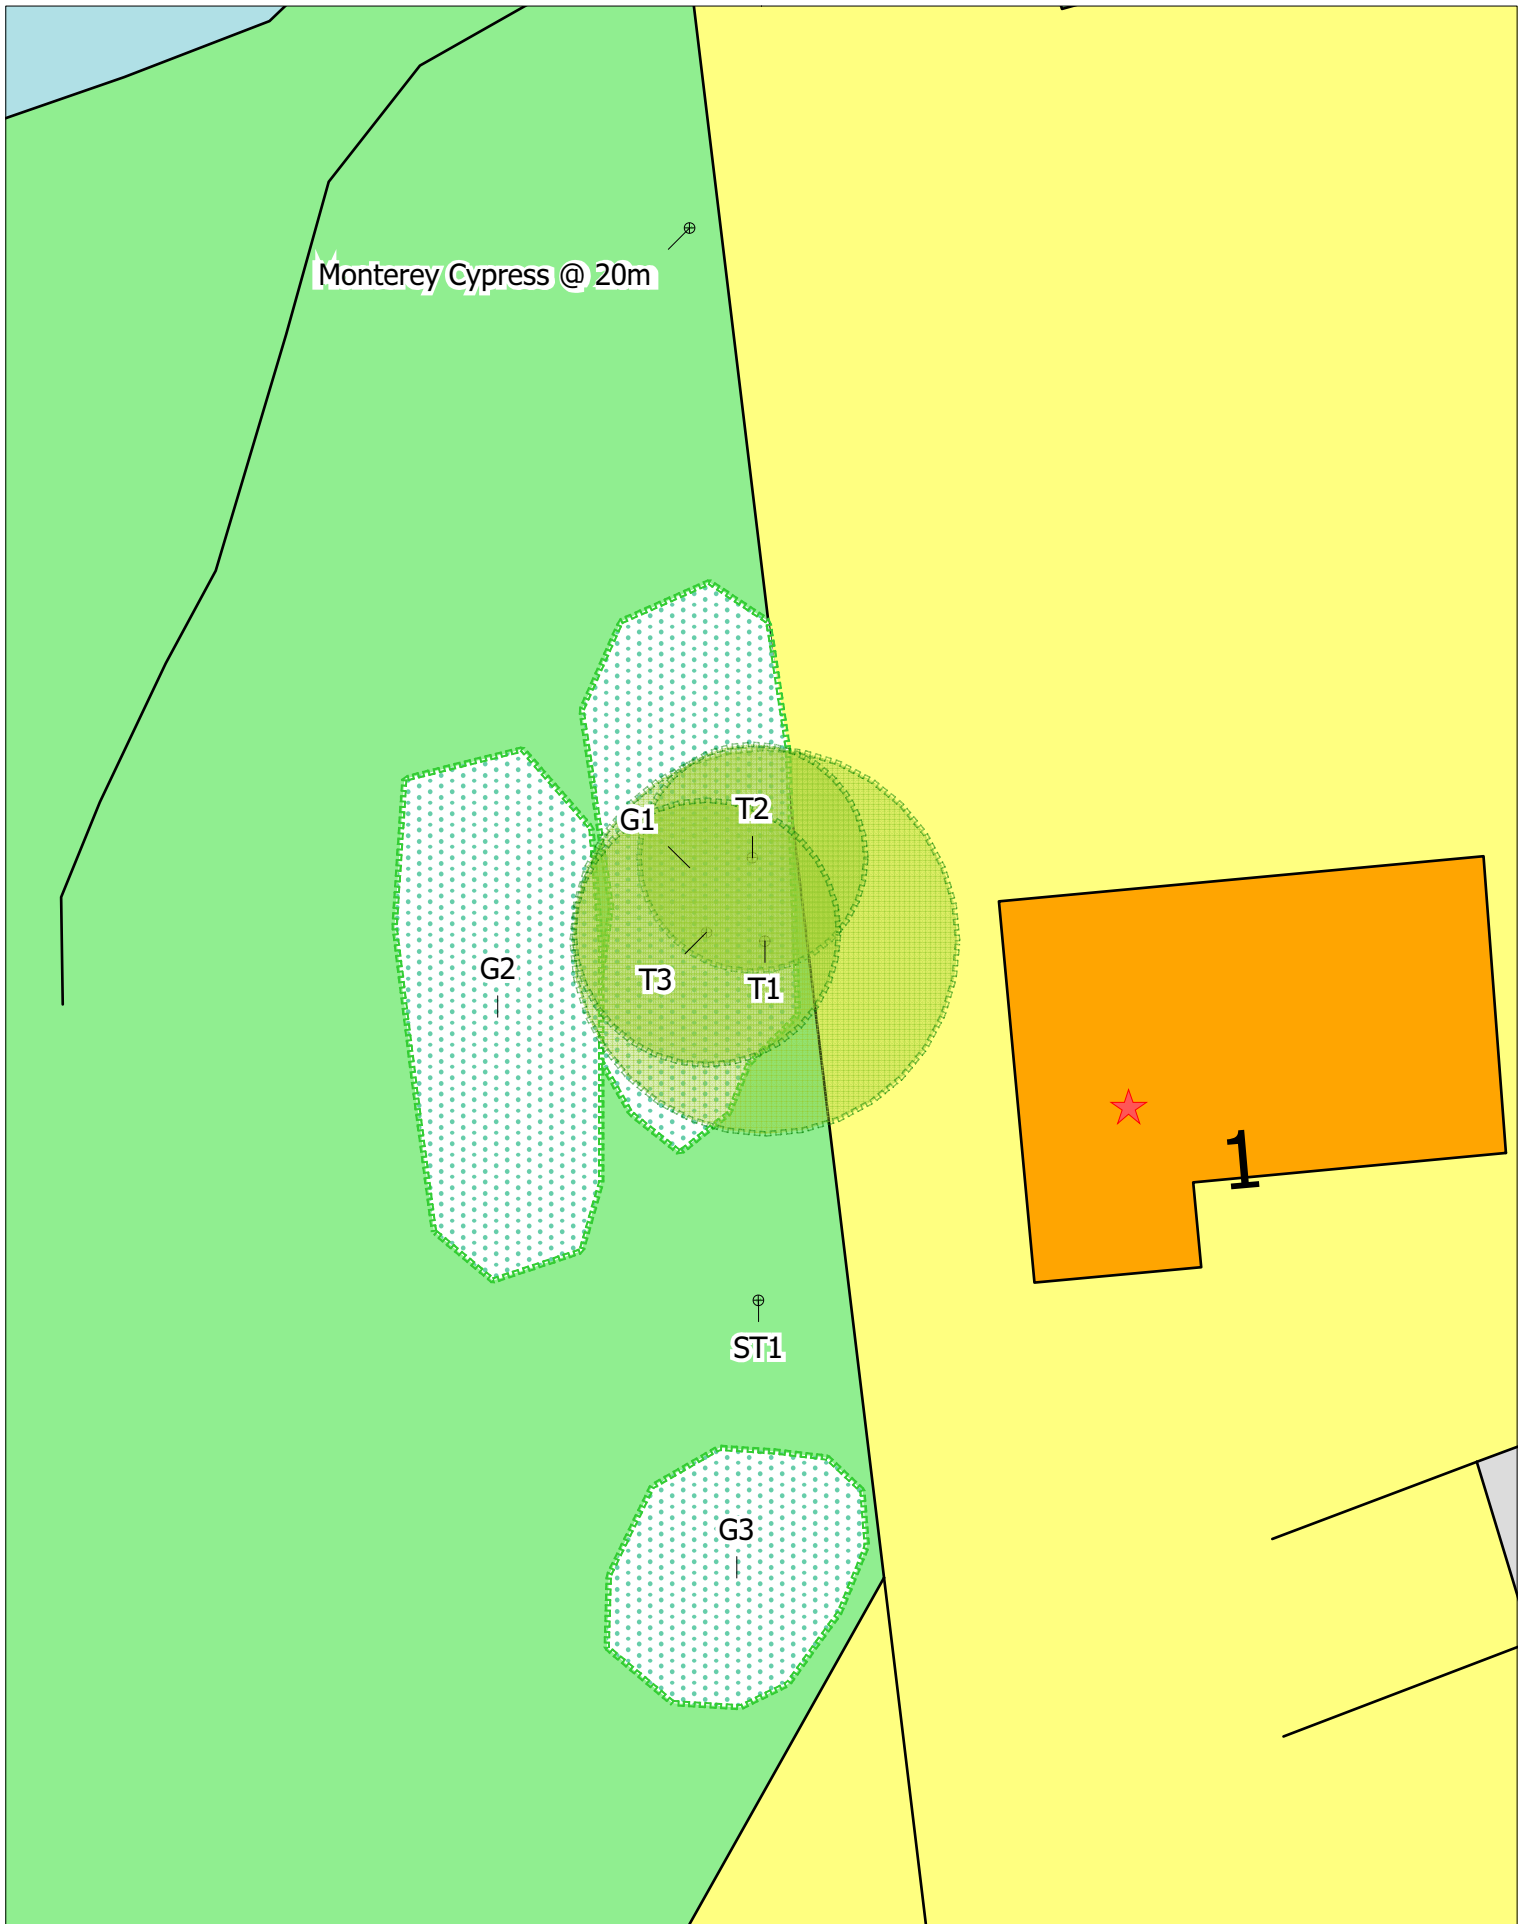
Location: 1 Swans Walk, Salterns Lane, Hayling Island, PO119TX  
Job Ref.: 54748  
Survey Date: 29/08/2013  
Scale: 1:200 @ A4

During our vegetation survey, vegetation within third party ownership was noted. This vegetation was located within close proximity to the left elevation of the insured property and included a mature European Black Pine tree (T1), two semi-mature English Oak trees (T2 and T3), a group of semi-mature Holm Oak trees (G1), a group of early-mature Monterey Cypress trees (G2), and a group of early-mature English Oak trees (G3)

Details of the above vegetation are listed in the Tree Tables and their locations are shown on the Site Plan, both attached to this report.

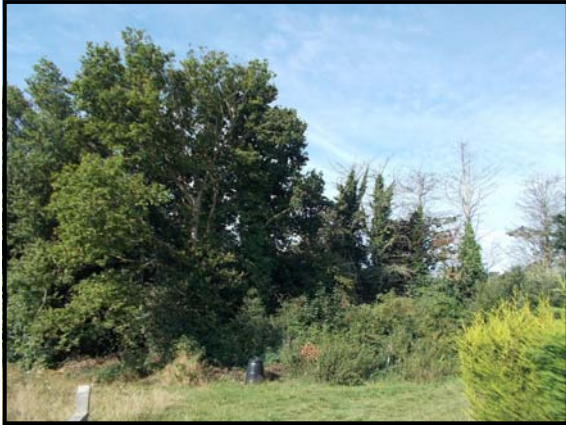
1. Vegetation to left of property

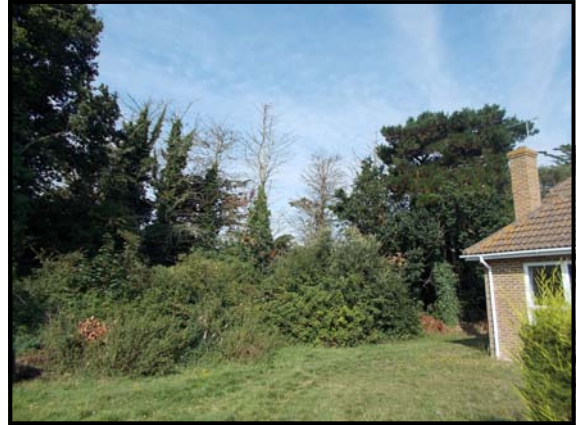
With reference to the Cypress roots recovered, during our survey no living trees relating to this were noted within the immediate vicinity. I note Monterey Cypress G2 to the left of the insured property but these trees appear to have been dead for some time. Although these trees are dead, they currently pose no health and safety issues. However, it is recommended that they be monitored on a regular basis.

2. Monterey Cypress G2 to centre

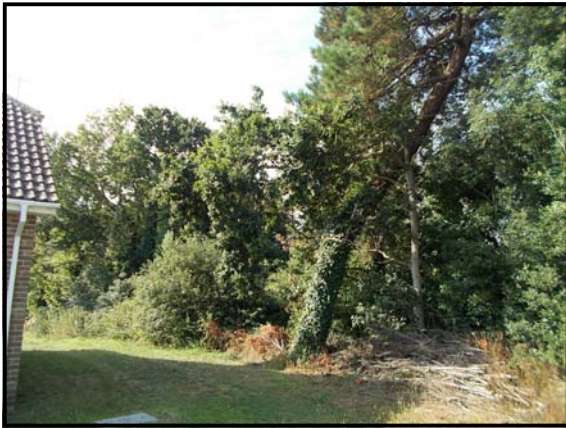
With reference to the Pine roots recovered, given its size, species, and proximity to the location of the trial pit/borehole we consider that these roots have emanated from European Black Pine T1.

Given the above we consider that European Black Pine T1 and English Oak T2 are the most significant vegetation in relation to soil drying beneath the insured property and as such are the material cause of the current subsidence damage.

3. European Pine T1

We do not consider that pruning works will offer either an effective or sustainable means of controlling water use of European Black Pine T1 and English Oak T2. Therefore and in order to provide a long-term solution to the current subsidence damage, we recommend that European Black Pine T1 and English Oak T2 be removed.

| Tree No: | Species | Works Required |
|---|---|---|
| T1 | European Black Pine | Fell to ground level as close as practicable |
