## **Arboricultural Report**

**2 Emsworth Road, Havant, Hampshire**

Beechdown ref: B/0003/11  
2 Emsworth Road – tree impact assessment – march 2011

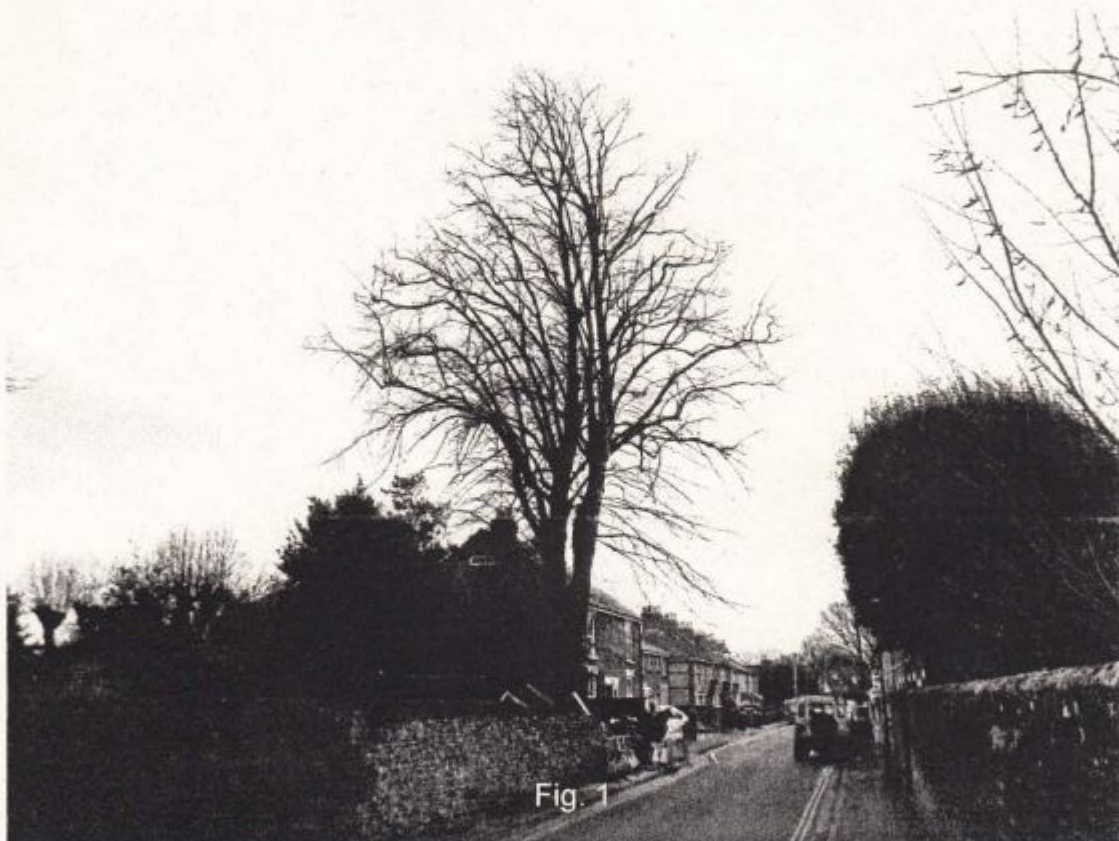
- 6.2 A mature tree dividing into two stems at 4m (**Fig. 1**) and subsequently pollarded at approximately 8m. The crown becomes multi-stemmed at the pollard points with the branches ascending sharply then arching to form a full and balanced crown.
- 6.3 The lateral growth is marginally less developed to the south.

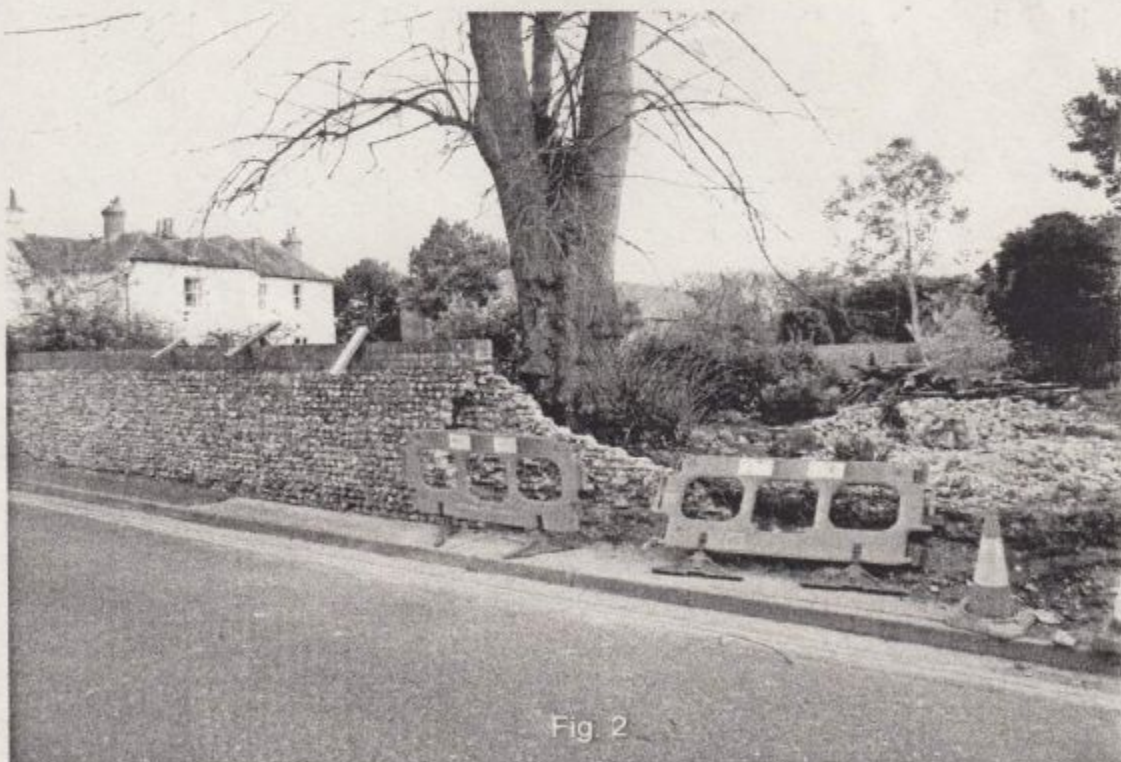
- 8.1 The boundary wall, running parallel with Lymbourn Road, was constructed of two leaves of flint facing with a rubble core (ref. Havant Borough Council correspondence 59352) with a brick coping.
- 8.2 The wall was fully collapsed from the southern end to approximately 3m from the tree at which point the inner flint facing partially remained and gradually stepped up to a point where it joined the intact wall (**Fig. 2**).

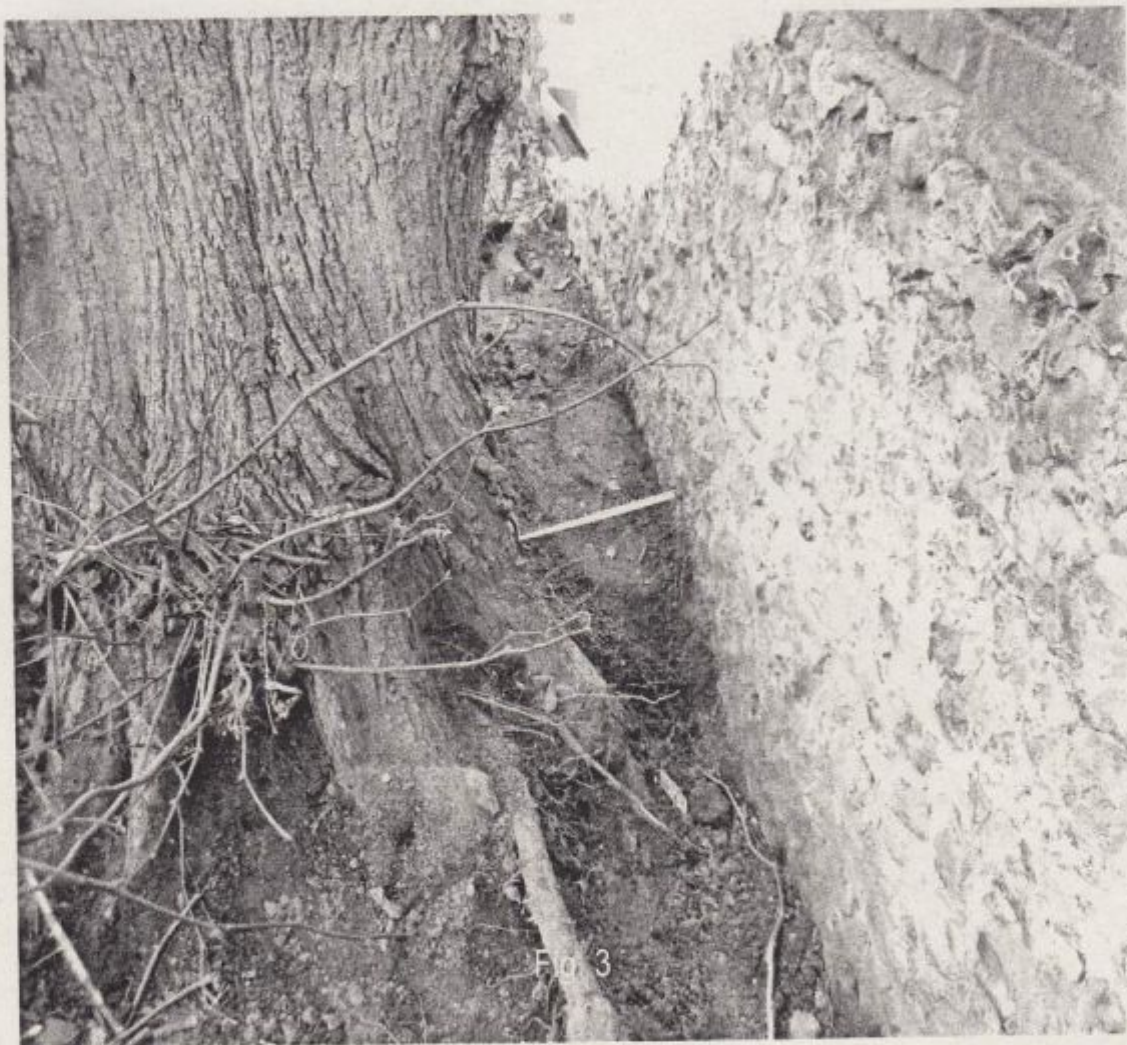
- Main stem above buttress flare - 50cm
- Buttress root at ground level - 30cm (**Fig. 3**)
- Buttress root 30cm below ground level - 20cm

9.2.3 As can be seen from **Fig. 3** there appears to be no obvious cracking or movement of the inner face of the flint wall at the closest point to the tree. Images from Google Earth taken in April 2007 show a section of wall missing at the southern end and some cracking in the adjacent brick coping but no apparent damage in the vicinity of the tree.

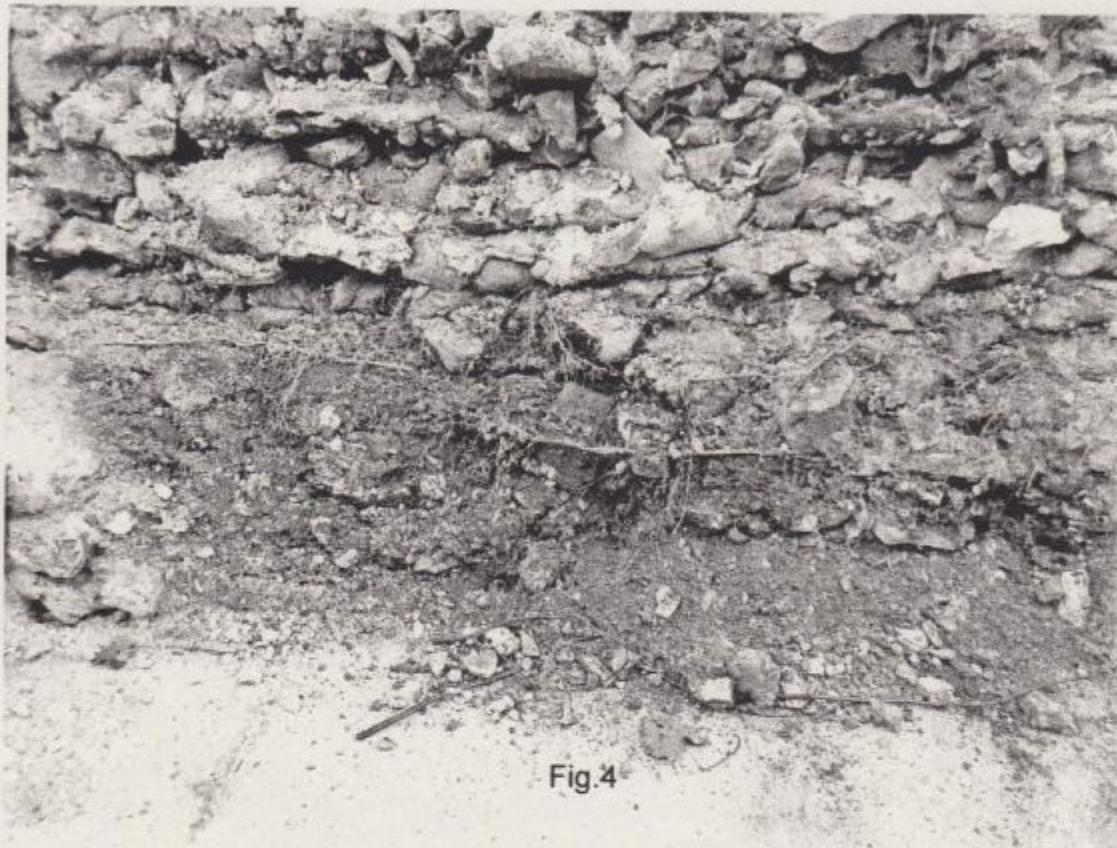
Fig.4

8.4 There were no major roots visible at any point in or along the line of the collapsed wall but some minor roots were present (**Fig. 4**).
