# Arboricultural Appraisal Report

## Subsidence Damage Investigation at:

Nirvana  
Woodgaston Lane  
Hayling Island  
PO11 0RL

| REPORT DATE: | 08 January 2014 |

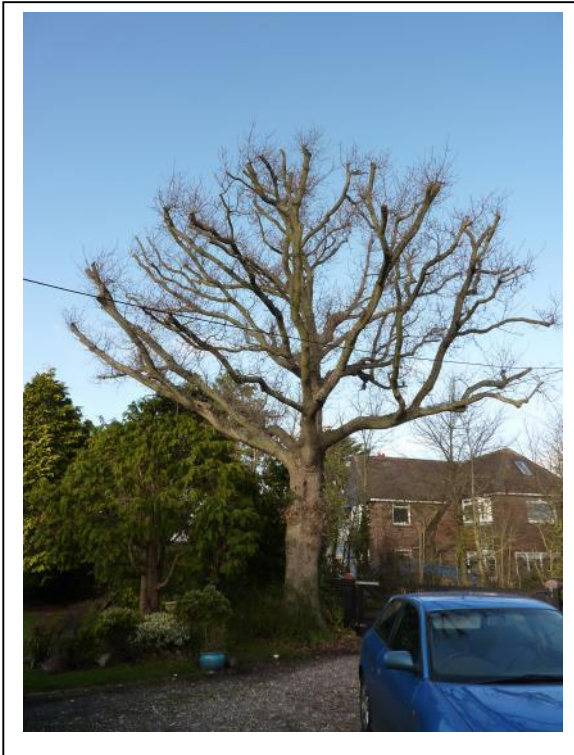
View of T1 - Oak

Having considered the available information, it is our opinion that T1 Oak and S1 Pyracantha are the material cause of the current subsidence damage. T1 Oak is considered to be the principal cause of damage with S1 Pyracantha considered a contributory factor and to be causing only localised damage around the front right hand bedroom.

In respect of T1 we have given consideration to pruning as a means of mitigating the vegetative influence. The tree has been reduced significantly over the years and well maintained on a 2-3 year frequency however these works appear to have had no sustained impact on the trees water uptake.

| Tree No. | Species | Ht (m) | Dia (cm) | Crown Spread (m) | Dist. to building (m) | Age Classification | Ownership |
|---|---|---|---|---|---|---|---|
| T1 | Oak | 9 | 74 | 9 | 12.7 | Significantly older than extension | Policy Holder |
| Management history | | Reduced in past on 2-3 yearly cycle | | | | | |

If an arboricultural solution is to be implemented to mitigate the current damage and allow the soils beneath the property to recover to a position such that an effective engineering repair solution can be implemented we recommend that T1 and S1 are removed.

We are therefore of the opinion that complete removal is the only viable long-term option in mitigating the damage in this instance.

T1 significantly predates the more recent extension to the property therefore we would advise that a heave assessment is made prior to tree works commencing.

| Tree No. | Species | Ht (m) | Dia (cm) | Crown Spread (m) | Dist. to building (m) | Age Classification | Ownership |
|---|---|---|---|---|---|---|---|
| Recommendation | | Remove subject to heave assessment | | | | | |

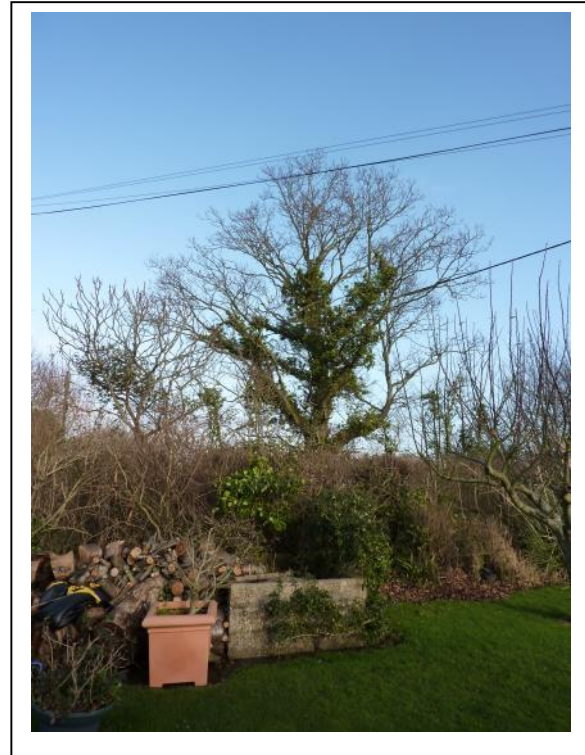
View of T4 - Oak

| Tree No. | Species | Ht (m) | Dia (cm) | Crown Spread (m) | Dist. to building (m) | Age Classification | Ownership |
|---|---|---|---|---|---|---|---|
| T4 | Oak | 9.5* | 55* | 12* | 15* | Significantly older than extension | Unknown |
| Management history | | No significant recent management | | | | | |

| Tree No. | Species | Ht (m) | Dia (cm) | Crown Spread (m) | Dist. to building (m) | Age Classification | Ownership |
|---|---|---|---|---|---|---|---|
| Recommendation | | No works | | | | | |

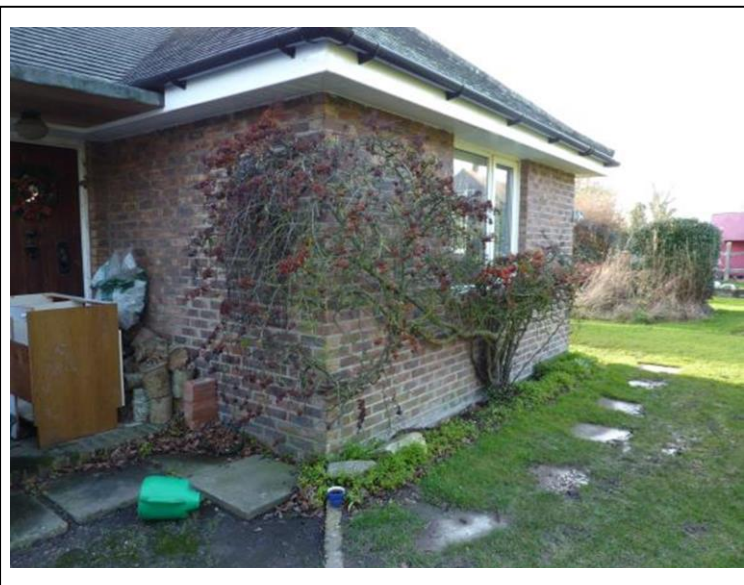
View of S1 – Pyracantha

| Tree No. | Species | Ht (m) | Dia (cm) | Crown Spread (m) | Dist. to building (m) | Age Classification | Ownership |
|---|---|---|---|---|---|---|---|
| S1 | Pyracantha | 2.4 | 6 | 3.5 | 0.1 | Similar age to property | Policy Holder |
| Management history | | No works | | | | | |

| Tree No. | Species | Ht (m) | Dia (cm) | Crown Spread (m) | Dist. to building (m) | Age Classification | Ownership |
|---|---|---|---|---|---|---|---|
| Recommendation | | Remove and treat stump to inhibit regrowth | | | | | |
