Arboricultural Report

CRANBROOK VILLA  
COPSE LANE  
HAYLING ISLAND  
PO11 0RJ

MARCH 2015

Arboricultural Report and Arboricultural Implications Assessment

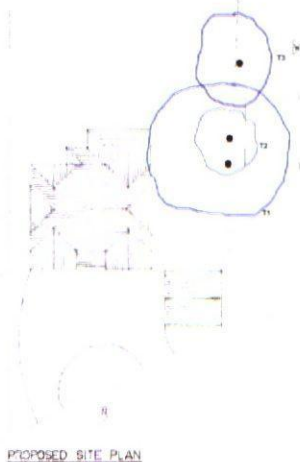
APPENDIX 1 - TREE QUALITY ASSESSMENT PLAN, CRANBROOK VILLA

- Tree of moderate quality
- Tree of low quality

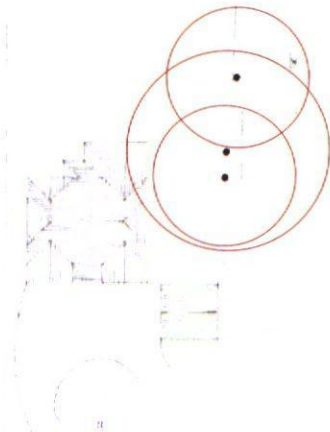
APPENDIX 2 - ROOT PROTECTION AREA PLAN, CRANBROOK VILLA

The proposed foundation line marginally breaches the RPA of T2 Field Maple. It is considered that this will not be detrimental to the tree if site investigations are undertaken in this area to determine the rooting pattern of the tree. It is proposed that this small area of the proposed foundation line is excavated by hand under arboricultural supervision and if any significant roots are found details will be submitted to the Tree Officer with a proposed foundation design.

Hand dug exploratory trenches will be excavated under supervision along the proposed foundation line; the width of the proposed foundation and to a depth of 600mm to determine the rooting pattern of the tree T2 Field Maple. If significant roots are found these will be recorded and details sent to the Tree Officer with the Arboriculturalist comments on the proposed course of action regarding foundation design. The results will be submitted as part of the planning application or in response to a planning condition.
