# Arboricultural Consultancy for HBOS

| Insured | Mrs C Watson | Address | 31 Hollybank Road, Emsworth, West Sussex, PO10 7UE |

Date: 22/11/2013

Property: 31 Hollybank Road

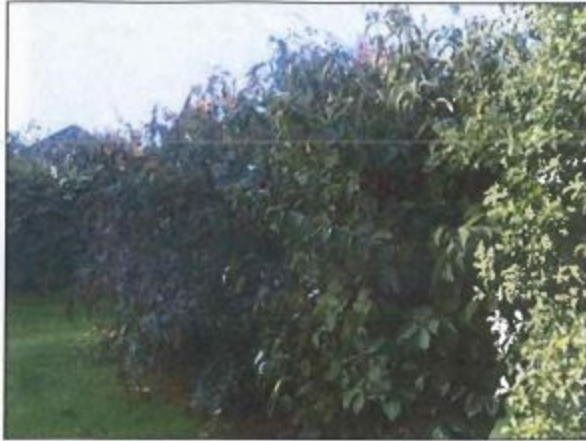
SG1 Mixed

Whilst there is currently no positive root identification to implicate SG1 (Mixed Species Group), T2 (Oak) and TG1 (Oak) in the current damage, our assessment on site considers that the footings of the subject property fall within the anticipated rooting zone of this vegetation.

In order to mitigate the current damage and allow soils beneath the property to recover to a position such that an effective engineering repair solution can be implemented we recommended that T2 (Oak) and TG1 (Oak) are removed. Shrubs within 4m of the rear conservatory within SG1 should be removed to eliminate them as a causal factor.

| Tree No. | Species | Age Cat | Approx. Height (m) | Distance to Building (m) | Ownership | Action | Requirement |
|---|---|---|---|---|---|---|---|
| SG1 | Mixed species shrubs including; Dogwood, Acer | 1 | 2.6 | 3.4 | C - Insured | Maintain as detailed | Remove to ensure 4m clearance to the rear conservatory. Do not allow remainder to exceed current dimensions. |

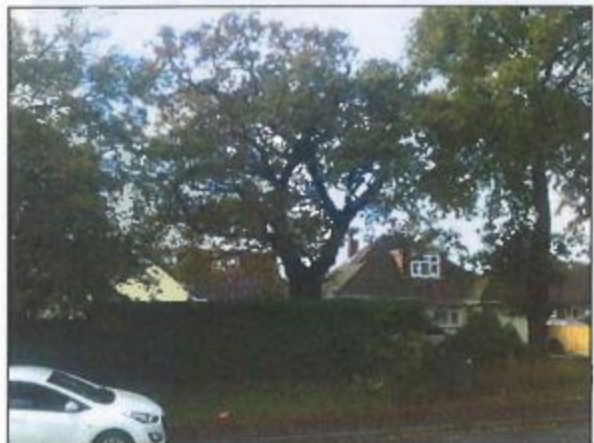
T2 Oak

In assessing the potential drying influence of the vegetation on site, T2 (Oak) and TG1 (Oak) are considered the dominant feature and accordingly we have identified them as the principal cause of subsidence.

| Tree No. | Species | Age Cat | Approx. Height (m) | Distance to Building (m) | Ownership | Action | Requirement |
|---|---|---|---|---|---|---|---|
| T2 | Oak | 3 | 10 | 13.8 | C - Insured | Remove | Remove subject to heave assessment. |
