**Asbestos Refurbishment/Demolition Survey for**

Jacobs Foreman Developments Ltd

Land South of Ranelagh Road

Project Number: S1710C

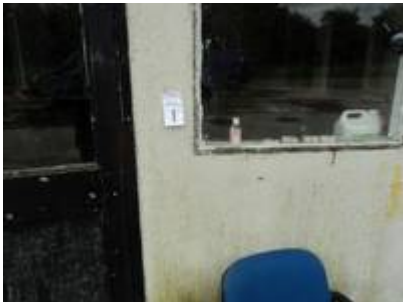
| Location ID: | 18769 | Location Ref: | 1 | Product Type: | NADIS |

| Area/ Floor/ Room/ Product: | External: Ground floor: Yard Office: Textured coating |

| | Action: | | No Action Required | | |
| | Material Comments: | | Textured coating to external walls | | |

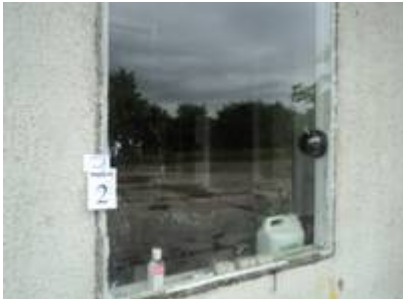
| Location ID: | 18770 | Location Ref: | 2 | Product Type: | NADIS |

| Area/ Floor/ Room/ Product: | External: Ground floor: Yard Office: Window Putty |

| | Action: | | No Action Required | | |

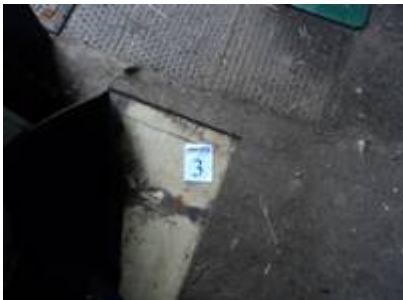
| Location ID: | 18771 | Location Ref: | 3 | Product Type: | NADIS |

| Area/ Floor/ Room/ Product: | Internal: Ground floor: Yard Office: Vinyl Flooring |

| | Action: | | No Action Required | | |
| | Material Comments: | | Vinyl under carpet | | |

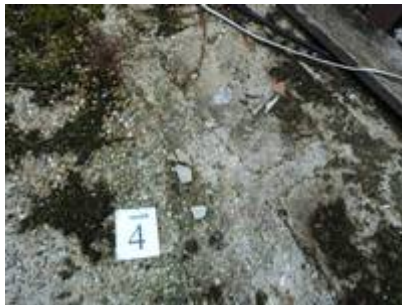
Sample 4 - GF Barn - Cement debris to floor - Chrysotile

External: Ground floor: Barn: Cement Debris

High damage

Chrysotile

Cement debris spread over internal footprint of building

6

Low Risk

| Location | Product type and name | | Extent | Accessibility | Condition | Surface treatment | Asbestos Type | Sample | Sample no | Material Risk Score | Priority Risk Score | Total Score |
|---|---|---|---|---|---|---|---|---|---|---|---|---|
| External, Ground floor, Barn | Asbestos cement | Cement Debris | approx 250m <sup>2</sup> | Easy Accessibility | High damage | Asbestos cement sheets etc | Chrysotile | Identified | 4 | 6 | | N/A |

Removal under HSE guidelines

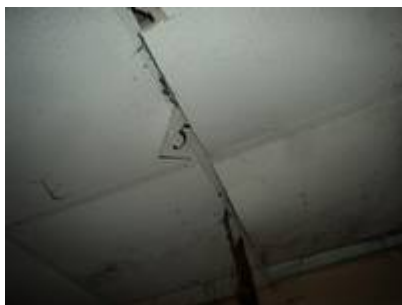
5

Internal: Ground floor: Stables: Ceiling tiles

No Action Required

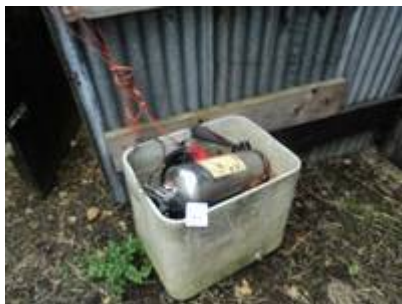
Sample 6 - GF External - Water tank - Chrysotile

External: Ground floor: External: Water tank

Low damage

Chrysotile

On floor outside stables

4

Very Low Risk

| Location | Product type and name | | Extent | Accessibility | Condition | Surface treatment | Asbestos Type | Sample | Sample no | Material Risk Score | Priority Risk Score | Total Score |
|---|---|---|---|---|---|---|---|---|---|---|---|---|
| External, Ground floor, External | Asbestos cement | Water tank | 1no | Easy Accessibility | Low damage | Asbestos cement sheets etc | Chrysotile | Identified | 6 | 4 | | N/A |

Removal under HSE guidelines

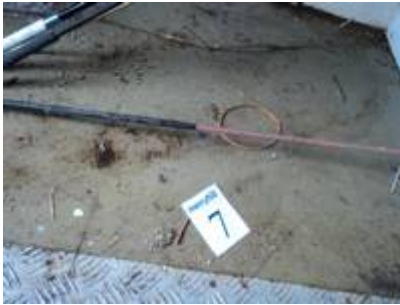
7

Internal: Ground floor: Fridge Unit: Vinyl Flooring

No Action Required
