# Subsidence management Services

## ENGINEERING ADDENDUM REPORT

Infront Innovation Reference: IFS-DLG-SUB-13-0044404

Address of Property: 25 Galaxie Road, Waterlooville, Hampshire, PO8 9AT

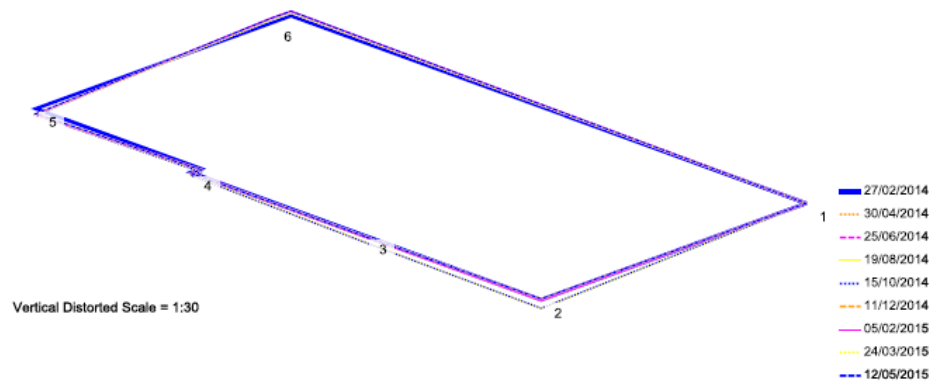
Figure 3– Level monitoring displacement map

- 8.2. Level monitoring was set up in February 2014 and readings have been taken at approximately 6-8 week intervals and results up to and including May 2015. The monitoring results, which are presented below, show that the property is affected by seasonal downward movement with particular reference to points 2, 3 and 4 which are located along the left hand side elevation. The maximum degree of seasonal downward movement has occurred to point 2 (front left corner) which saw a decrease in level between February 2014 and August 2014 of -6.2mm.

- 8.3. The monitoring shows the affected parts of the property moving down during the summer months when the tree is in leaf, demanding larger amounts of water and rainfall is lower and the net moisture content within the clay soil below the property decreases. Recovery or upward movement is then witnessed during December 2014 when the trees begin to shed their leaves, demands less moisture and the rainfall events increase, allowing the soil to rehydrate to some degree and swell, causing upward movement and consequential closing of cracks within the property.

- 9.4. The monitoring results (*Figures 3 & 4*) clearly indicate an unacceptable scale of seasonal foundation movement of the property.
- 9.5. Where a tree is causing localised movement to a house it is common for the effects to be transmitted throughout the superstructure and for cracks to appear at weak points, such as the junctions of walls and ceilings or the ends of lintels. In my opinion, the seasonal movement associated with the oak trees TG3, is now the only plausible explanation for the movement.

- 11.5. The level monitoring confirmed that the foundations were moving seasonally and with greater movement at the rear elevation
- 11.6. The submitted evidence therefore points conclusively towards the oak trees TG3 being the substantial and effective cause of the damage that appeared in 2013 to the left hand side of the property. It also indicated the scale of the movement associated with the tree to be unacceptable.

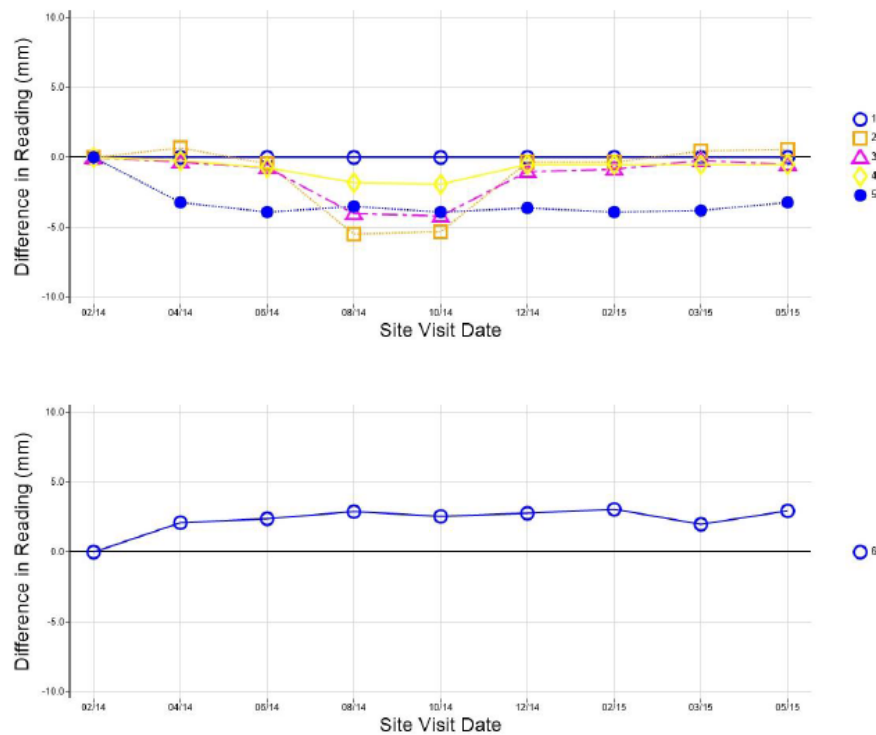
Figure 4 – Level monitoring results

- 8.5. In this instance, the only significant vegetation within influencing distance of the left of the property are the oak trees (TG3).
- 8.6. For reference the trees (T1 & T3) which were said to be influencing the conservatory were removed in February 2014. The monitoring results to the two points set up on the conservatory located at the rear left and rear right corners (points 5 & 6 respectively) have levelled out indicating relative stability since this date.
