# Engineer's Report

| Our Reference | <b>IFS-DLG-SUB-13-0044404</b> |

| Address | <b>25 Galaxie Road, Waterlooville, Hampshire, PO8 9AT</b> |

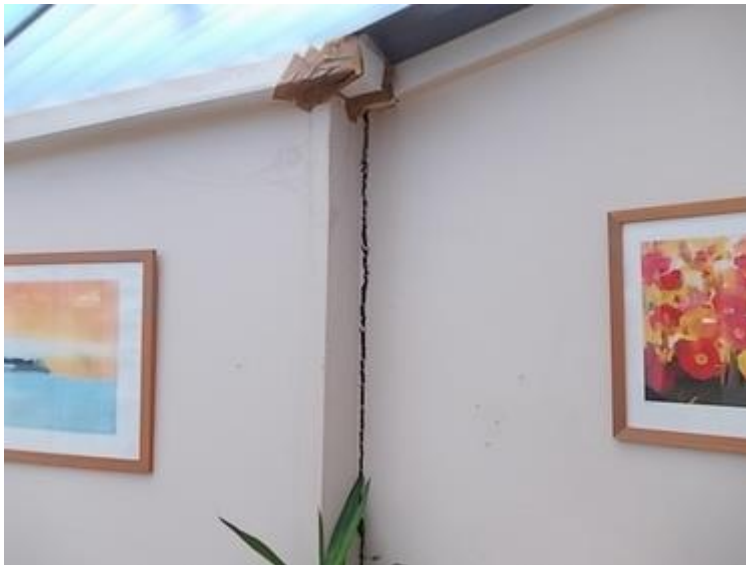
Within the conservatory, there is a vertical crack along the right hand wall which increases in width with height. The roof is noted to be leaking within the conservatory and the right hand wall is suffering from water ingress.

FIGURE 03 Verical crack on RHS of conservatory.

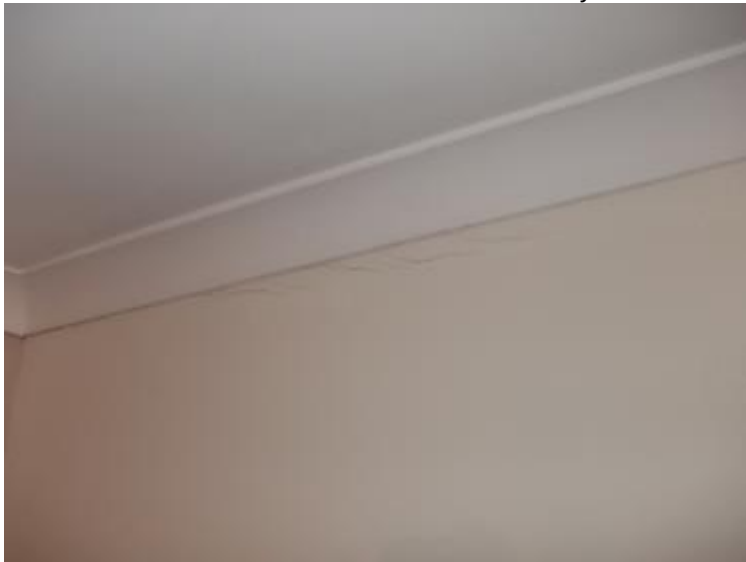
Within the living room, there are cracks along wall ceiling junctions and the coving was noted to have been pulled and is coming adrift on the rear elevation.

FIGURE 04 Stress crack along wall ceiling joint in lounge

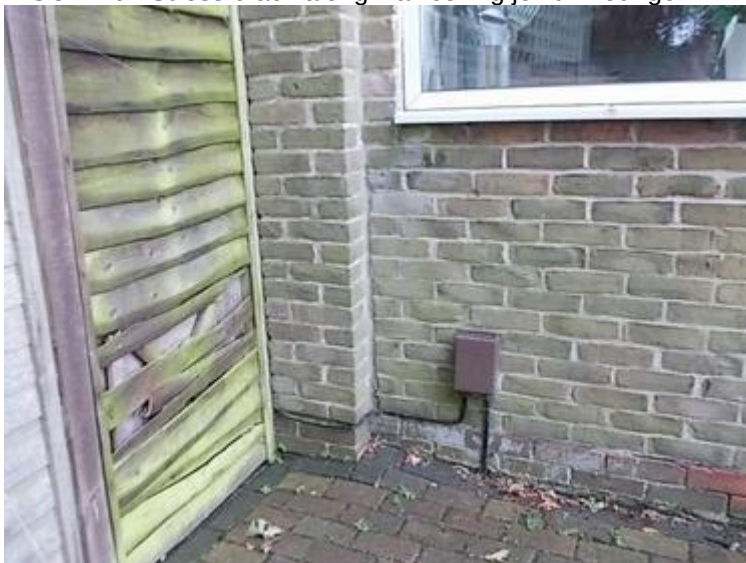
On the front elevation, there is a diagonal tapering crack which increases in width with height and tends towards the left hand elevation. The brickwork below the kitchen window has become loose and the window has elongated.

FIGURE 05 cracks on front elevation below kitchen window

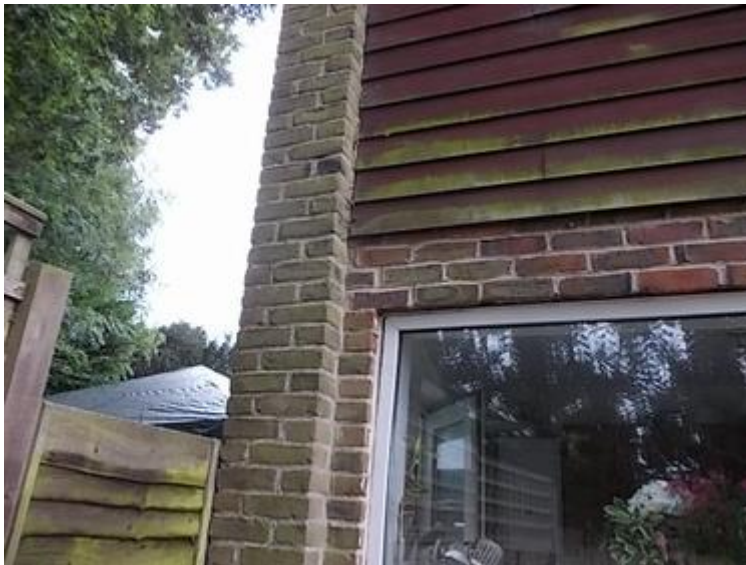
FIGURE 06 Diagonal crack above kitchen window
