## ARBORICULTURAL SURVEY AND TREE PROTECTION PLAN 6 and 6a New Brighton Road, Emsworth, PO10 7PS

Report in support of an application to construct rear single storey extensions at 6  
and 6a New Brighton Road

**Report by Dr Martin Dobson**

*20 May 2013*

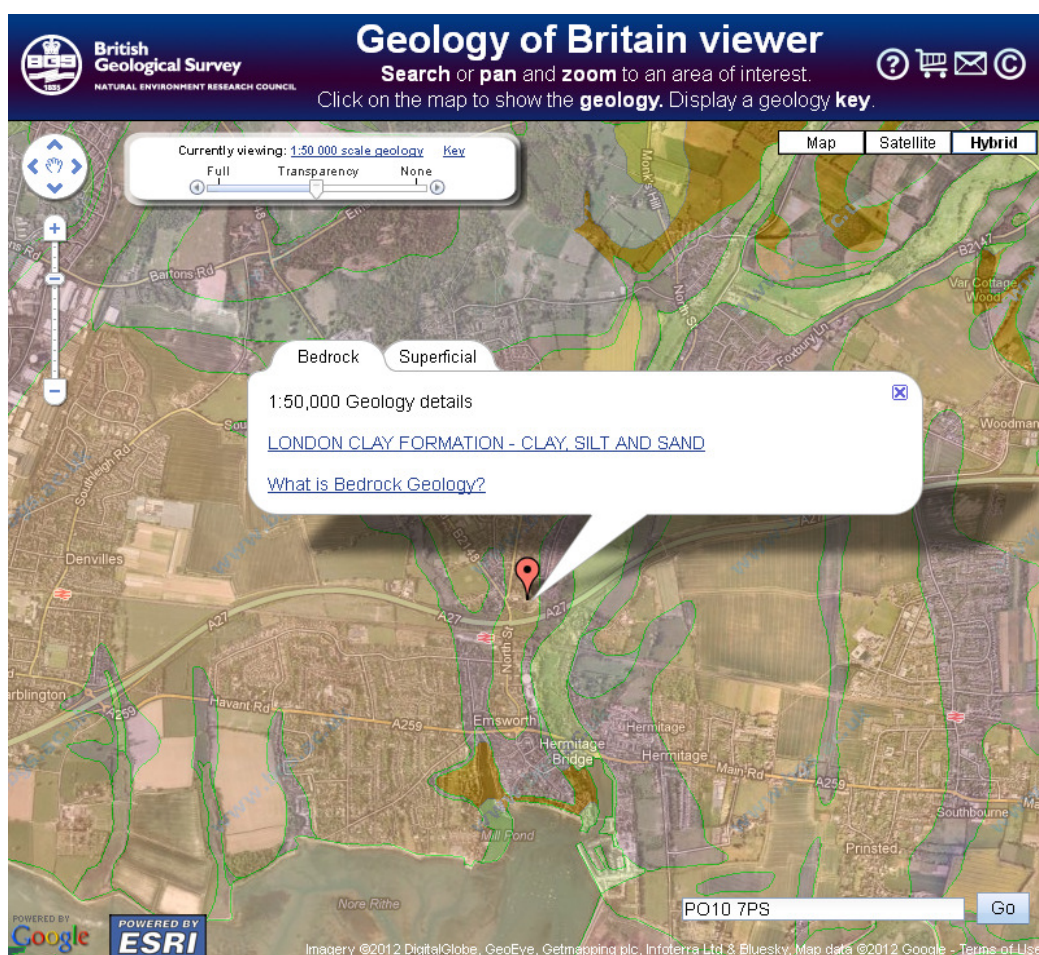
- 2.7 The British Standard advises that soil type should be considered when designing foundations. The British Geological Survey records that the soil in the vicinity of the Property is London Clay which is often highly shrinkable (Figure 1). Foundations which can withstand shrinkage and swelling of clay should therefore be carefully considered. The National House Building Council has provided guidance on appropriate foundations depths in its 2010 publication Chapter 4.2 'Building Near Trees' (Appendix **MD5**).

**Figure 1.** The property is on an area of shrinkable London clay. Design of foundations for the extensions should therefore take into account risks posed by trees through subsidence and/or heave.

- 2.8 Oak can grow to a height of 20 m and is considered to be a high water demand species. The London clay probably has a high shrinkage potential. The Oaks are 8 m from the extensions giving a D/H of 0.4. This means that foundations will need to be at least 2.5 m deep - but NHBC advises that they should be designed by an engineer.

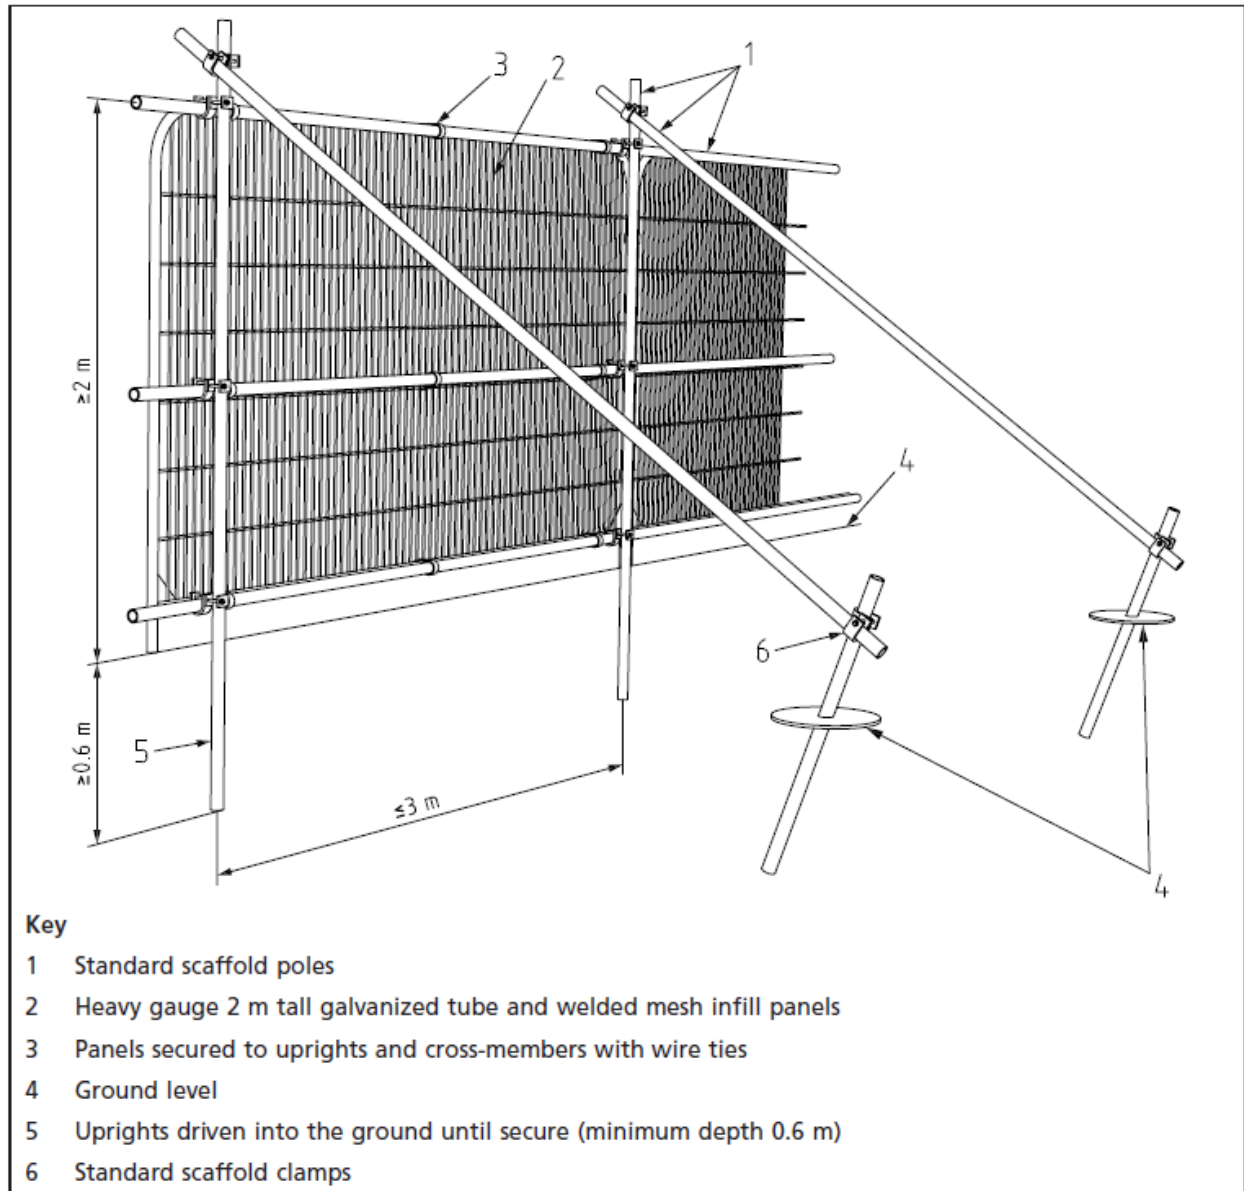
**Figure 2.** Diagram to illustrate design of protective fencing

- 3.5 Protective fencing will consist of a scaffold framework, well braced to resist impacts, with vertical tubes spaced at a maximum interval of 3 m (Figure 2). Onto this, weld mesh panels or 2 m high plywood board will be securely fixed with wire or scaffold clamps. Weld mesh panels on rubber or concrete feet should not be used as these are not resistant to impact and are too easily moved by site operatives. It will be installed before any materials are delivered to site or construction work takes place.

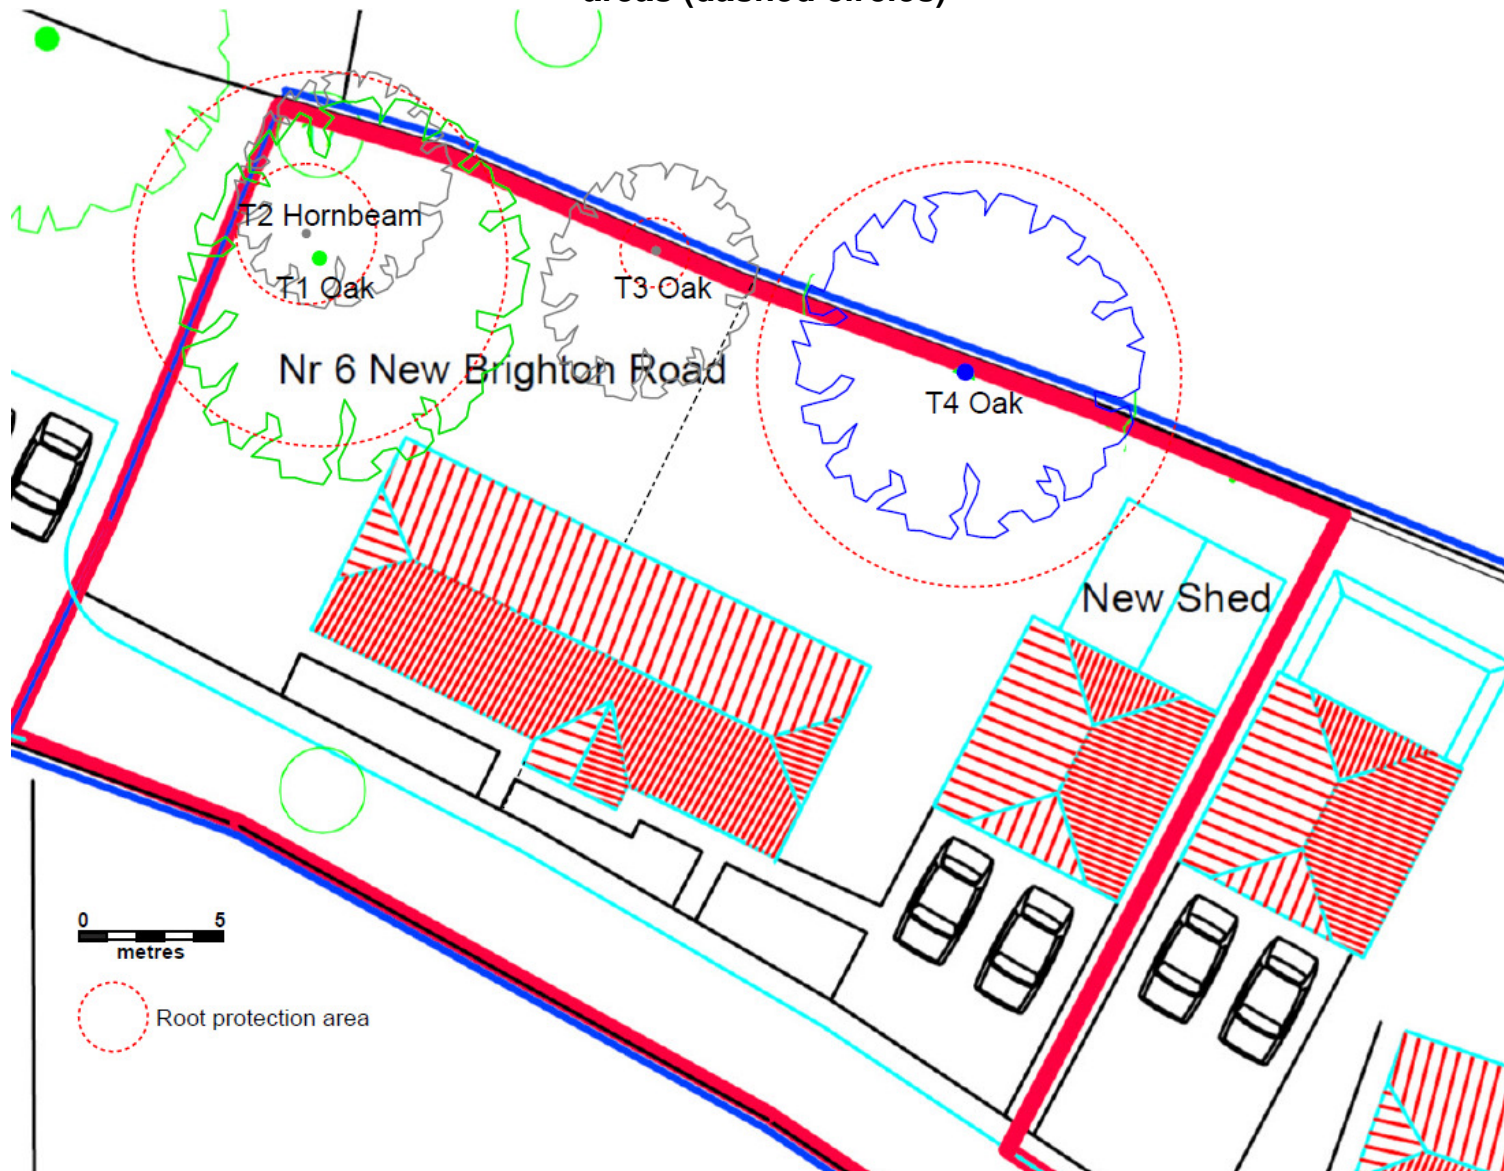
## APPENDIX MD2

- 2.4 Information from the survey enabled suitable root protection areas to be calculated for each tree and these are shown on the plan appended at **MD2** and in the schedule at **MD3**. The positions of the surveyed trees and a reasonable indication of their comparative branch spreads are shown on the plan. The drawing has been colour coded as follows:

Site survey drawing showing tree numbers, BS5837 colour codes (A – Green, B – Blue, C – Grey) and root protection areas (dashed circles)

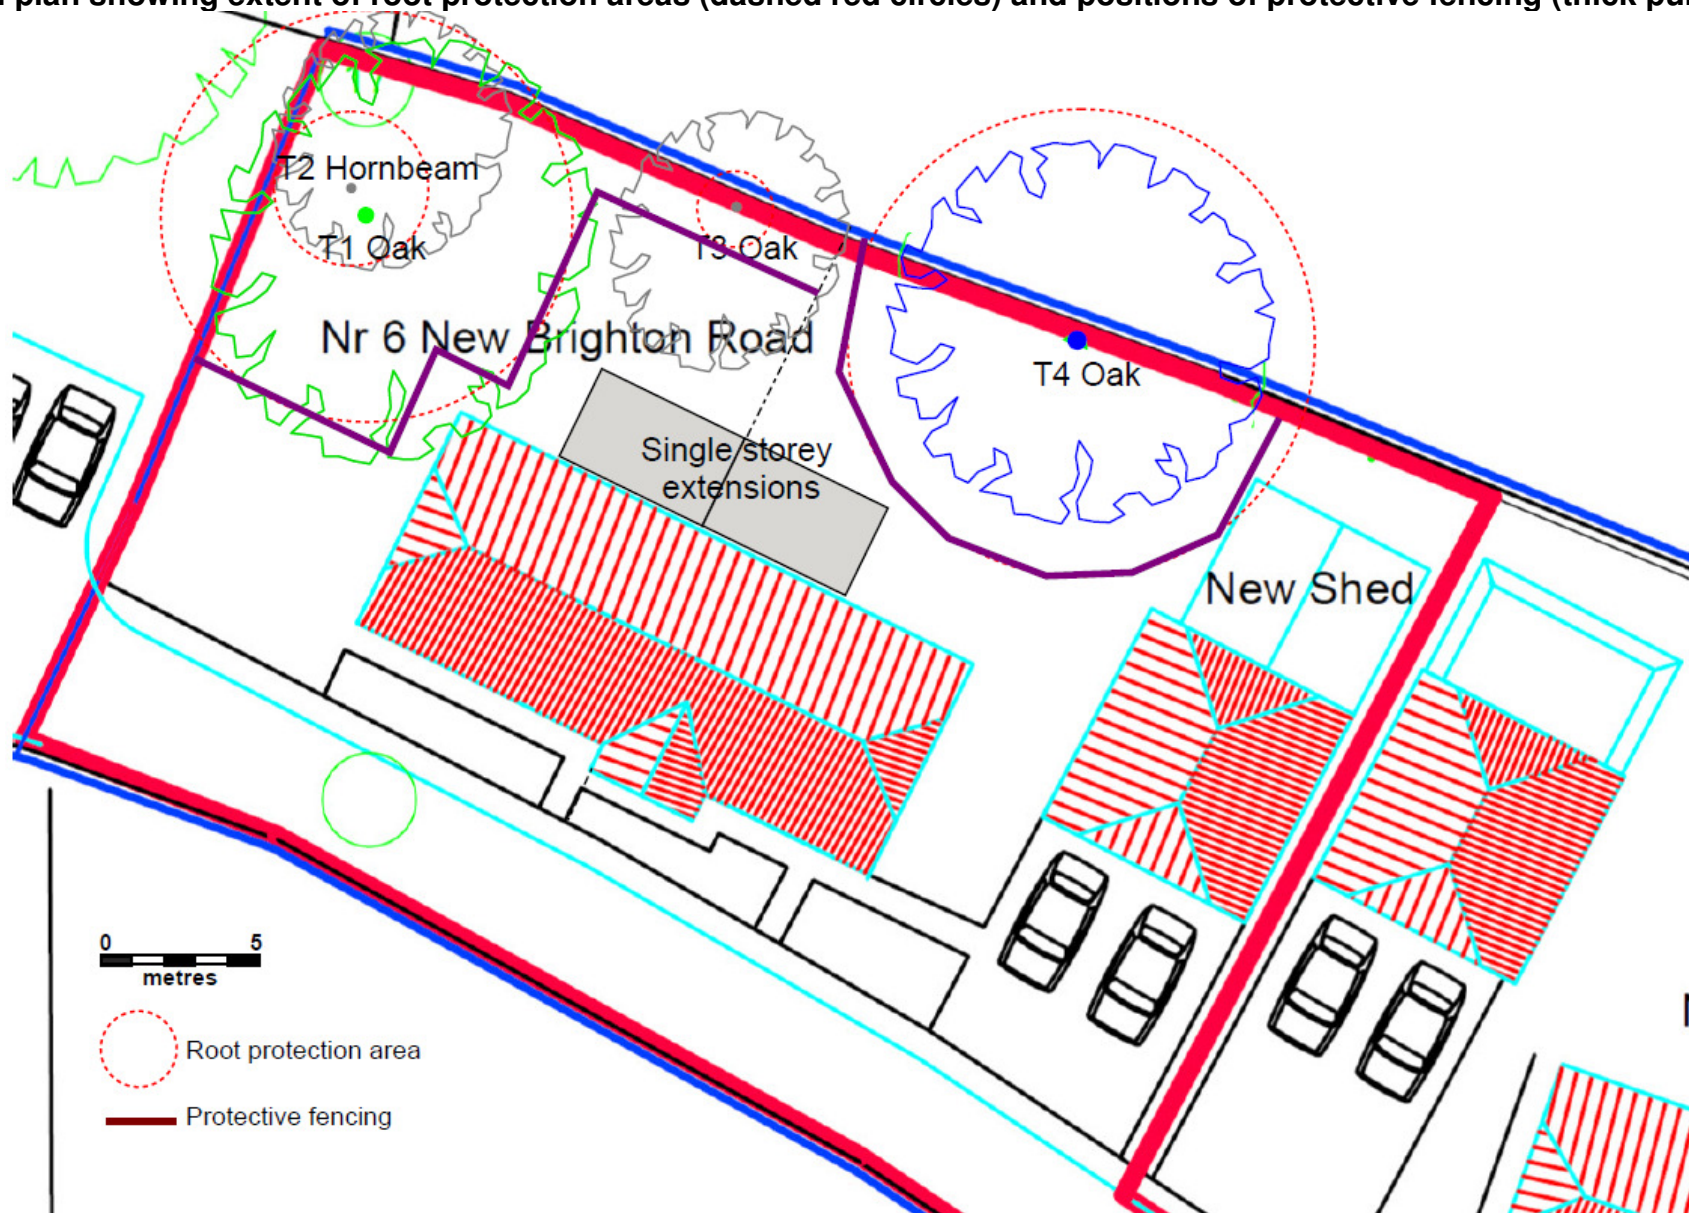
## APPENDIX MD4

- 3.4 The guidance contained in BS5837: 2012 recommends that there should be a root protection area (RPA) around trees which is kept free of all construction activities by means of an exclusion zone enforced through protective fencing or ground protection. The RPA is calculated as the area equivalent to a circle with a radius of 12 times the trunk diameter at a height of 1.5 m above ground level and is shown at **MD4**.

Proposed plan showing extent of root protection areas (dashed red circles) and positions of protective fencing (thick purple lines)

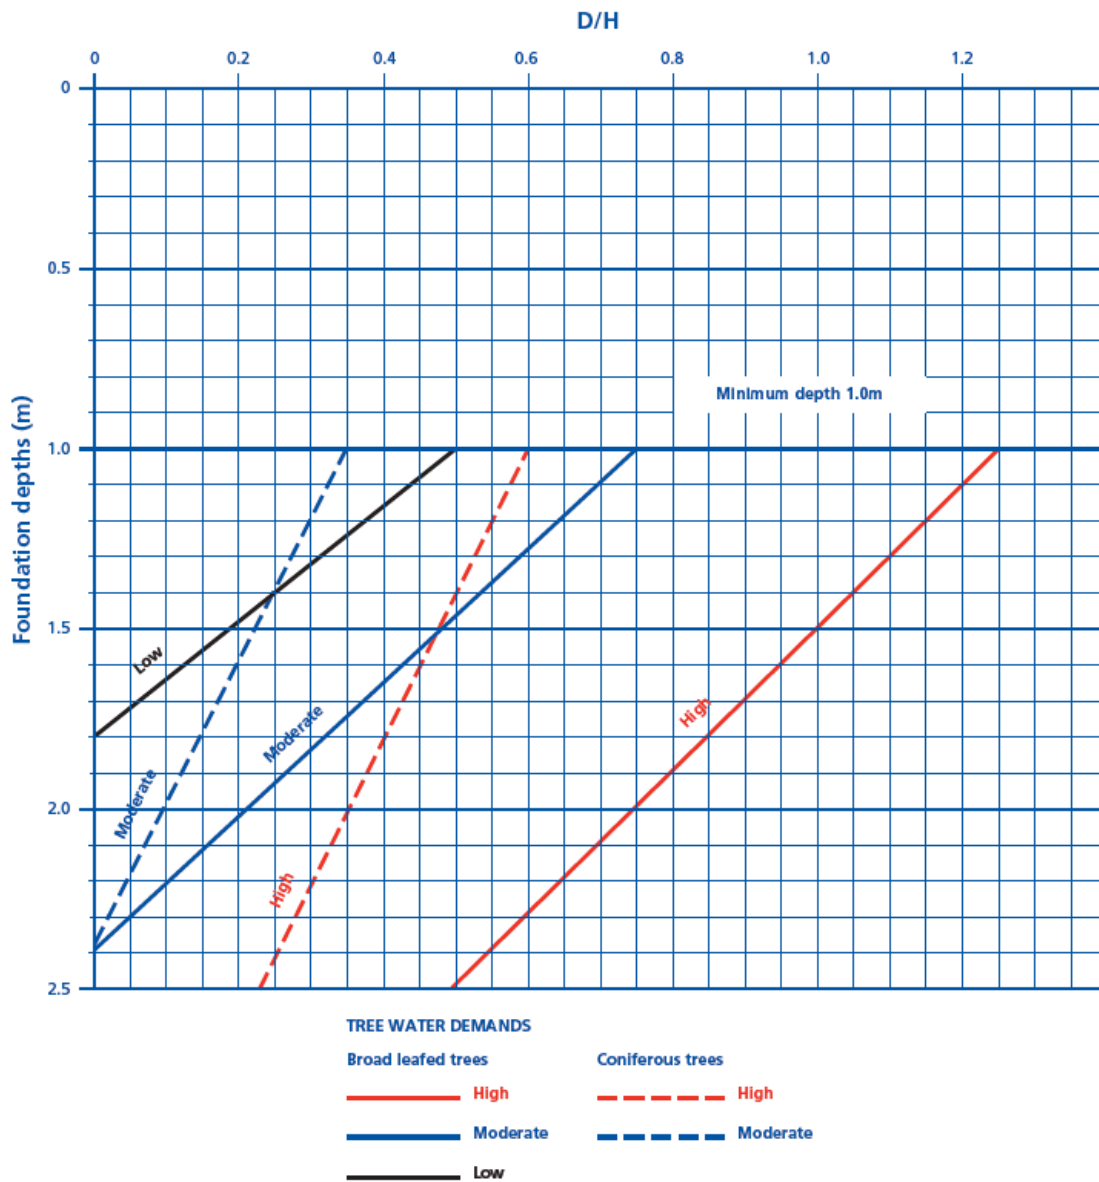
Chart 1 Soils with HIGH volume change potential: Modified Plasticity Index 40% or greater  
(see Design clause D5(b))
