# GEOTECHNICAL

## for Lloyds Banking Group

31 Hollybank Road, W. Sussex, PO10 7UE

Client: Lloyds Banking Group  
Client Contact: David Elliot  
Claim Number: 101431391  
Policy Holder: Mrs C Watson  
Report Date: 03 December 2013  
Our Ref: C9805G4330

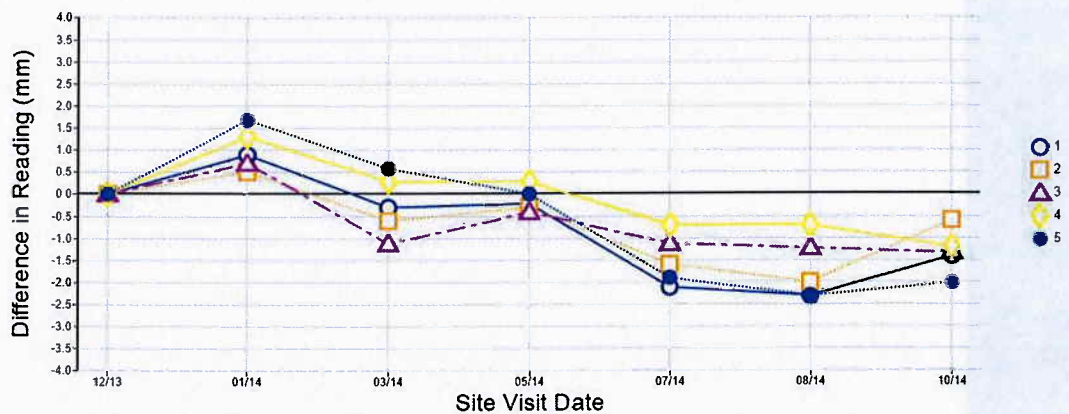
The following graphs display the progressive movement that each Level Monitoring Station recorded at each separate site visit date to give an overall look at how much the property is moving.

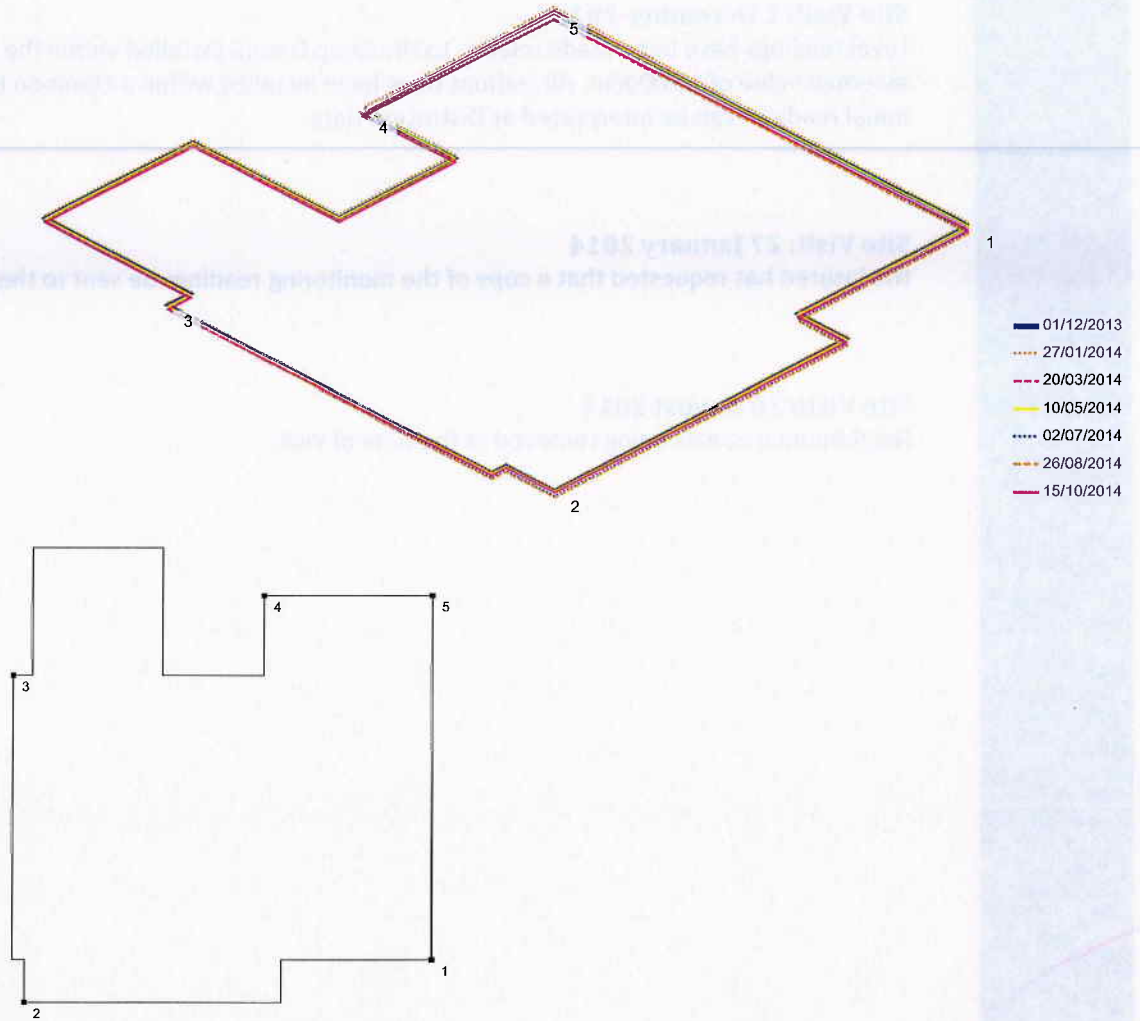
The following image shows an isometric representation of the movement of the property, based on the Level Monitoring Stations that were installed.
