## RISK ASSESSMENT

### WESTBEDHAMPTON RESIDENTS ASSOCIATION

**Paul Brooks** BSc MIIRSM GradIOSH  
Health and Safety Consultant / Trainer  
Dated: 10<sup>th</sup> July 2014  
Contact Tel No: 08450 50 40 60

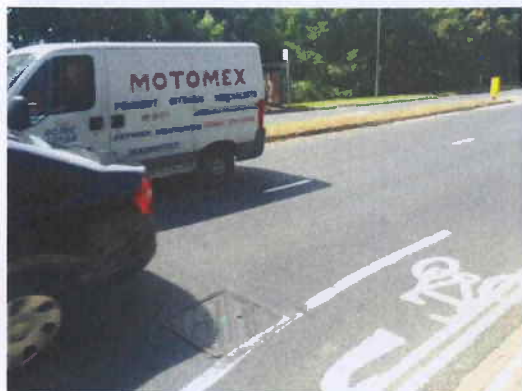
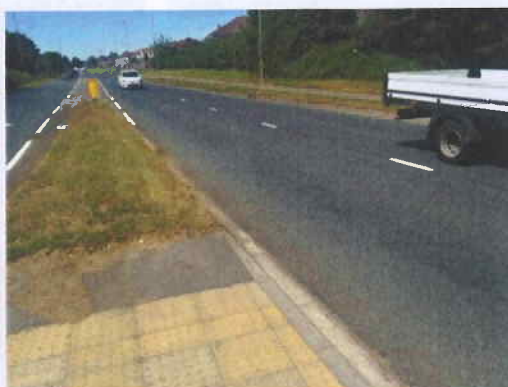
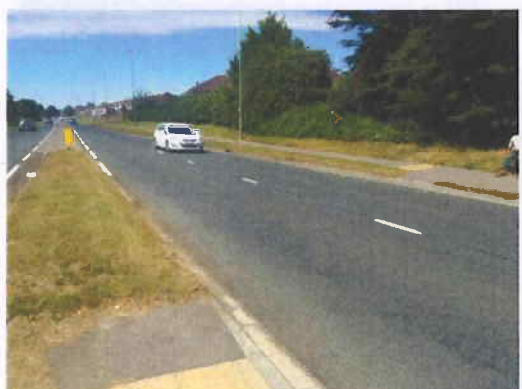
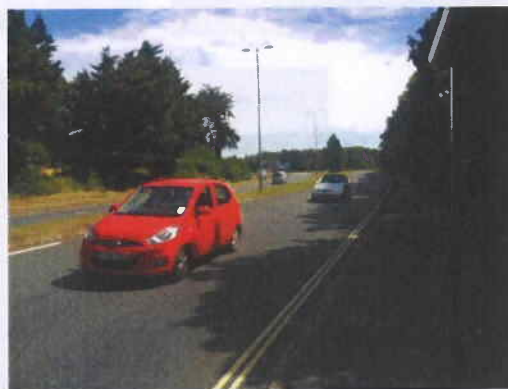
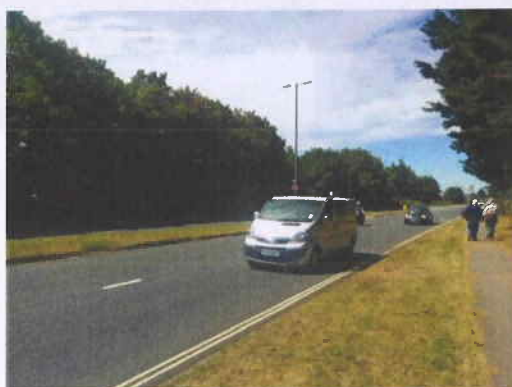
The first part of the site observed was the bus stop area. To access this location a pedestrian must first cross a dual carriageway to a central reservation area, and then proceed to cross a carriageway exactly at a pinch point where a dual carriageway becomes a single carriageway.

Taking an average of the two figures, 737 vehicles pass this area in an hour this equates to one vehicle every 5 seconds travelling at 40 miles per hour that pedestrians need to allow for. As the average person walks at a pace of 3.1 miles per hour (1.39 m/sec) and the distance from the footpath to a relative place of safety (central area) is 7.3m, this would take the average person 10.15 seconds to achieve this. As we have already stated in this time two vehicles have also required use of the same space.

The second part of the crossing is from the central area to the footpath on the Westbound side of the road. As identified above this area is where there is a reduction in carriageway width from dual carriageway to single carriageway. Although this does reduce the time required to cross, the pedestrians are now crossing an area where merging traffic is taking place.

*Photographs taken while attempting to cross the road to access the bus stop, showing a constant flow of traffic and the use of the dual carriageway.*

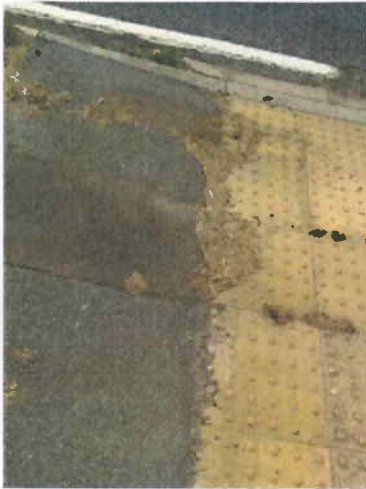
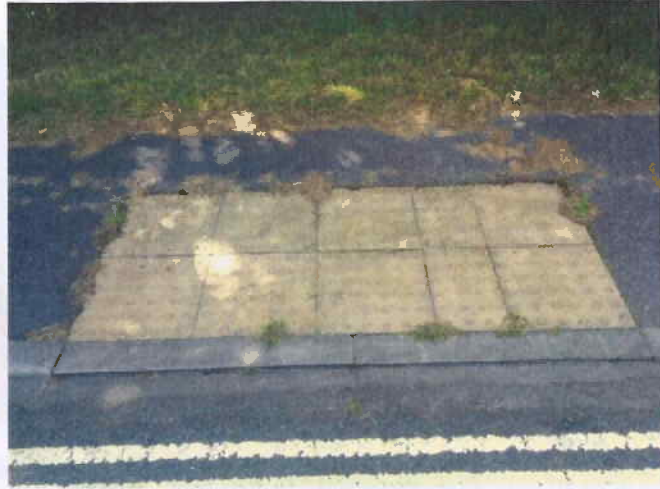
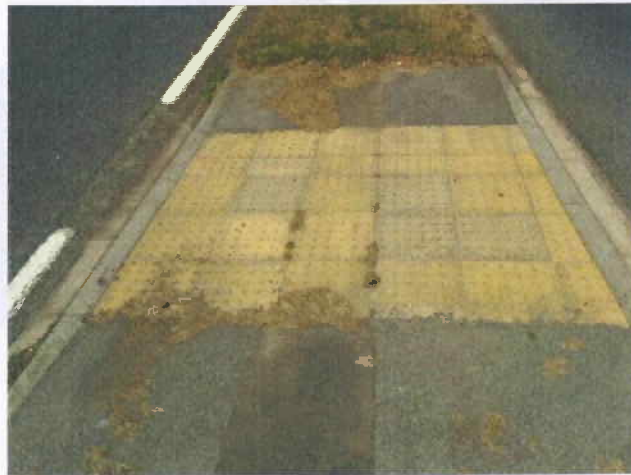
Furthermore, although the carriageway is currently in a reasonable condition the pedestrian paved "slabbed" areas were poorly maintained with vegetation such as weed growth evident and the debris from recent grass cutting left to accumulate on these areas. This leaves a potential for a slip or trip being caused.

*Photographs showing lack of maintenance observed at the crossing points.*

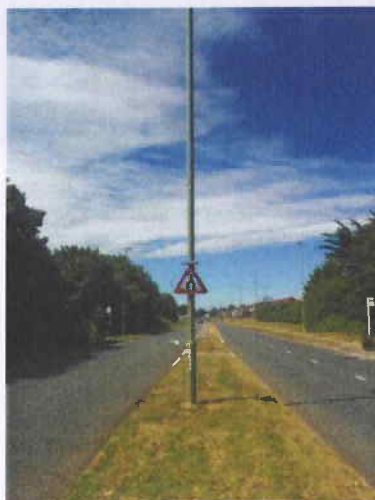
*Photograph highlighting crossing point, the dual carriageway shown on the right and the merging point shown on the left.*

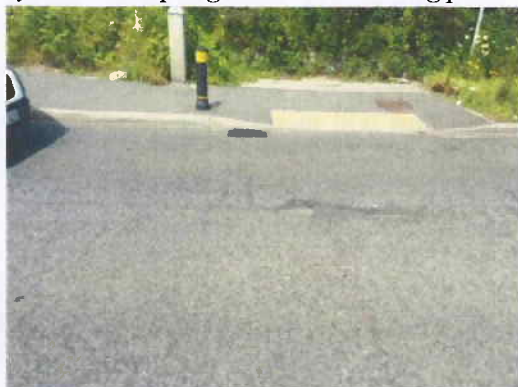
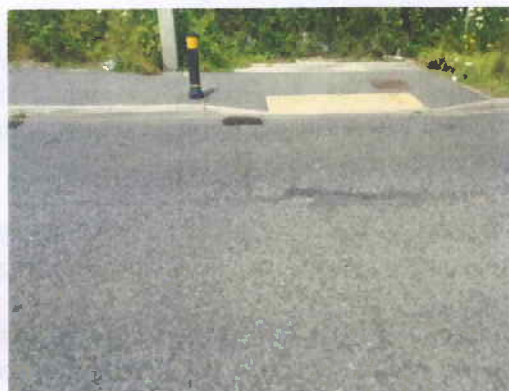
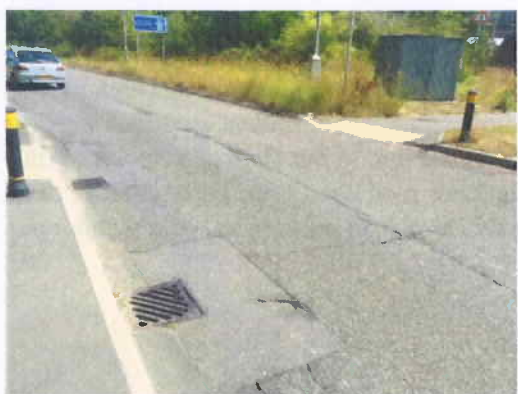
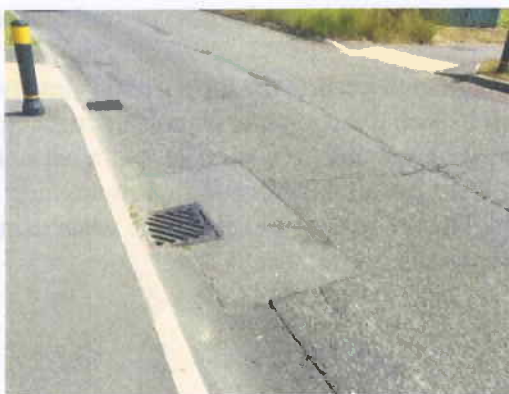
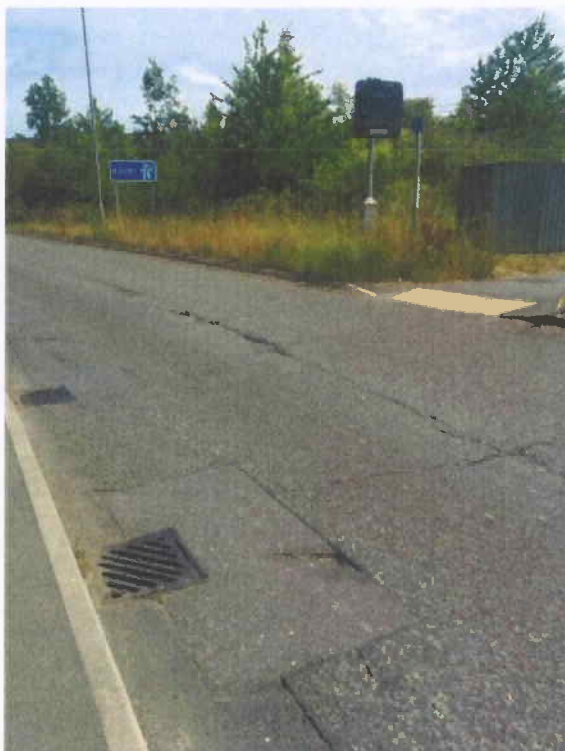
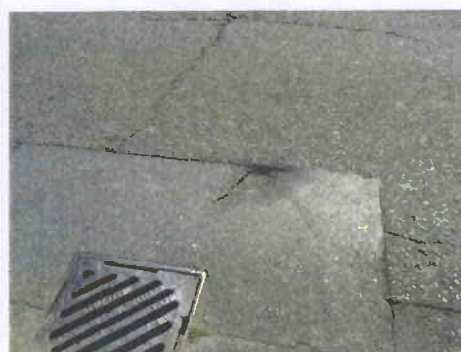
The same issues presents here as the previous dual carriageway crossing (above), but this time pedestrians and cyclists need to also account for traffic speeding (travelling in excess of the 40mph limit), vehicles lane changing without indication and also a very poor road condition (potholes, cracks, uneven surfaces etc.).

During the inspection the three persons involved in the inspection crossed this area twice, once in each direction and on neither crossing did anyone feel confident or safe doing so. You were not able to walk across at a reasonable pace due to the flow of vehicles. And when increasing the footspeed when crossing the poor road conditions became more of a risk. Further risks would also arise when using this area with pushchairs, young children, walking aids.

*Photographs showing the poor road condition, increasing the risks for pedestrians and cyclists attempting to use the crossing point.*

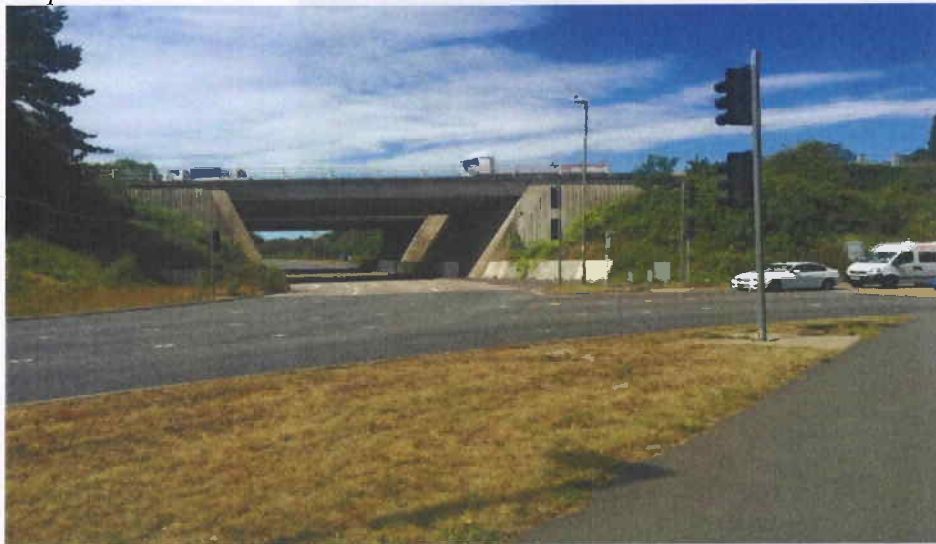
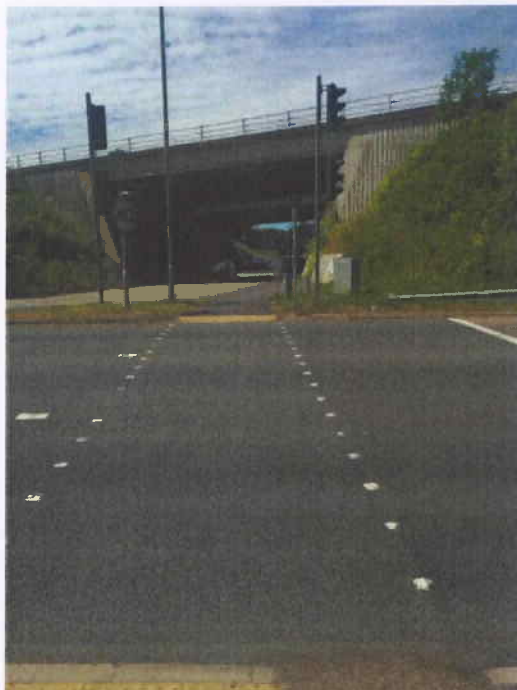
The traffic light system controls the vehicle flow onto the roundabout, and stops vehicles just before the crossing point, this would be ideal if there were pedestrian indicators in place to show when it was safe to cross and when not (green man & red man crossing lights).

*Photographs of the Southbound exit sliproad, showing the crossing point but no indicators to assist pedestrians.*

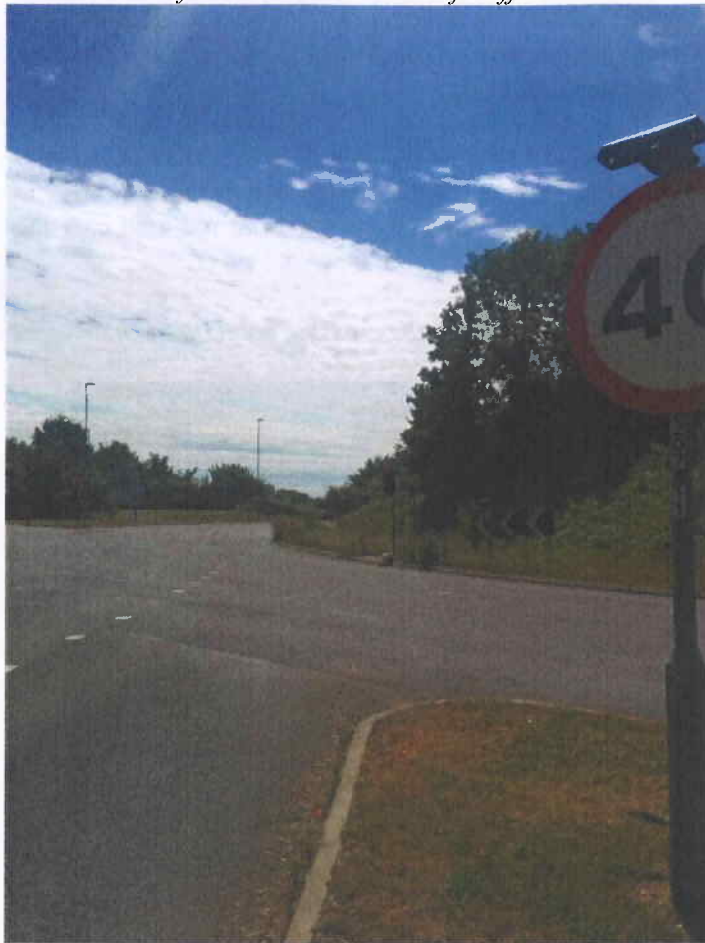
*Photograph showing the only traffic signal visible to pedestrians as an indicator of whether it is safe to cross three lanes of traffic.*

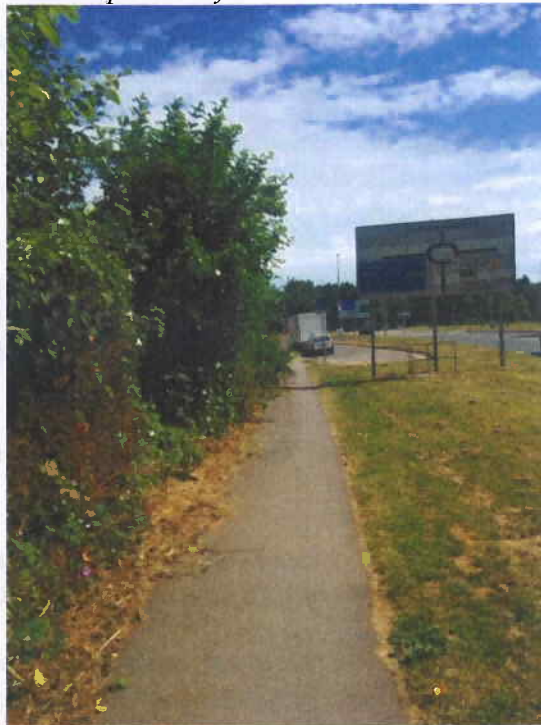
*Photographs showing poor maintenance generally of the footpaths, this continues on to the crossing points as detailed previously.*

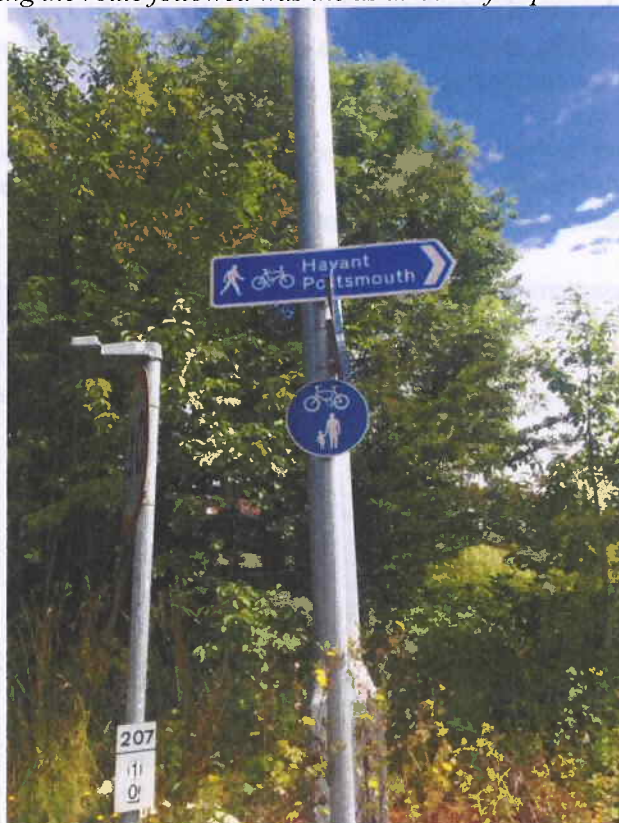
*Photograph showing the route followed was the as directed footpath direction.*
