## **Arboricultural Report**

**2 Emsworth Road, Havant, Hampshire**

Beechdown ref: B/0003/11  
2 Emsworth Road – tree impact assessment – march 2011

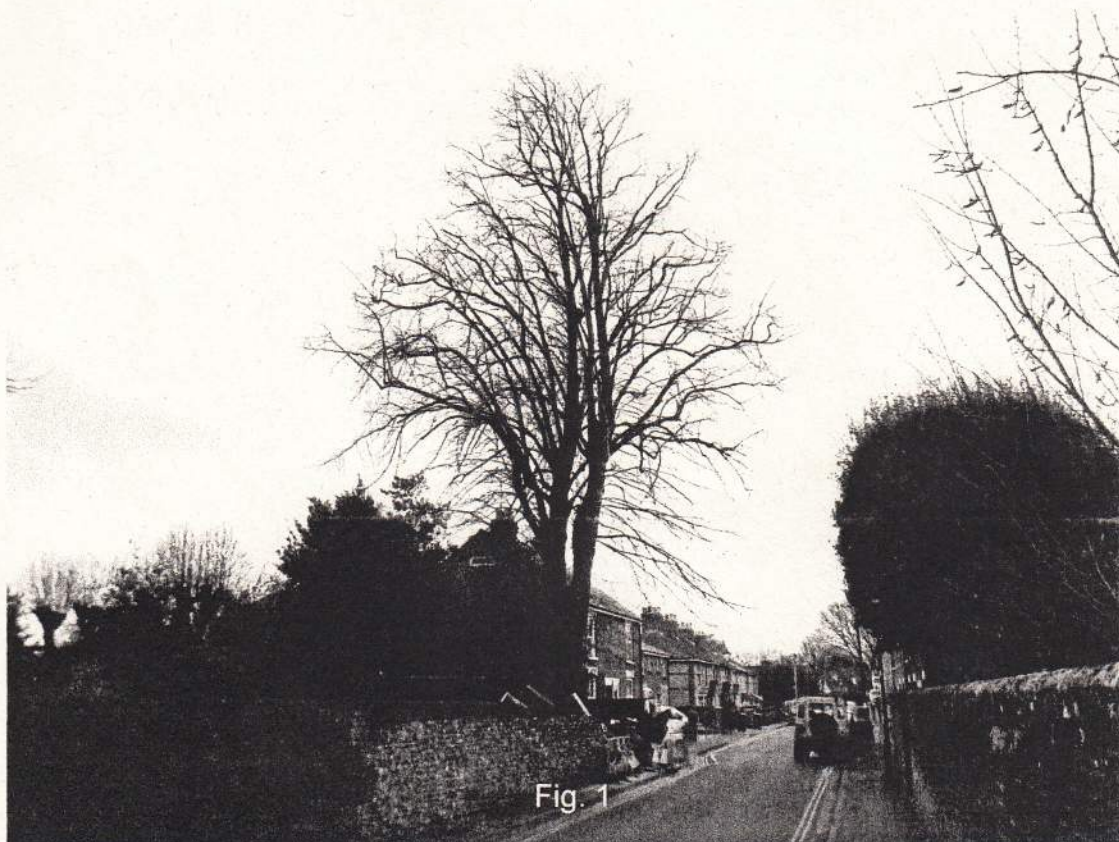
- 6.2 A mature tree dividing into two stems at 4m (**Fig. 1**) and subsequently pollarded at approximately 8m. The crown becomes multi-stemmed at the pollard points with the branches ascending sharply then arching to form a full and balanced crown.
- 6.3 The lateral growth is marginally less developed to the south.

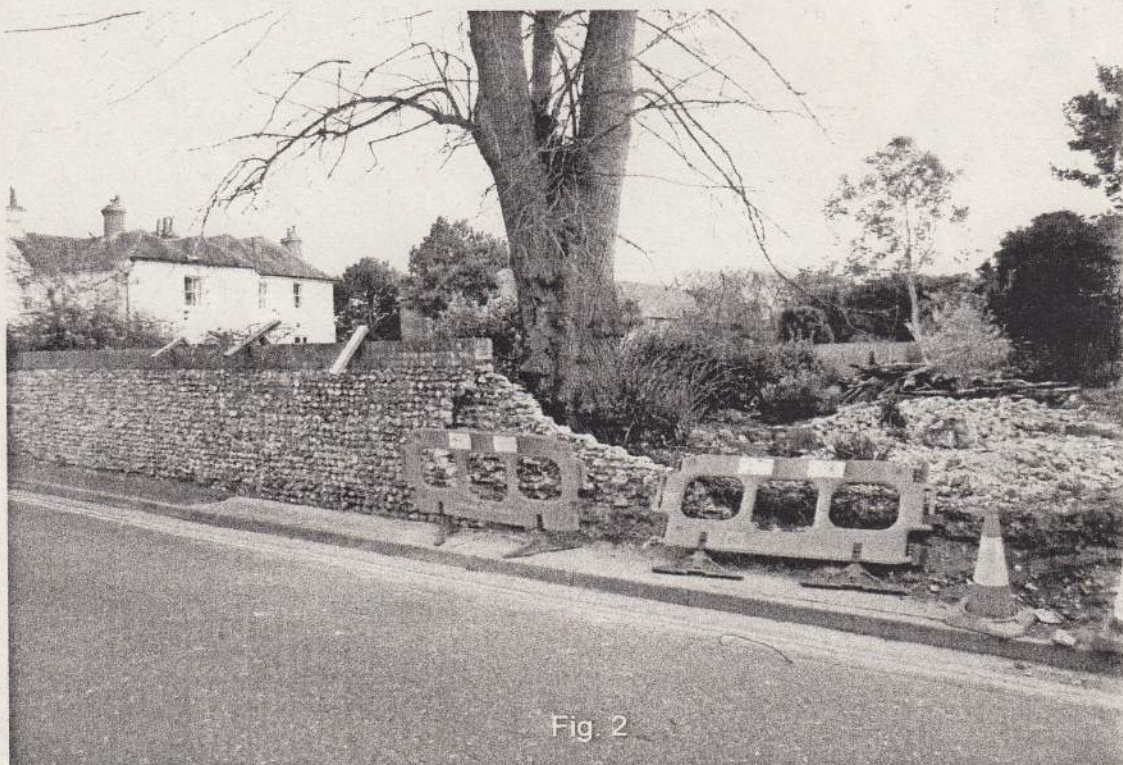
- 8.1 The boundary wall, running parallel with Lymbourn Road, was constructed of two leaves of flint facing with a rubble core (ref. Havant Borough Council correspondence 59352) with a brick coping.
- 8.2 The wall was fully collapsed from the southern end to approximately 3m from the tree at which point the inner flint facing partially remained and gradually stepped up to a point where it joined the intact wall (**Fig. 2**).

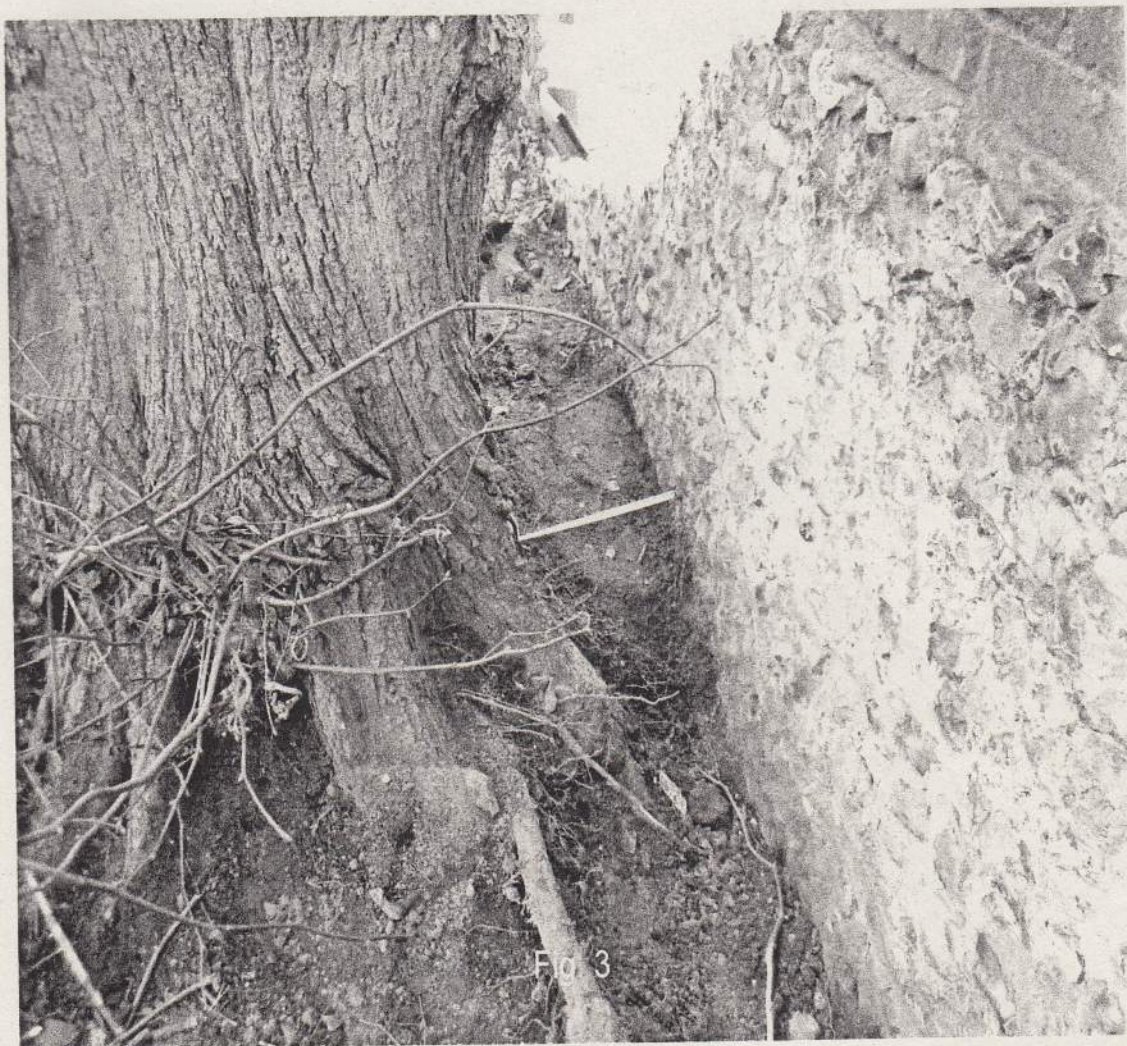
8.3 Distance between tree and wall from:

- Main stem above buttress flare - 50cm
- Buttress root at ground level - 30cm (**Fig. 3**)
- Buttress root 30cm below ground level - 20cm

9.2.3 As can be seen from **Fig. 3** there appears to be no obvious cracking or movement of the inner face of the flint wall at the closest point to the tree. Images from Google Earth taken in April 2007 show a section of wall missing at the southern end and some cracking in the adjacent brick coping but no apparent damage in the vicinity of the tree.

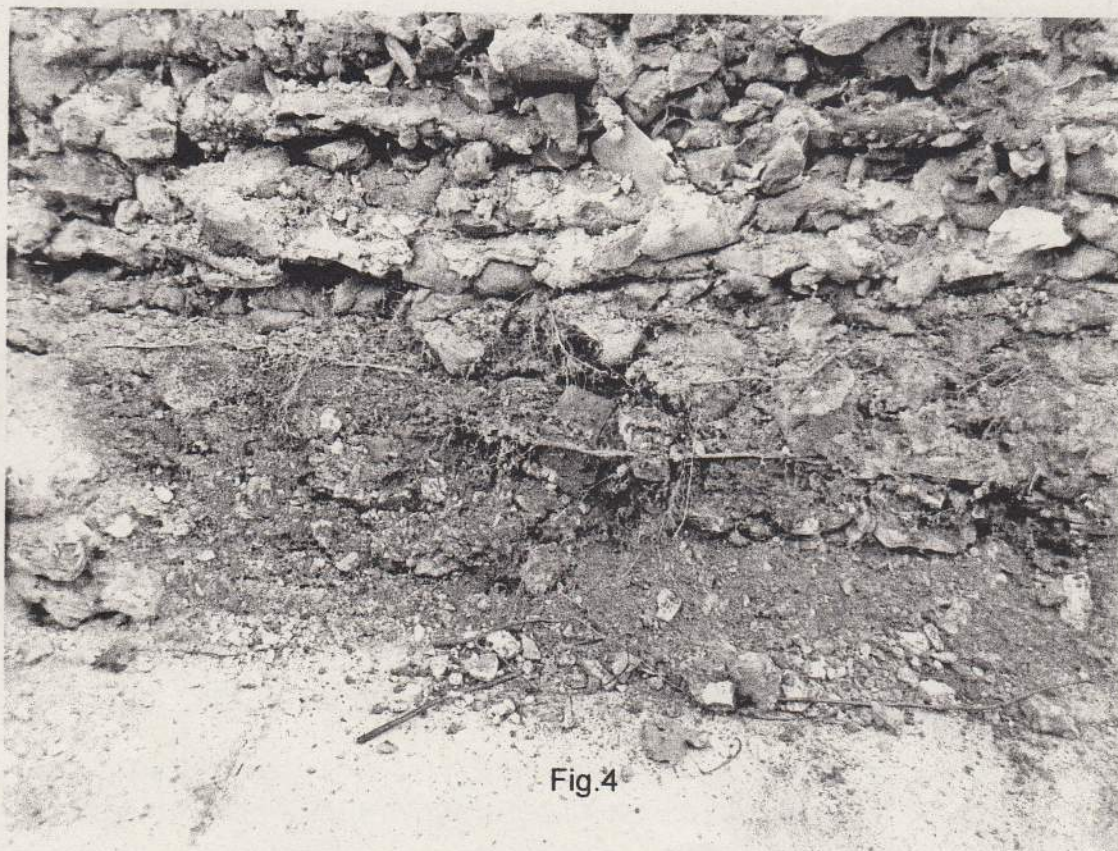
Fig.4

8.4 There were no major roots visible at any point in or along the line of the collapsed wall but some minor roots were present (**Fig. 4**).
