**SECOND STAGE APPRAISAL**

**ADDENDUM TO FIRST STAGE APPRAISAL 2844**

**86 WEST STREET**

**Job No: 2844**

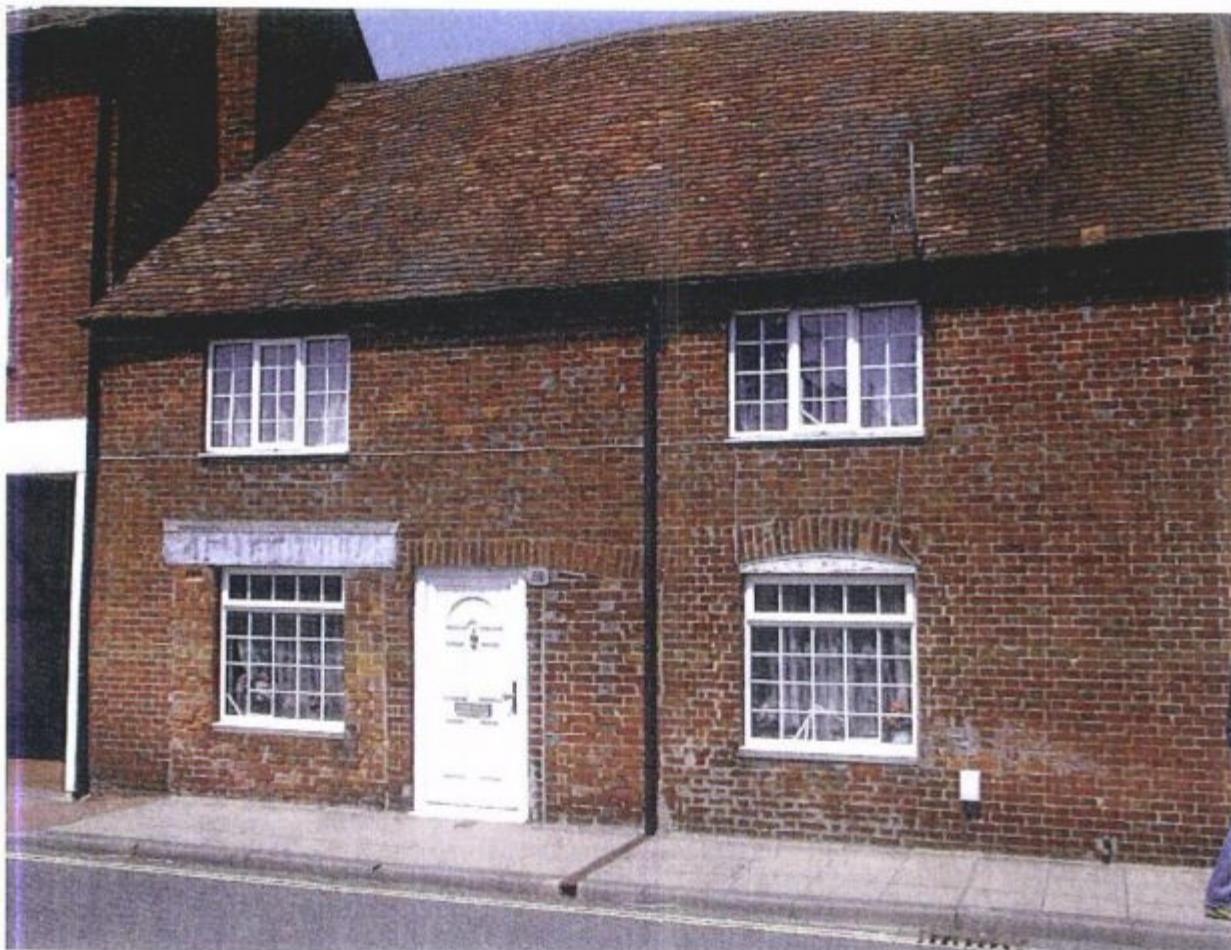
Photo No. 5 (June)

- Straight vertical joints evident either side of the front window indicating an earlier, wider opening. (See Photo No. June 005 and September 051.)
- North wall shows a straight vertical joint at the junction with the Party Wall and a 25 thick horizontal plate at approx mid-height.

- The proposed conversion of the building back to 2 No. dwellings, dictates the re-opening of a former infilled doorway adjacent to the existing entrance. (See Photo No. 06/005.)

Front (South) Elevation

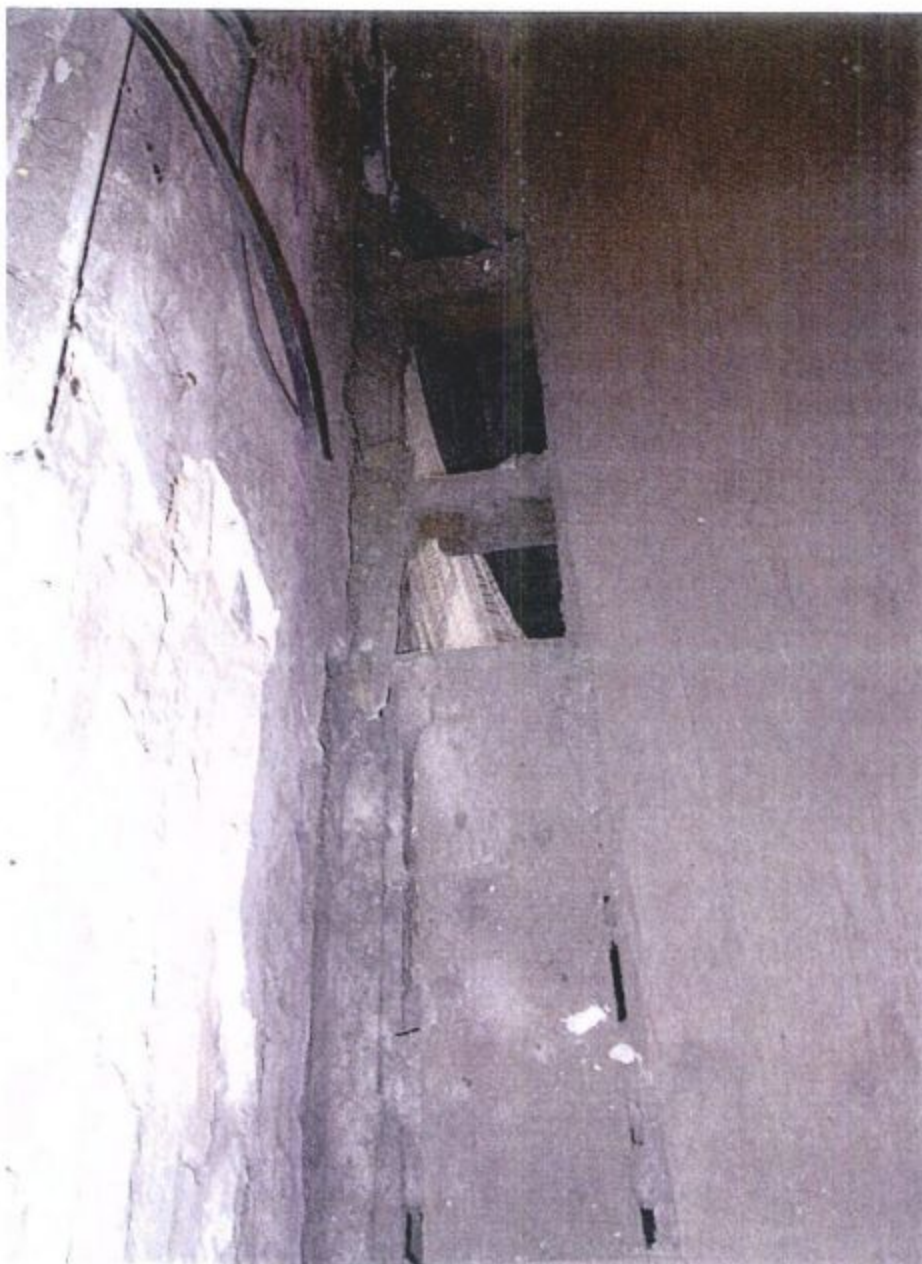
Photo No. 28

- First floor has been over-boarded (east/west) in the same direction as the original decayed boarding beneath.
- The floor joists are now exposed within the Study below and span north/south from the front (south) wall to the 230 x 200 wide carriage beam towards the rear of the Study.
- The floor joists are broken/decayed and crudely repaired and no longer have a bearing on the front wall. (See Photo Nos. 28, 47, 48, 49 & 51.)

Bedroom 1.  
1<sup>st</sup> Floor Junction with Front Wall

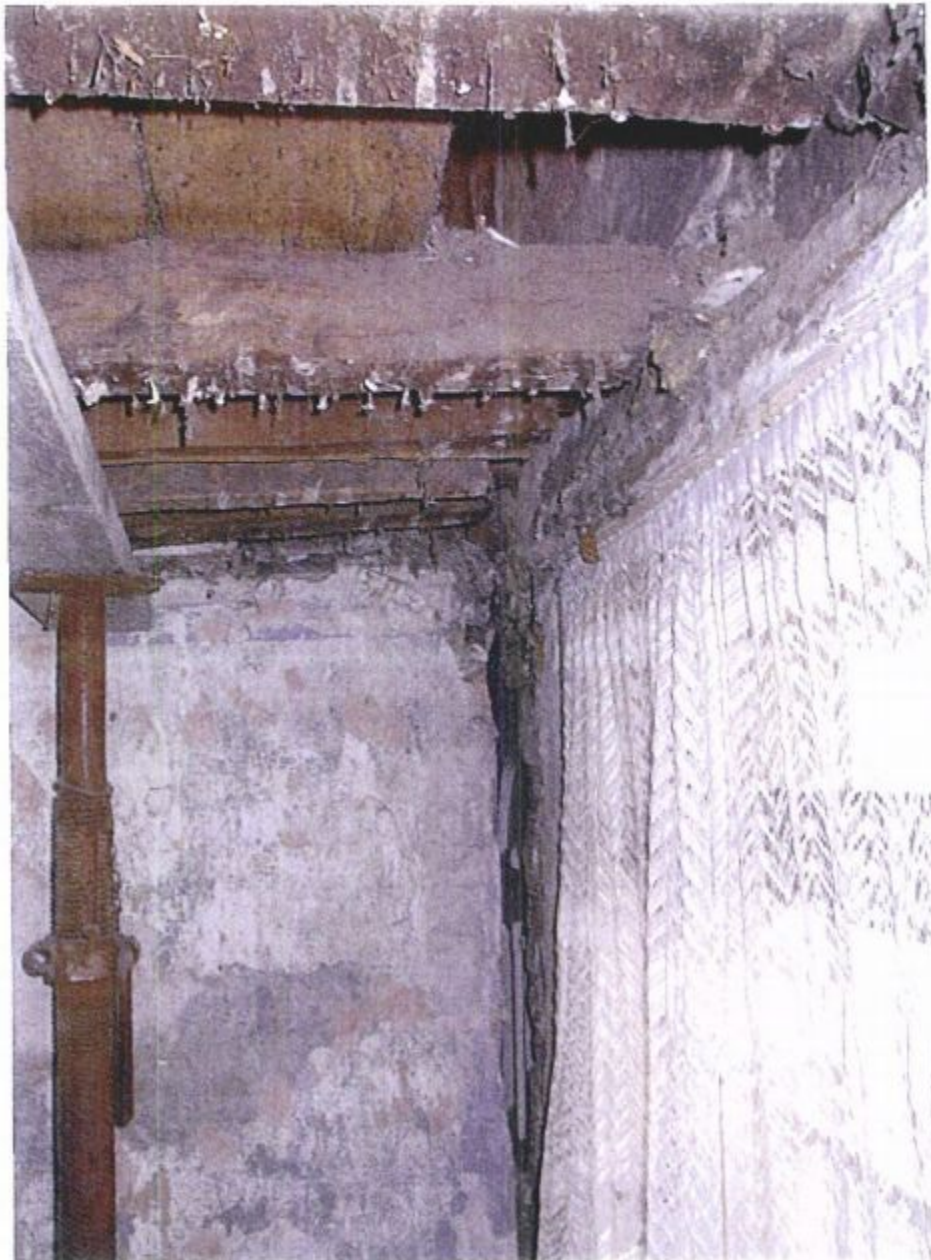
Photo No. 47

Study:- 1<sup>st</sup> Floor Junction with Front Wall.  
Separation in Study/Corridor Wall.

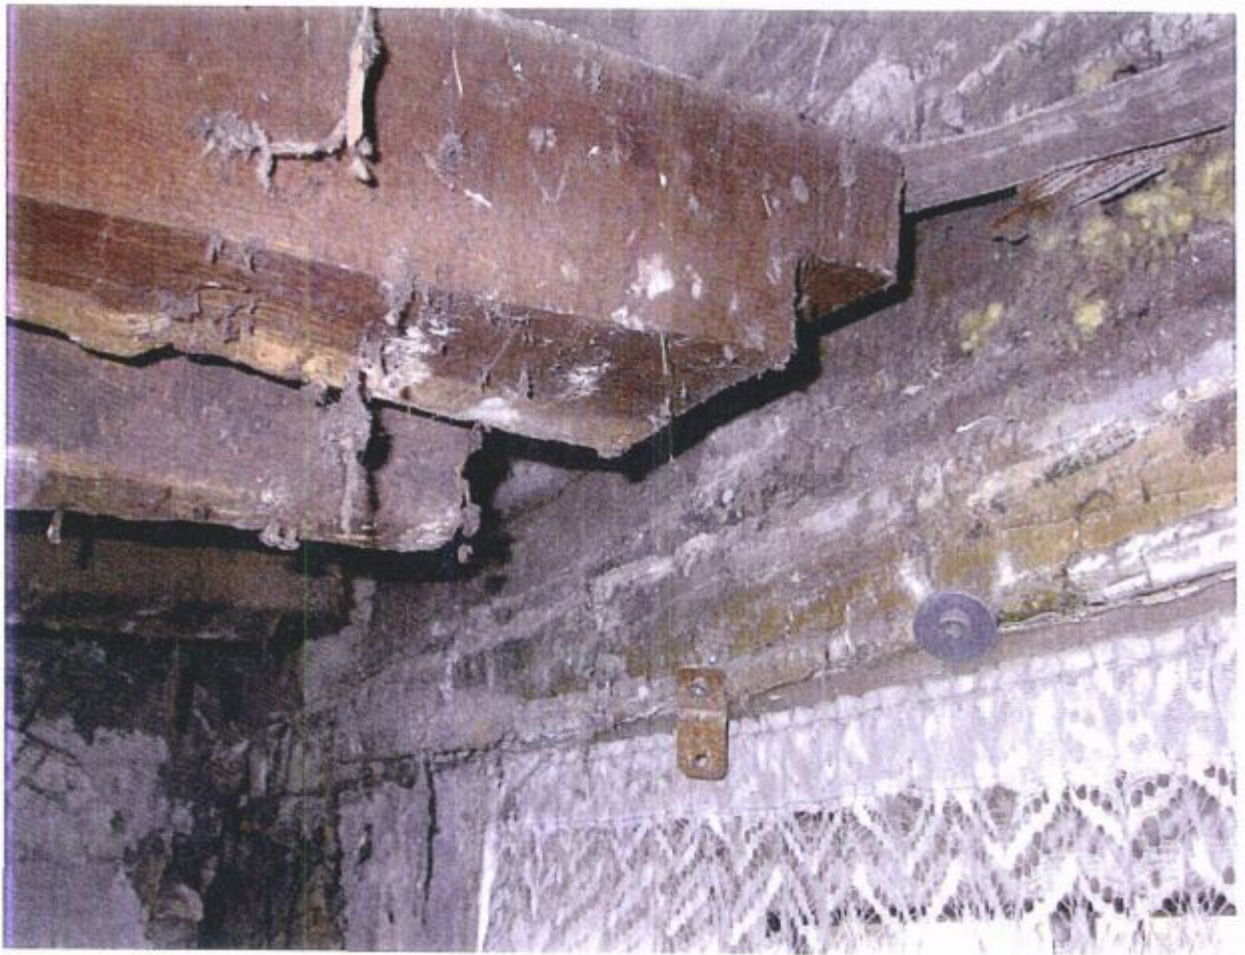
Photo No. 48

Study:- 1<sup>st</sup> Floor Junction with Front Wall.

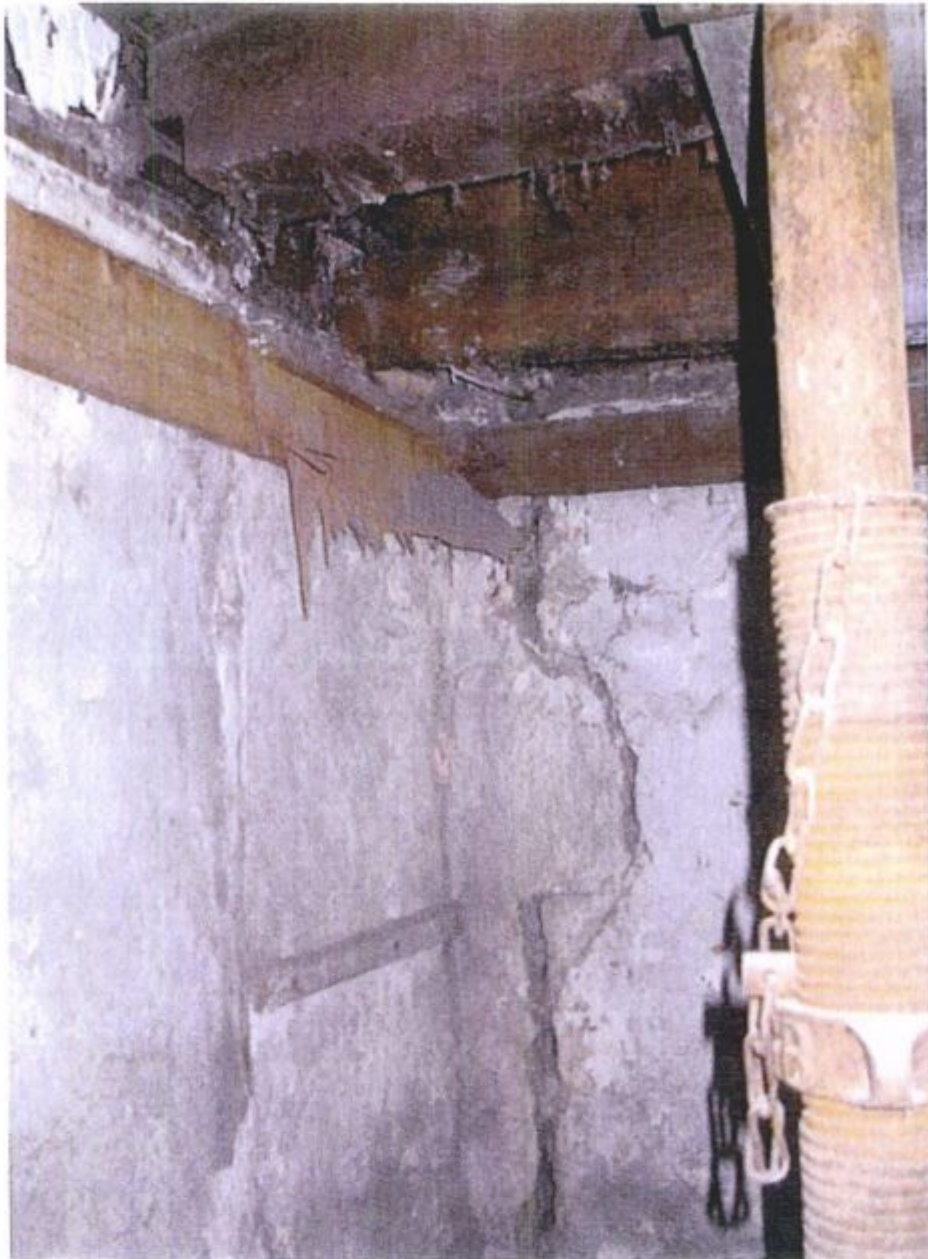
Photo No. 49

Study:- 1<sup>st</sup> Floor Junction with Front Wall.  
Separation in Party Wall.

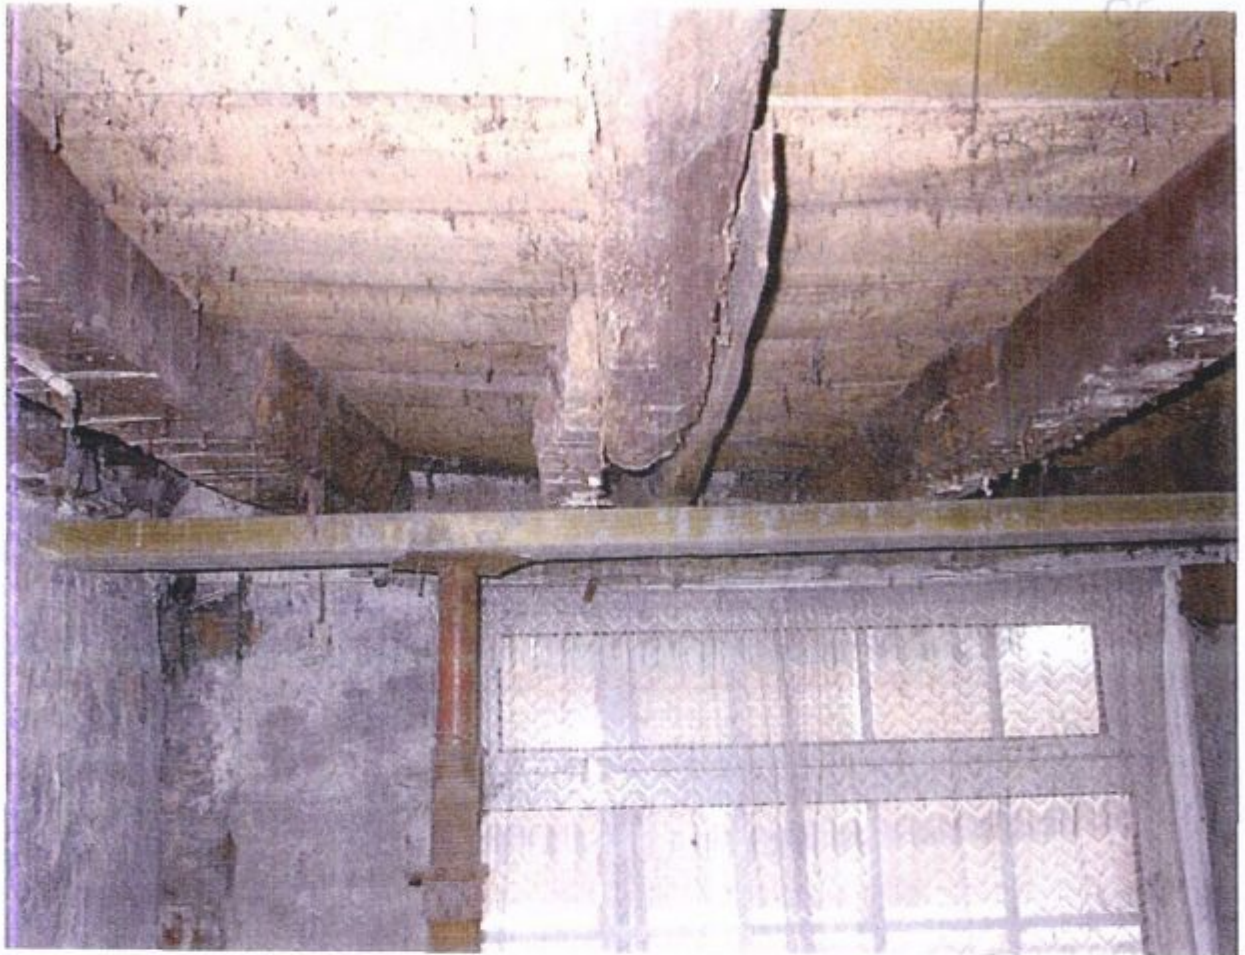
Photo No. 51 – Study:- 1<sup>st</sup> Floor Joists.

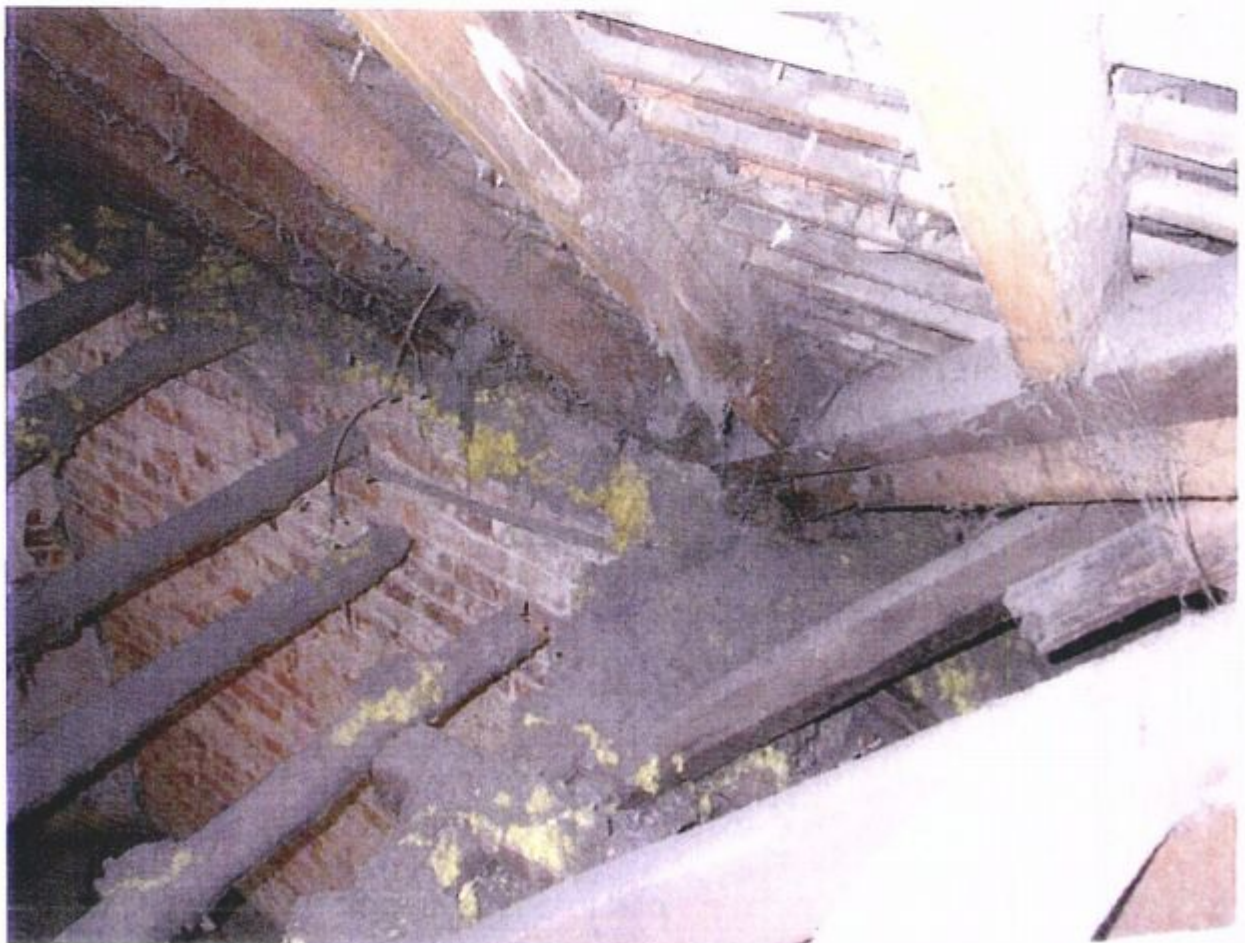
The joists are in very poor condition and have fallen away from the bearings in many instances.

This explains the previous bulge in the ceiling at the east. (See Photo No 11.)

Photo No. 11 – Bedroom 3. East Ceiling Joists at Junction with Rafters.

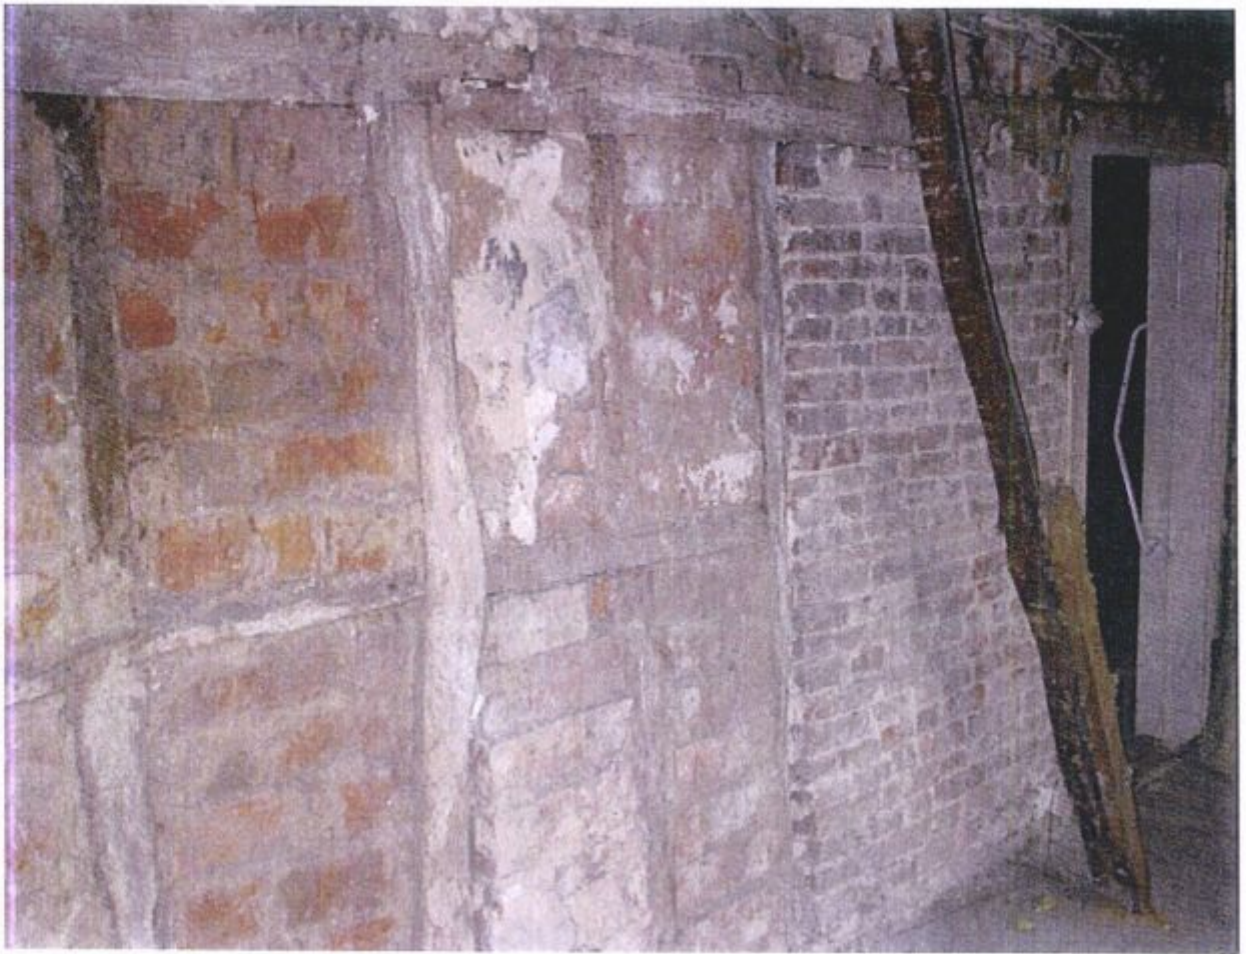
Photo No. 41

The load bearing wall between the Stair and Bedroom 3 is early timber frame with brick infill and the timbers show evidence of insect infestation and decay.

The bulge in the infill brickwork is indicative of the distress in the timber studs. (See Photo No. 41.)

Bedroom 3/Stair Load Bearing Wall.

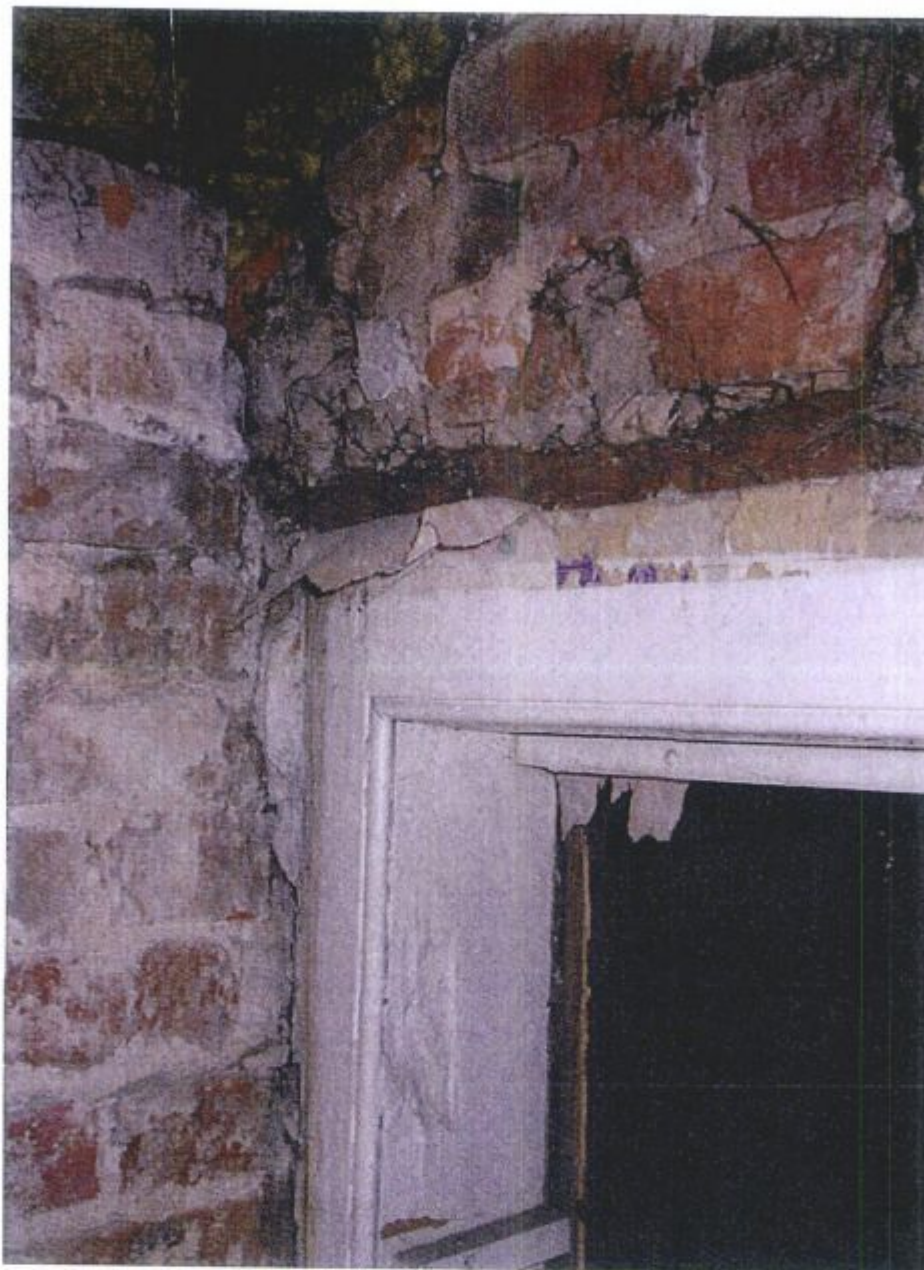
Photo No. 38

There is a vertical separation at the junction with the east Party Wall and the internal Stair wall where a cupboard doorway exists.

The timber lintel over the doorway appears to be an extension of the head plate in the wall and is showing considerable decay. (See Photo No. 38.)

Bedroom 3.

Internal Load Bearing Wall Junction with Party Wall at Cupboard Doorway.

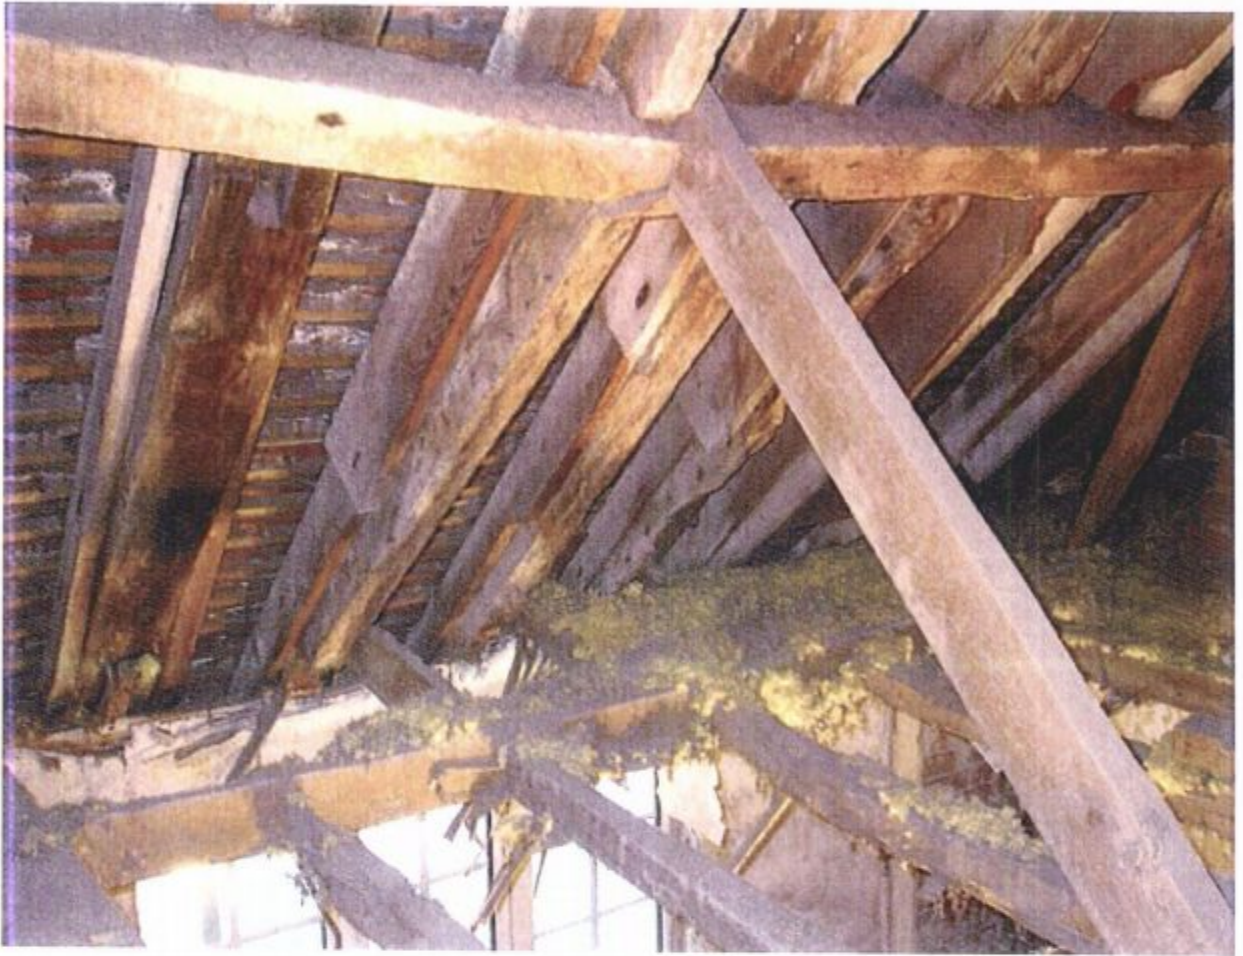
Photo No. 12

The roofs to the front pitches are in very poor condition, particularly that to the southwest, which is seriously distressed and lacks effective ceiling ties. (See Photo No. 012.)

Front Pitch over Bedroom 1.

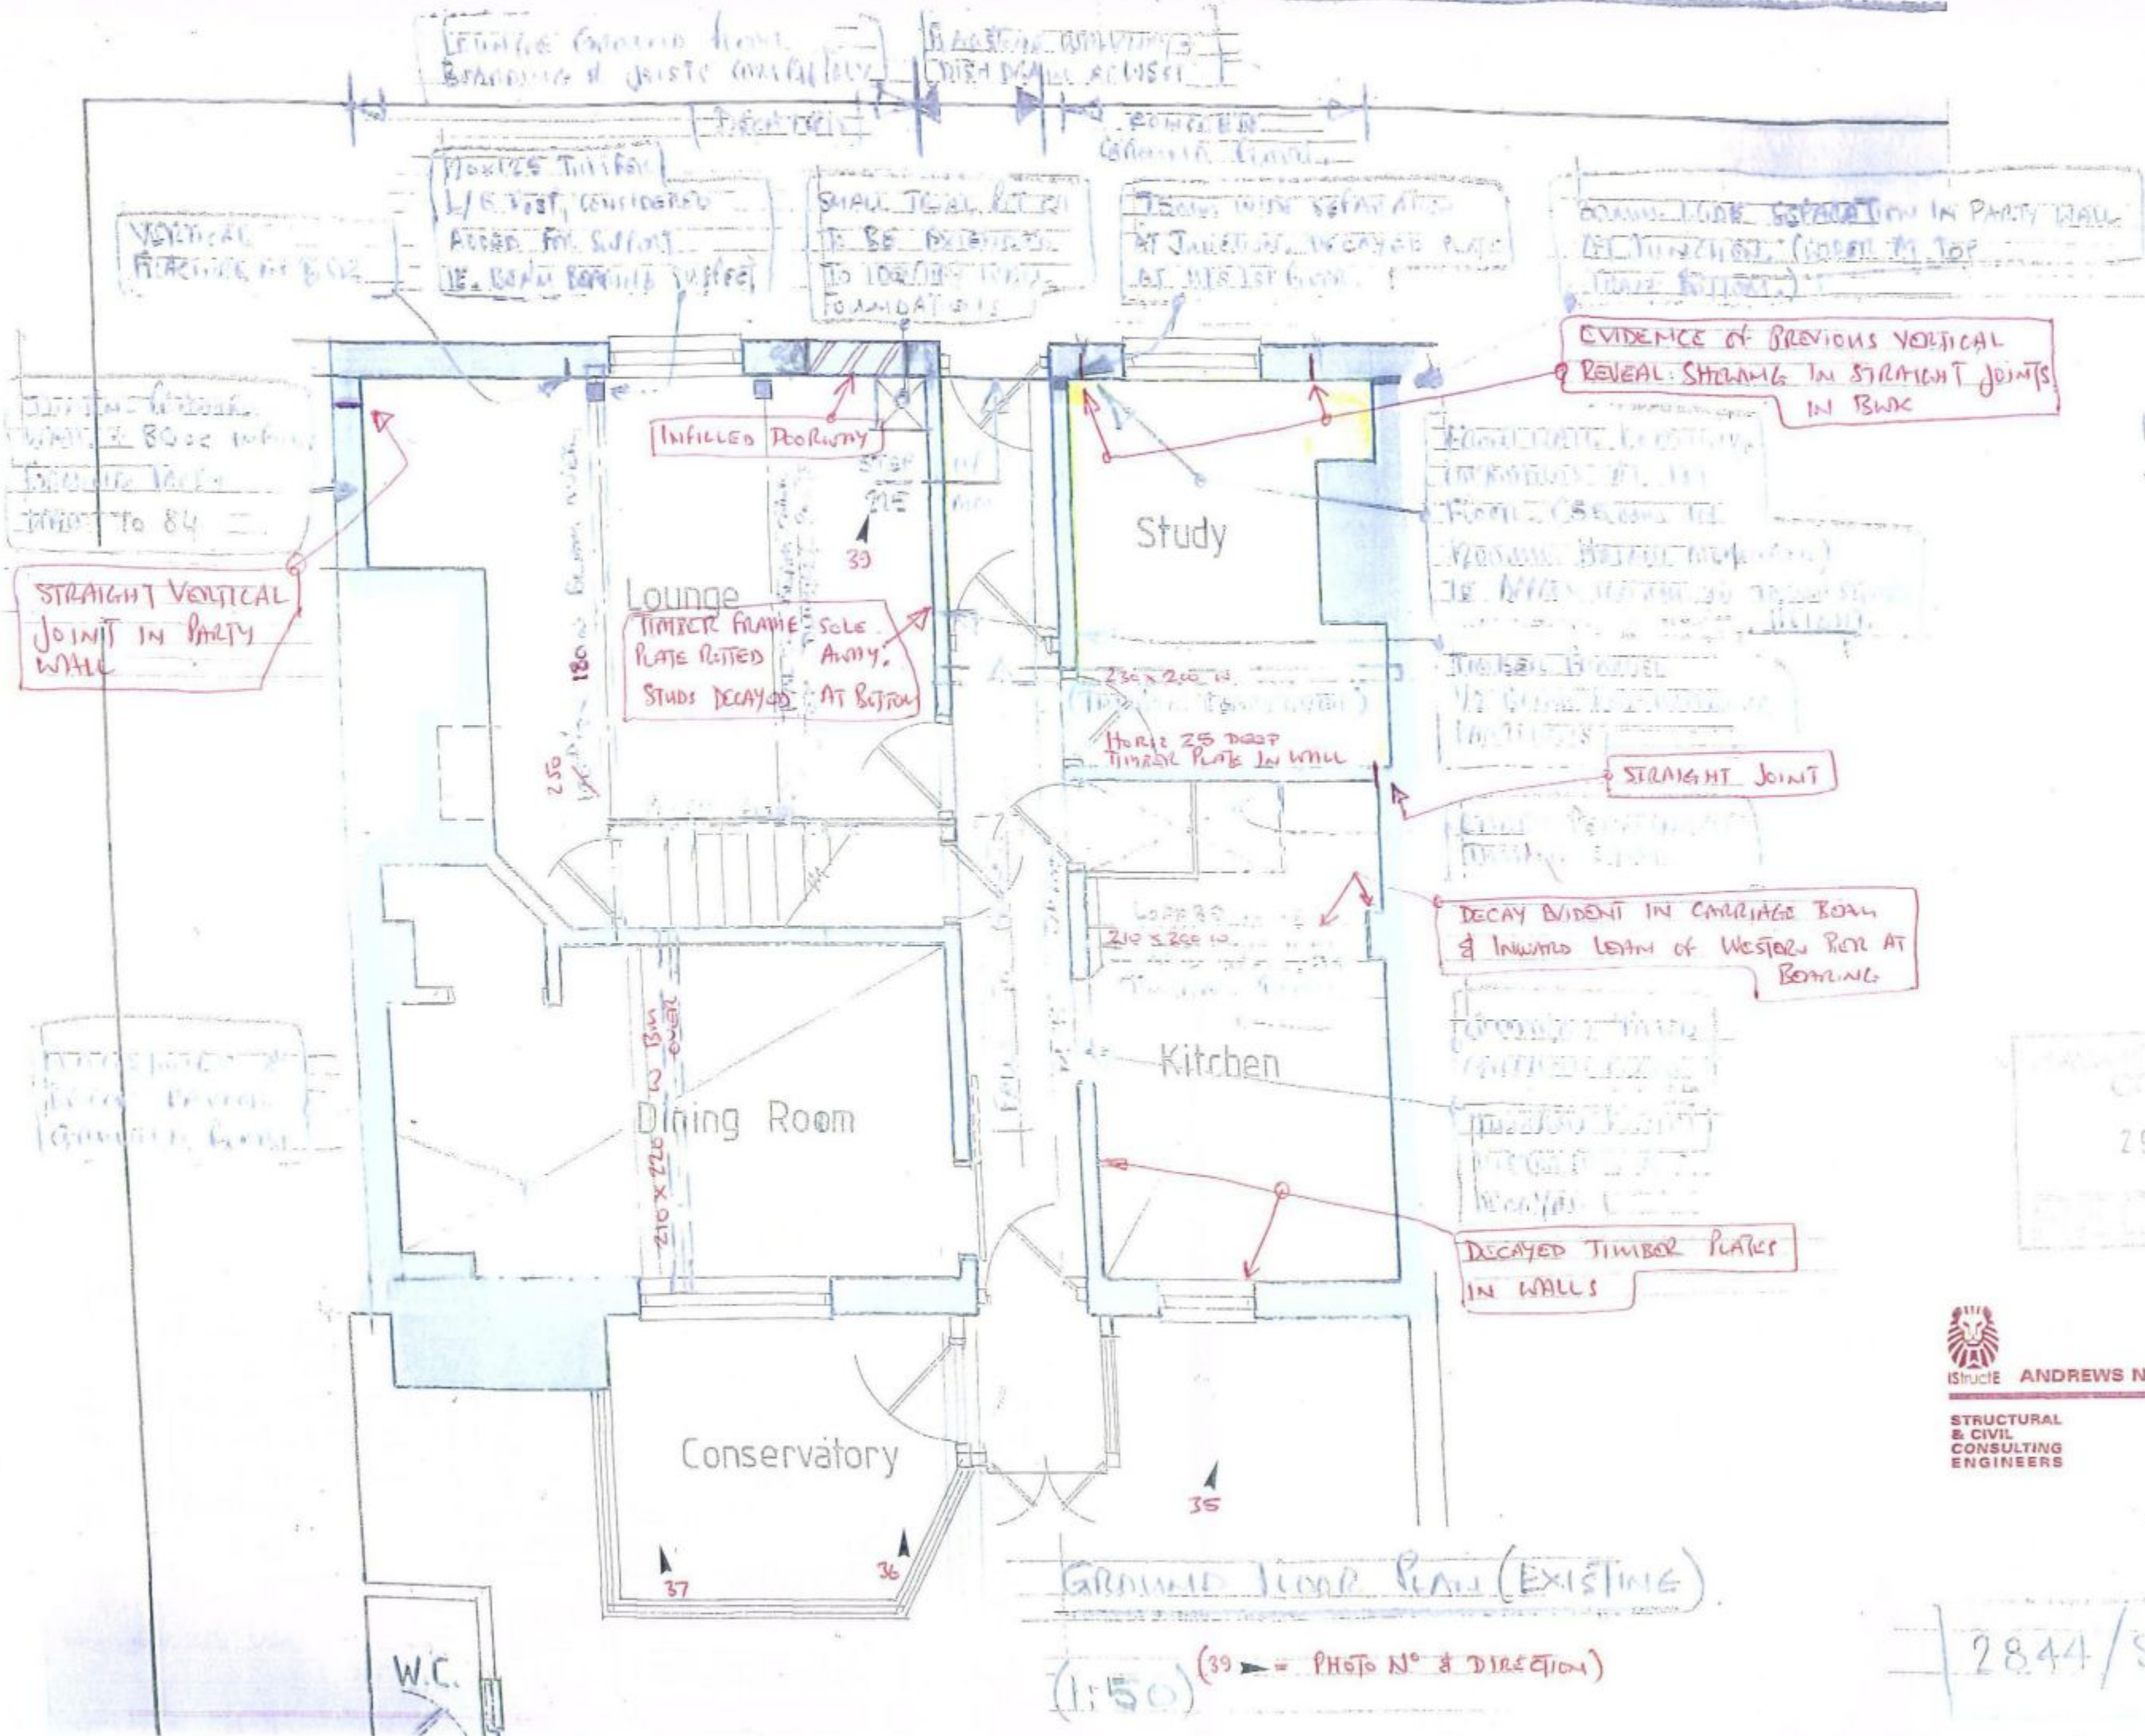
2844/SK/01/A

NOTE: - PARALLEL 1ST FLOOR JOISTS & SEPARATION OF CREEK WALLS WITH FRONT ELEVATION INDICATES NO LATERAL RESTRAINT AT THIS LEVEL

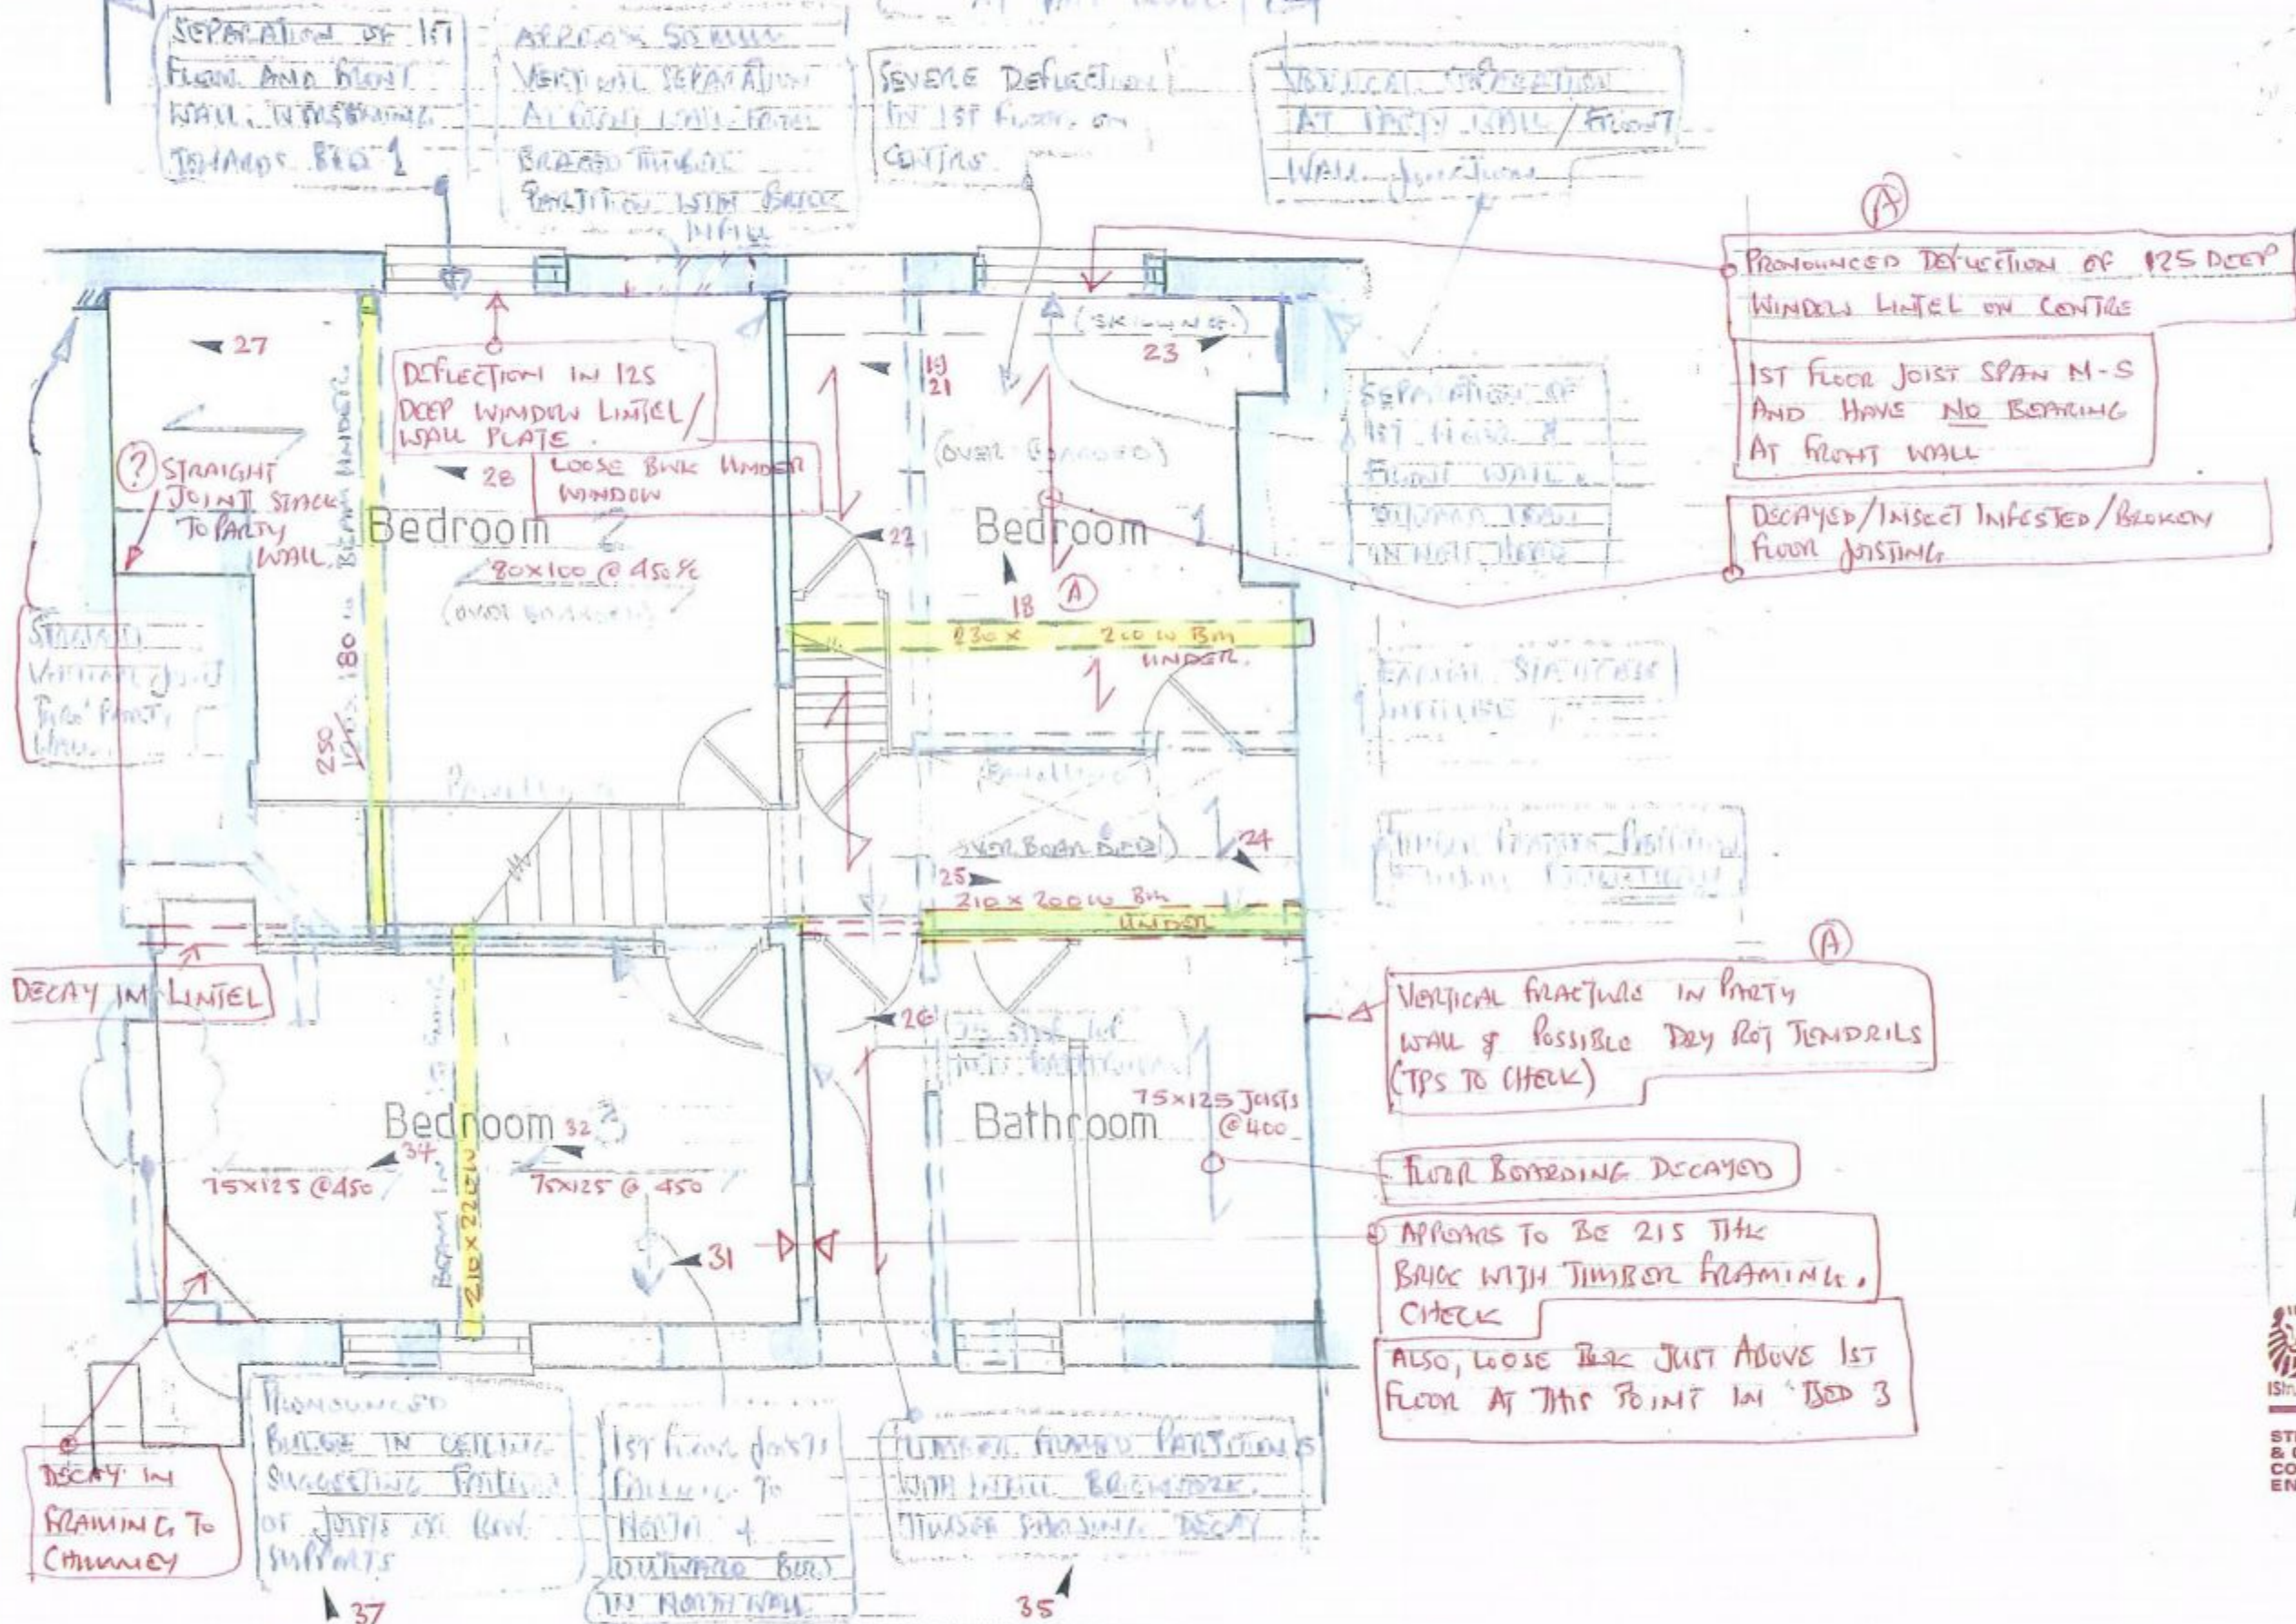
2844/SK/02 A

SEVERE DEFLECTION  
IN 1ST FLOOR ON  
CORNER

VERTICAL SEPARATION  
AT REAR WALL / FRONT  
WALL

PROMINENT DEFLECTION OF 125 DEEP WINDOW LINTEL ON CENTRE

1ST FLOOR JOIST SPAN M-S AND HAVE NO BEARING AT FRONT WALL

DECAYED / INSECT INFESTED / BROKEN FLOOR JOISTING

VERTICAL FRACTURE IN PARTY WALL & POSSIBLE DRY ROT TENDRILS (TPS TO CHECK)

FLOOR BOARDING DECAYED

APPEARS TO BE 215 TILE BACK WITH TIMBER FRAMING. CHECK

ALSO, LOOSE BRK JUST ABOVE 1ST FLOOR AT THE POINT IN BED 3
