# Arboricultural Assessment Report

## Detailed Report on Trees

| | <b>Risk Address:</b> | 18 Crystal Way, Waterlooville, Hants, PO7 8NB |
| <b>Refs:</b> | <b>OCA Ref:</b> | 55556 |

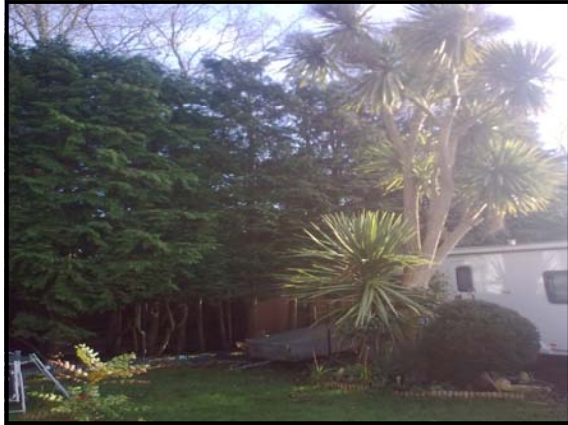
No roots relating to Beech or Cypress were recovered during investigations. However, given their size and proximity to the insured property we consider that it is likely that roots from Beech T3 and Lawson Cypress G1 have also extended beneath the depth of foundations. These trees have further significant growth potential.

1. Lawson Cypress G1.

| Tree No: | Species | Works Required |
|---|---|---|
| G1 | Lawson Cypress | Fell all trees as close as possible to ground level. |

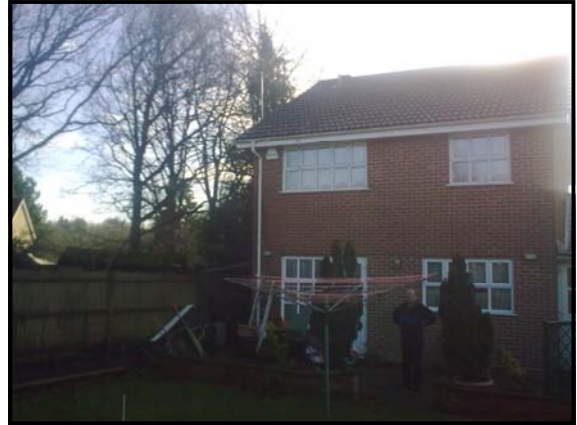
Given their size, species, and proximity to the location of the trial pit/borehole we consider that the roots formally identified as *Quercus* are most likely to have emanated Oak T1 or Oak T2. Both of these trees are situated within 12m of the property and their positions are consistent with the area of damage. Oaks T4 and T5 are also situated within potential influencing distance of the property although their positions are slightly less consistent with the area of damage. All of these Oak trees have significant further growth potential.

2. Rear elevation of the property with Oaks T1 and T2 and Beech T3 to the left.

| Tree No: | Species | Works Required |
|---|---|---|
| T1 | Oak | Fell and grind stump |
| T2 | Oak | Fell and grind stump |
| T3 | Beech | Fell and grind stump. |

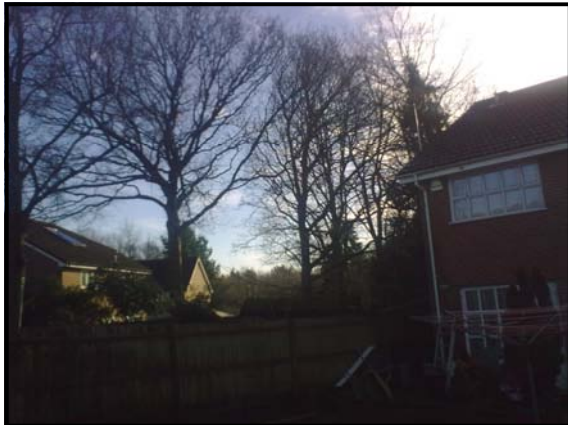
Therefore it is our opinion that sufficient information has been provided to demonstrate that, on the balance of probabilities, Oak T1, Oak T2, Beech T3, Oak T4, Oak T5 and Lawson Cypress G1 are the material cause of the current subsidence damage

3. Further view of the rear showing Oaks T1, T2, T4 and T5, and Beech T3

Given their close proximity to the insured property we do not consider that undertaking pruning works to the trees in question will provide either an effective or sustainable means of controlling their water use. Therefore and in order to provide a long-term solution to the current subsidence damage we recommend T1, T2, T3, T4, T5 and G1 be removed.
